# Admirable Home Inspections, LLC

## Home Inspection Report

Inspected on Mon, Nov 6 2023 at 3:43 PM

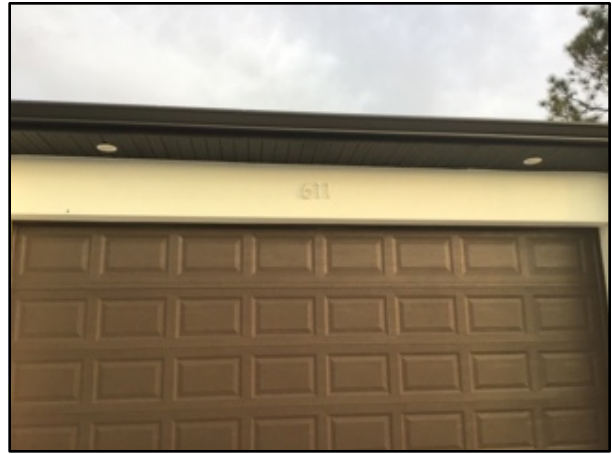
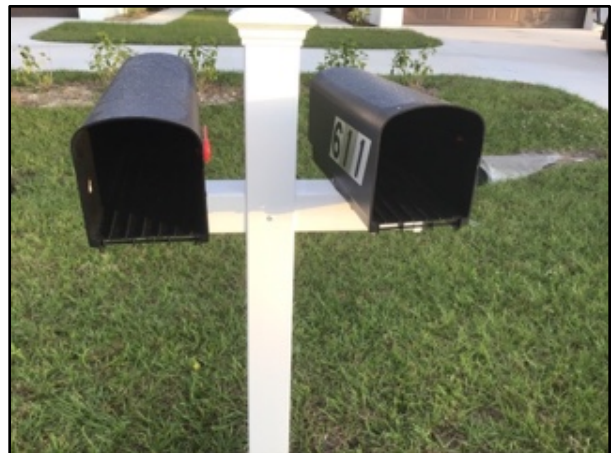
One of the mailboxes are missing the correct address numbering and doors are missing on both boxes. Recommend adding the correct address number and installing the doors.

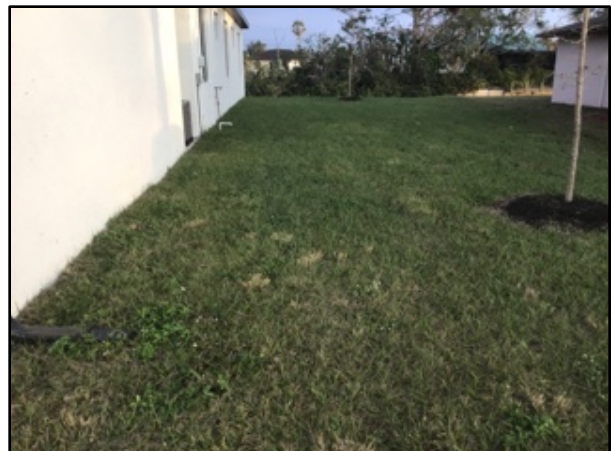
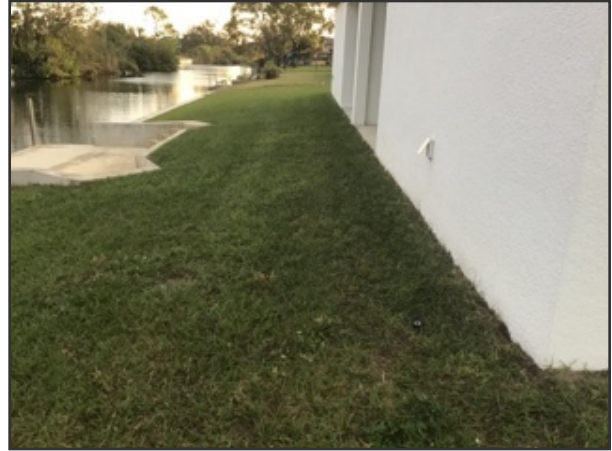
The majority of the site grading was in acceptable condition. There was one small depression by the main water line on the side of unit 609. This is collecting water and should be filled to meet the existing grade.

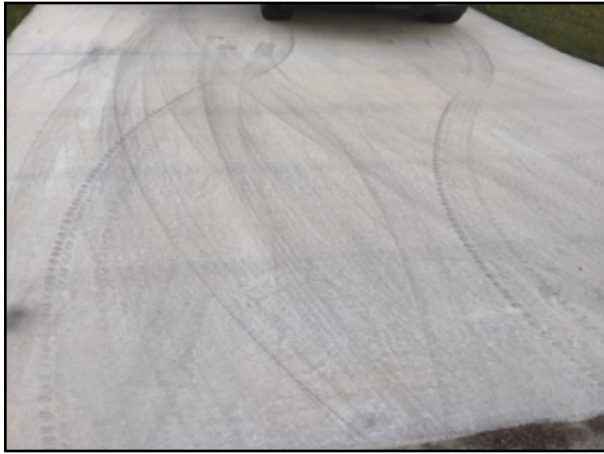
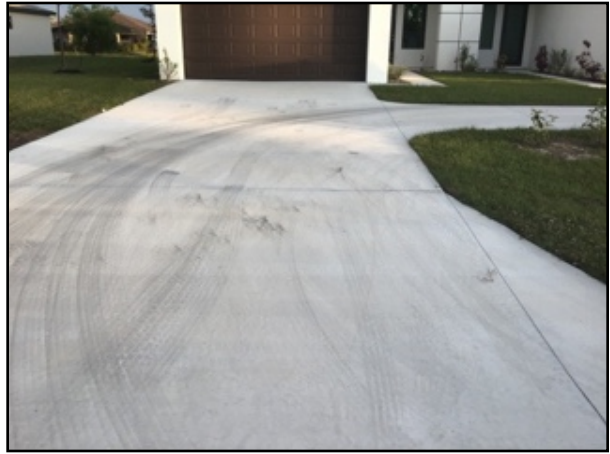
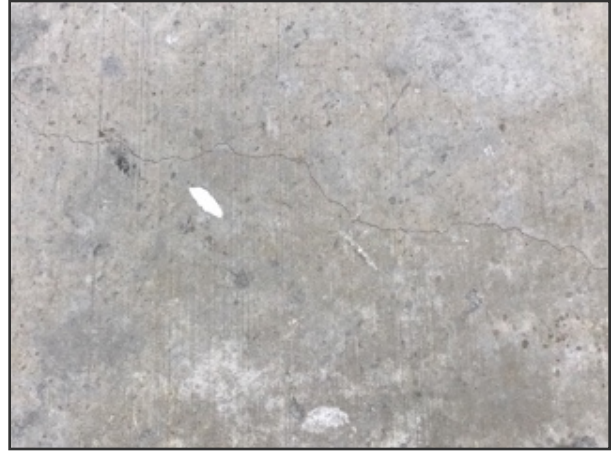
The driveways were in acceptable condition. Both walkways directly in front of the entryways have cracks. Cracks can develop from settlement in the soil below due to erosion, natural occurring slab settling, shrinking in the concrete which is typically from the evaporation of the water in the concrete during the curing process or expansion in the concrete due to the exposure to the extreme heat and fluctuations in the temperature. It is recommended to contact the contractor/builder to repair or replace as needed.

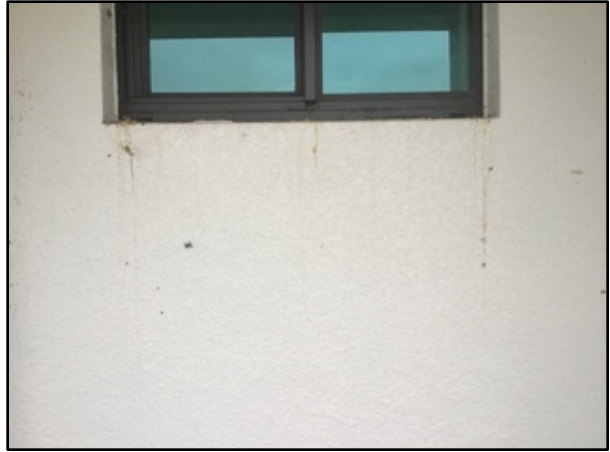
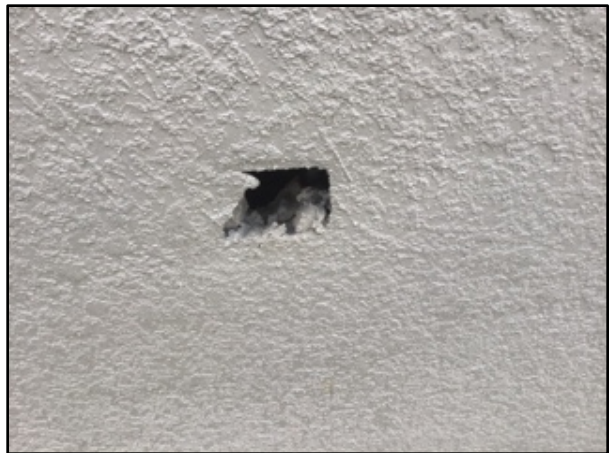
The majority of the exterior covering was in acceptable condition. There were multiple areas that have scuff marks, scratches, dirt, insect debris and one hole. It is recommended to pressure wash and repair any scratches in the stucco.

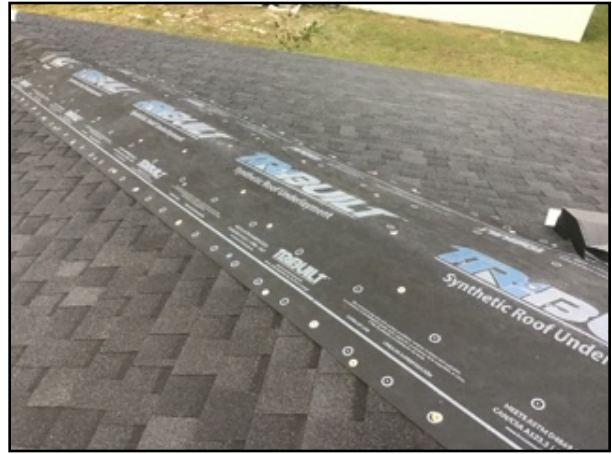
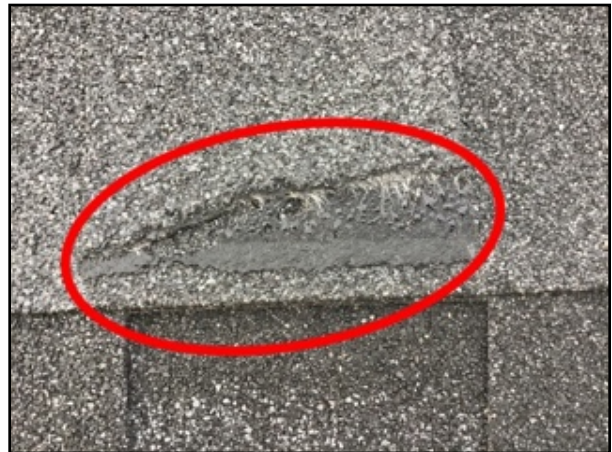
There were a few damaged shingle tabs and a section of hip cap shingles were missing. It is recommended to contact the contractor/builder to repair as needed. It is also noted that the temporary covering on the ridge caps have been nailed through the face of the existing shingles. Nails/holes should never be in the shingles that are "in the weather" Those shingles should be replaced.

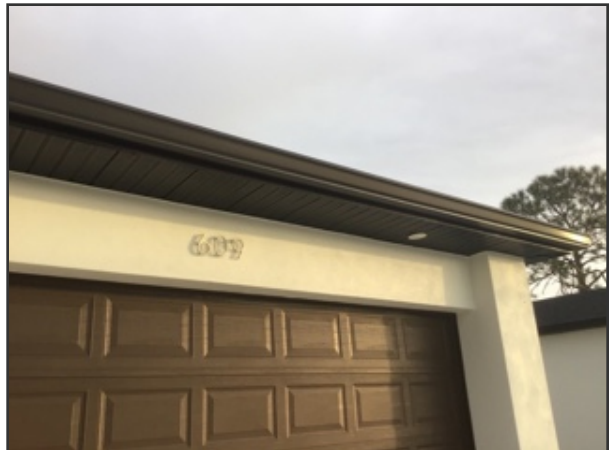
Day of inspection it was noted that some of the roof system had no gutters. Gutters help deflect water away from the foundation systems and components when accompanied with proper downspouts and extensions. Would recommend contacting a licensed or qualified contractor to install gutters, downspouts and extensions where needed.

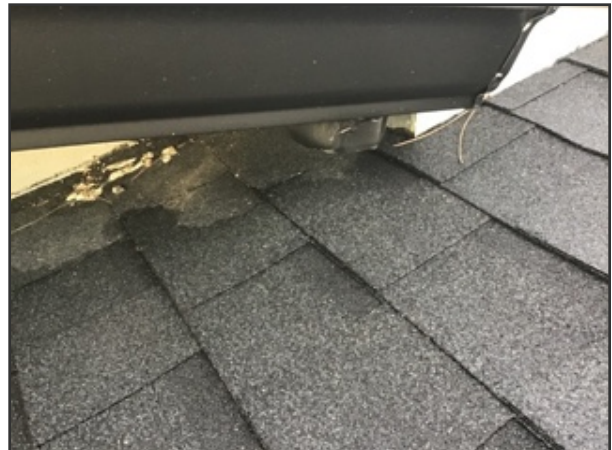
These sections of gutters do not have downspouts. This is allowing the gutter system to drain water directly on the shingles. This can cause premature wear in the shingles. It is recommended to contact the contractor/builder to install downspouts that drain directly to an existing gutter or the ground.

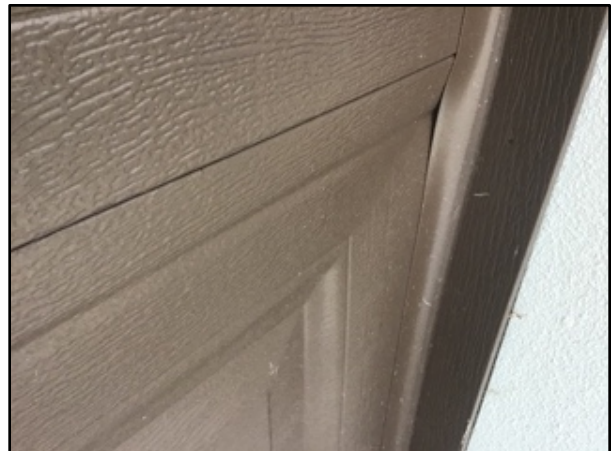
There were a couple of dents on the garage door. This does not affect the operation of the garage door however is creating the door to not seal completely against the weatherstripping. It was also noted that the weatherstripping was not fastened properly in some areas. Both concerns can allow hot air, water/moisture intrusion in the garage. It is recommended to contact the contractor/builder to replace the damaged section of doors.

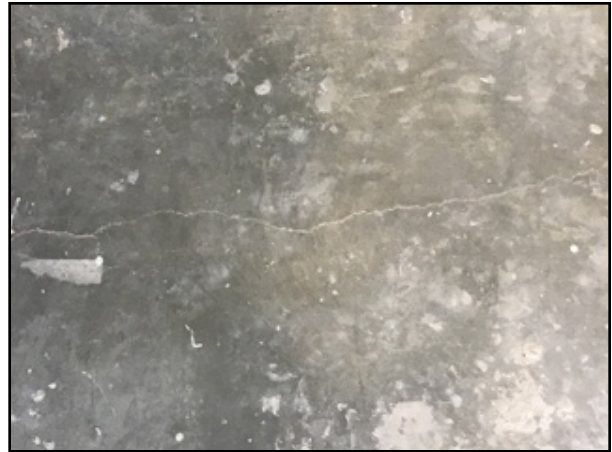
There were a few cracks in the garage floor. Cracks can develop from settlement in the soil below due to erosion, natural occurring slab settling, shrinking in the concrete which is typically from the evaporation of the water in the concrete during the curing process or expansion in the concrete due to the exposure to the extreme heat and fluctuations in the temperature. It is recommended to contact the contractor/builder to repair or replace as needed.

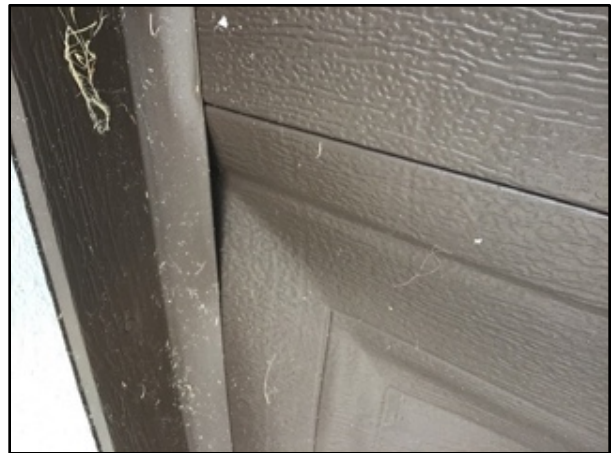
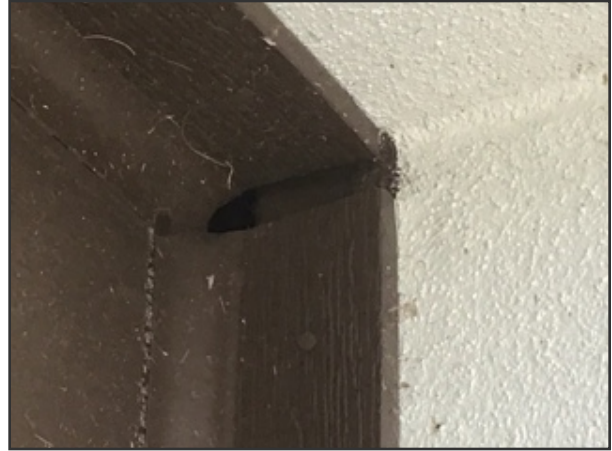
There were a couple of dents on the garage door. This does not affect the operation of the garage door however is creating the door to not seal completely against the weatherstripping. It was also noted that the weatherstripping has openings at the top corners. The weatherstripping was not installed properly. Both concerns can allow hot air, water/moisture intrusion in the garage. It is recommended to contact the contractor/builder to replace the damaged section of doors and replace the weatherstripping.

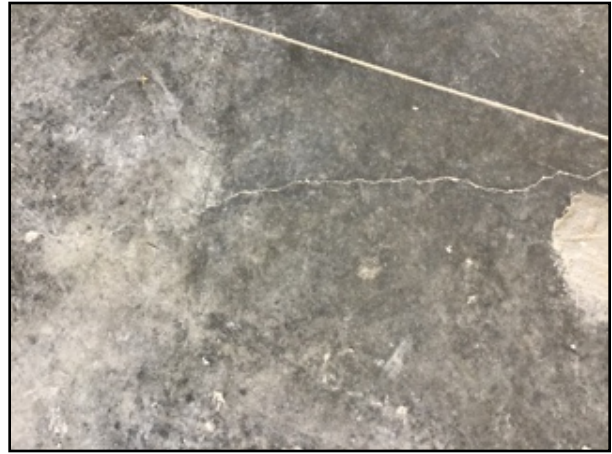
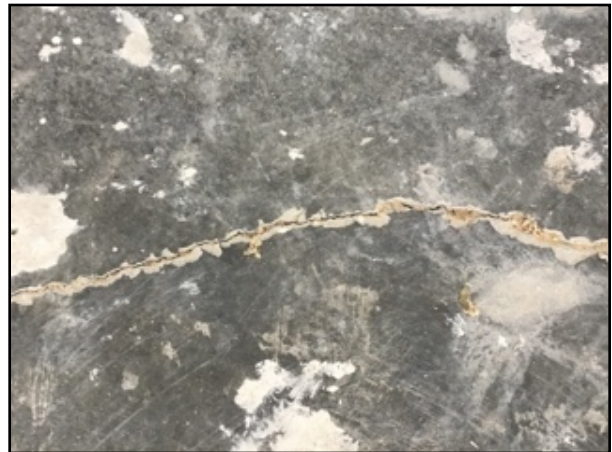
There were a few cracks in the garage floor. Cracks can develop from settlement in the soil below due to erosion, natural occurring slab settling, shrinking in the concrete which is typically from the evaporation of the water in the concrete during the curing process or expansion in the concrete due to the exposure to the extreme heat and fluctuations in the temperature. It is recommended to contact the contractor/builder to repair or replace as needed.

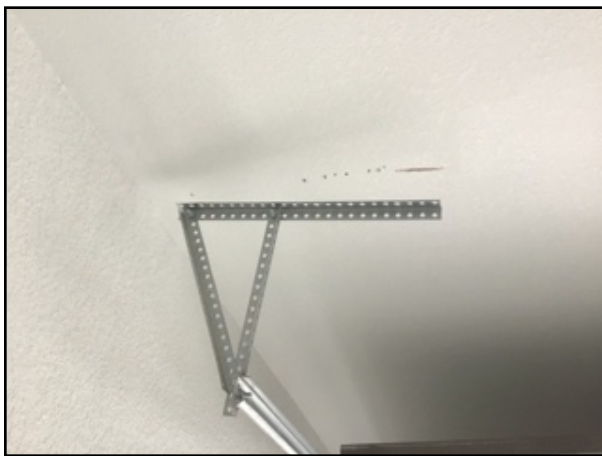
Figure 22-1

A mounting bracket for the garage door was not fastened. it is recommended to contact the contractor/builder to repair.

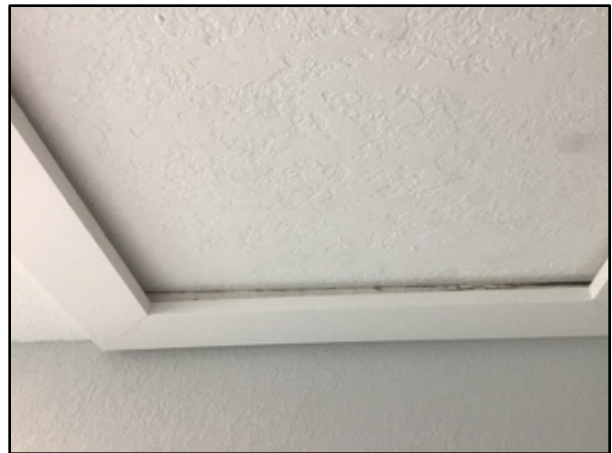
Unit 611 was missing the attic hatch cover. It was also noted that the attic hatch in unit 609 does not completely close. This can allow conditioned air to enter the attic. It is recommended to contact the contractor/builder to make repairs.

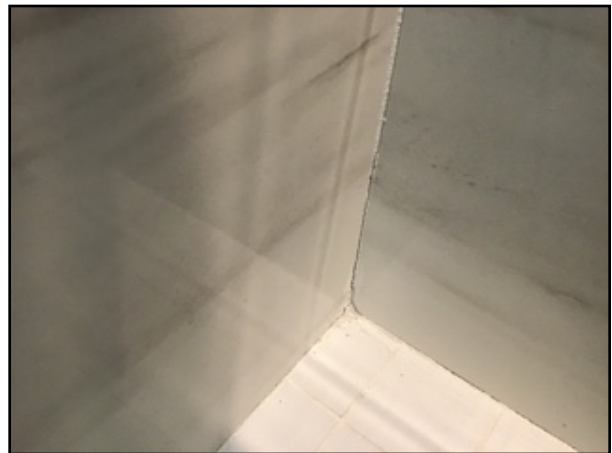
Day of inspection it was noted that there were areas of cracked/missing grout. This can allow water/moisture to get behind the tile and create additional concerns. Would recommend contacting a licensed contractor to repair as needed.

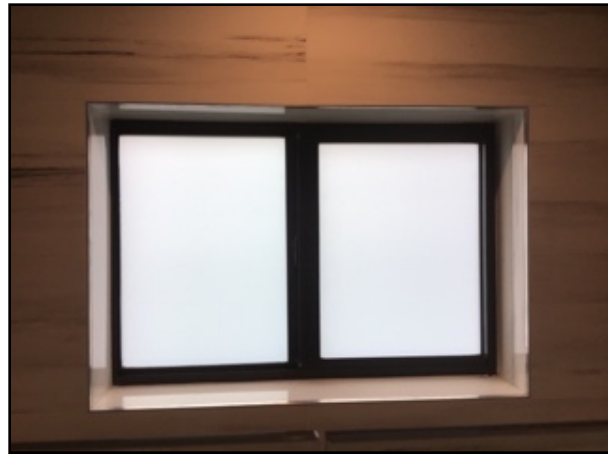
The window was difficult to open and close. It is recommended to contact the contractor/builder to repair.

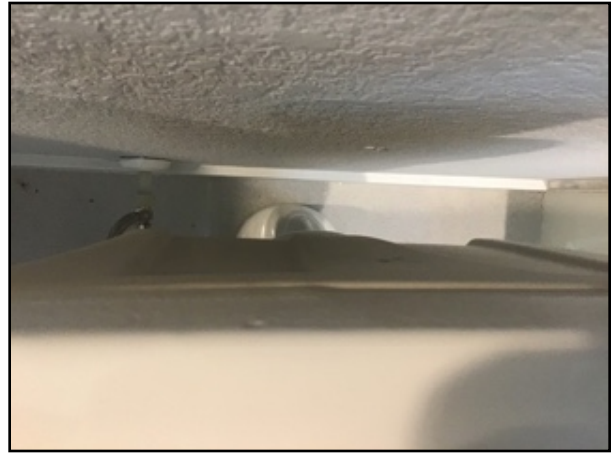
The toilet was placed too far from the wall. This is allowing too much space between the tank and the wall. The tank cover did not fit properly which is prohibiting the seat and cover to stay up. It is recommended to contact the contractor/builder to install the toilet properly and install the proper tank cover.

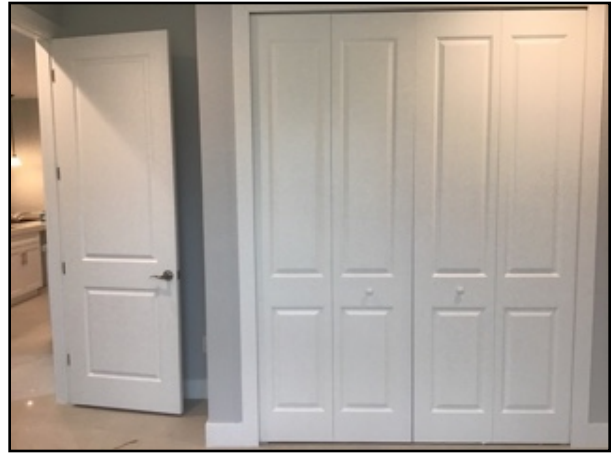
The bifold closet doors were not installed. It is recommended to contact the contractor/builder to install.

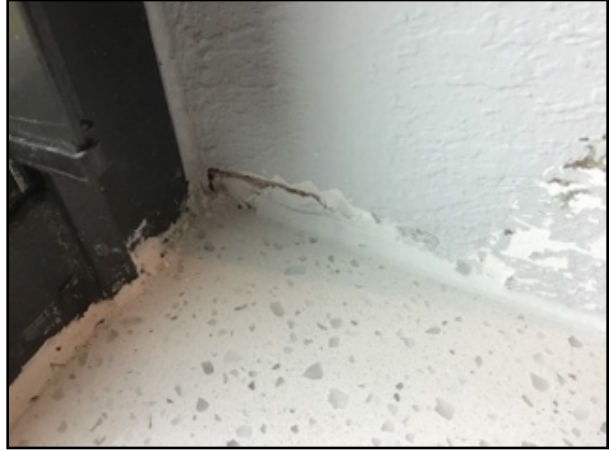
Some of the windows are difficult to open and close. It was also noted that some of the locks were difficult to operate. One of the windows has some damaged drywall near the window sill. it is recommended to contact the contractor/builder to make repairs.

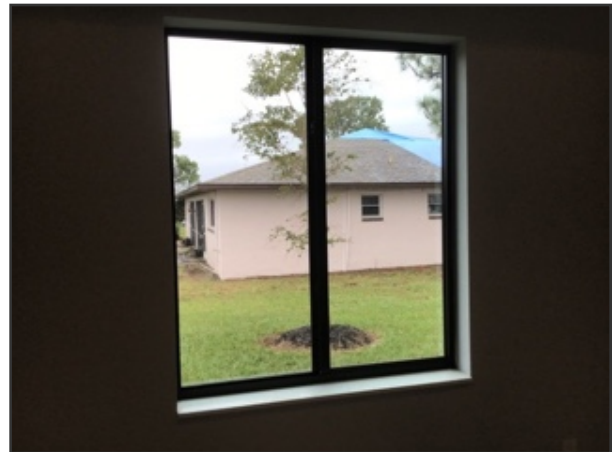
Some of the windows are difficult to open and close. It was also noted that some of the locks were difficult to operate. It is recommended to contact the contractor/builder to make repairs.

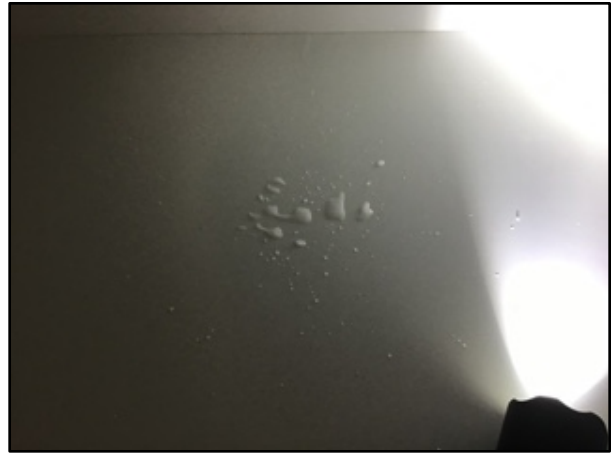
The sink was not sealed properly to the counter. This was causing a leak in the cabinet below. It is recommended to contact the contractor/builder to repair.

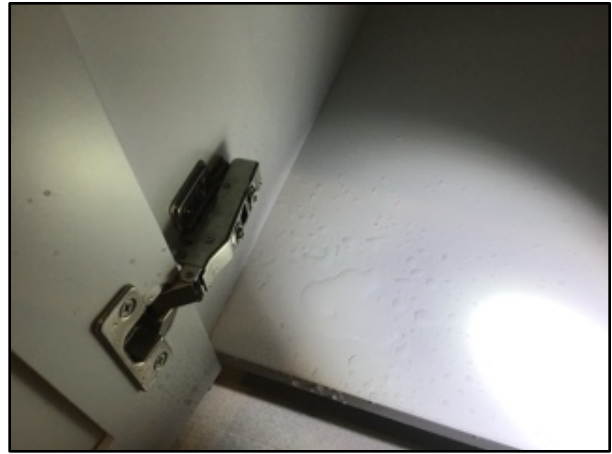
The sink was not sealed properly to the counter. This was causing a leak in the cabinet below. It is recommended to contact the contractor/builder to repair.

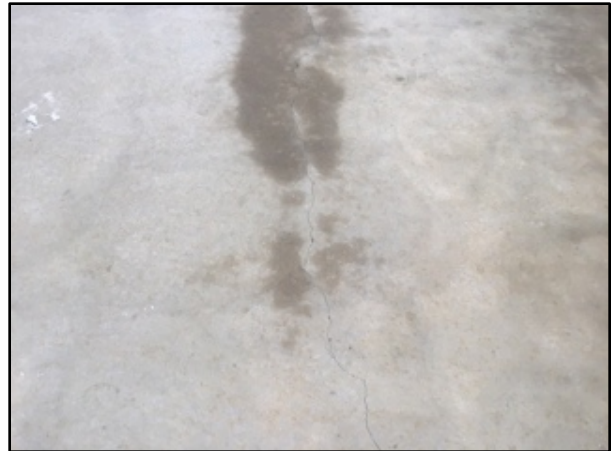
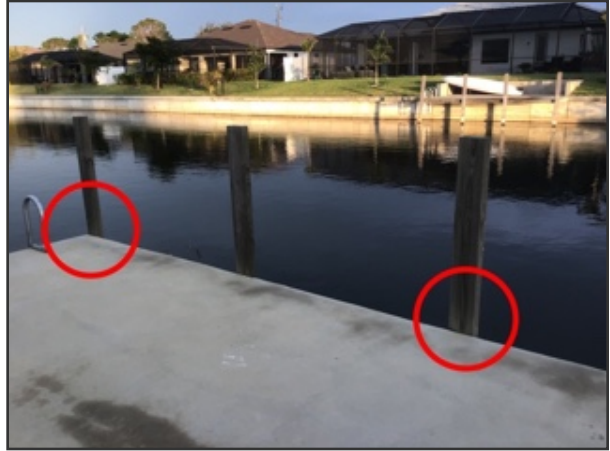
There was a crack in the concrete, an electrical outlet is missing and two of the wooden support columns have movement. It is recommended to contact the contractor/builder to make repairs.
