Admirable Home Inspections, LLC

Home Inspection Report

Inspected on Wed, Oct 25 2023 at 8:30 AM

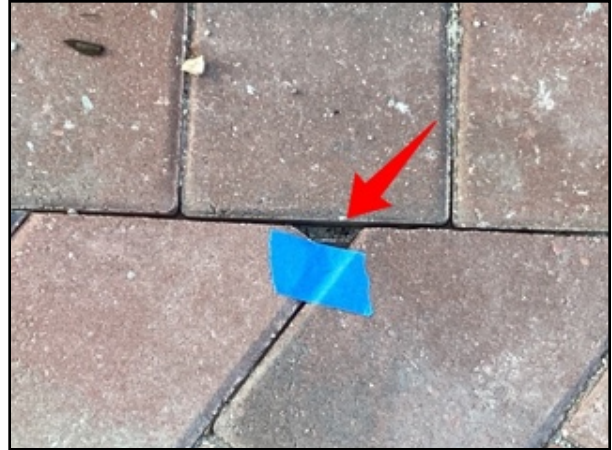
Condition: Requires Repair

The majority of the pavers were in acceptable condition. There was an area to the right side of the walkway that has a large sand joint. Pavers should be added in this area. If left unattended the sand will eventually erode and cause shifting, settling and or displacement in the pavers. It was also noted that there were a few smaller pavers missing and some defected pavers. It is recommended to add additional paver sand where needed. Paver sand will help secure the pavers from movement. In addition, the pavers then should be sealed. This will help the water run off of the pavers instead of draining down through the paver joints. If the water continues to drain through the paver joints this will allow additional disturbance of the soil below and cause the pavers to settle, shift, displace or become loose.

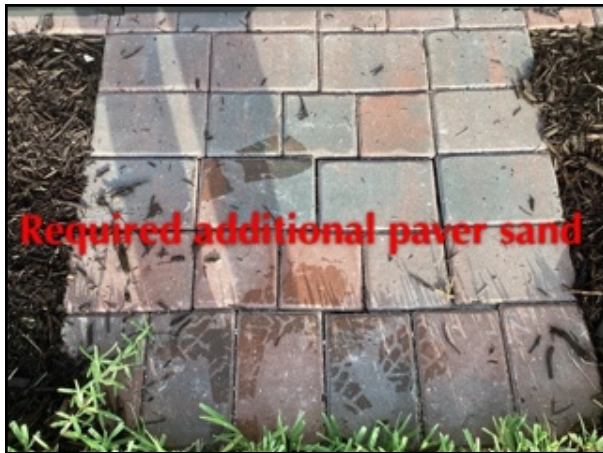
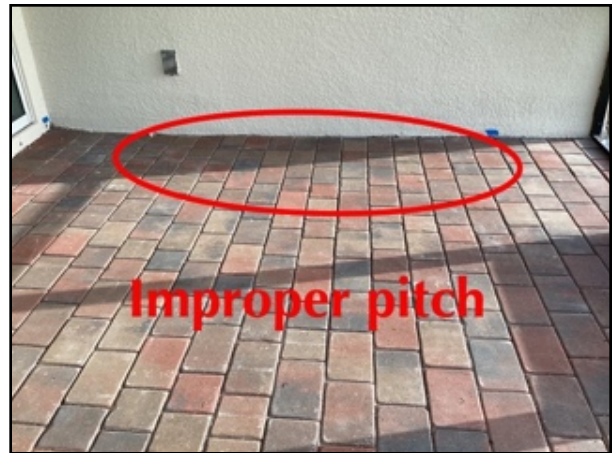
Condition: Requires Repair

There were areas of improper pitching or slope. If left unattended these areas will not allow water to run off the patio and possible create pooling/standing water. It is recommended to add additional paver sand where needed. Paver sand will help secure the pavers from movement. In addition, the pavers then should be sealed. This will help the water run off of the pavers instead of draining down through the paver joints. If the water continues to drain through the paver joints this will allow additional disturbance of the soil below and cause the pavers to settle, shift, displace or become loose.

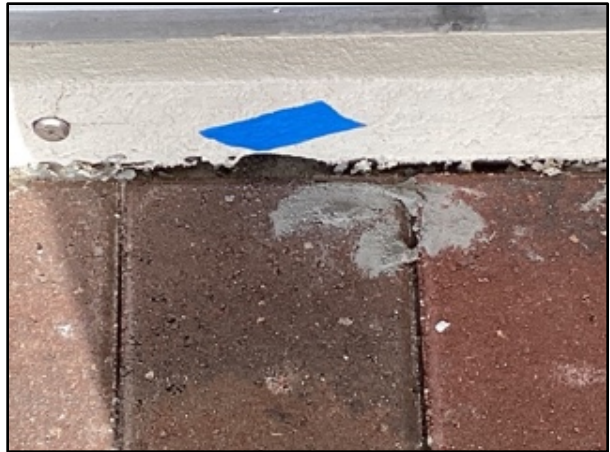
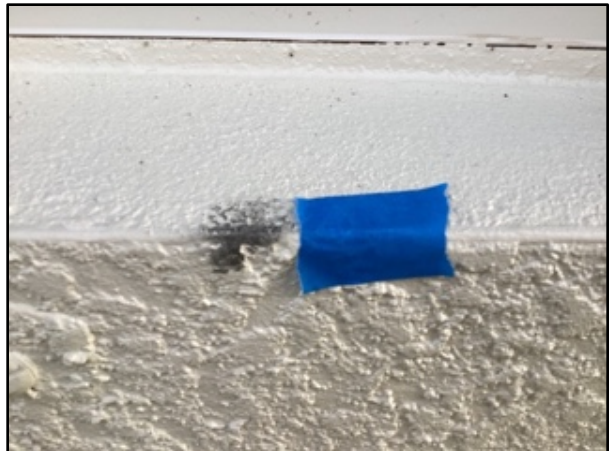
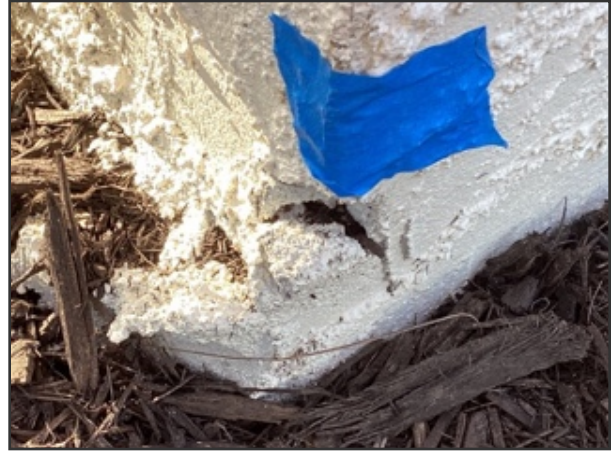
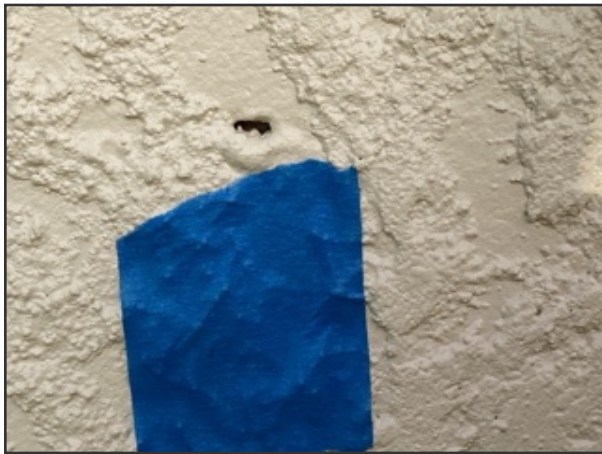
Concrete Block
Stucco
Condition: Requires Repair

There were several areas of the exterior covering that require immediate repair. These concerns include unfinished stucco application, damaged and or missing paint, improperly sealed protrusions.

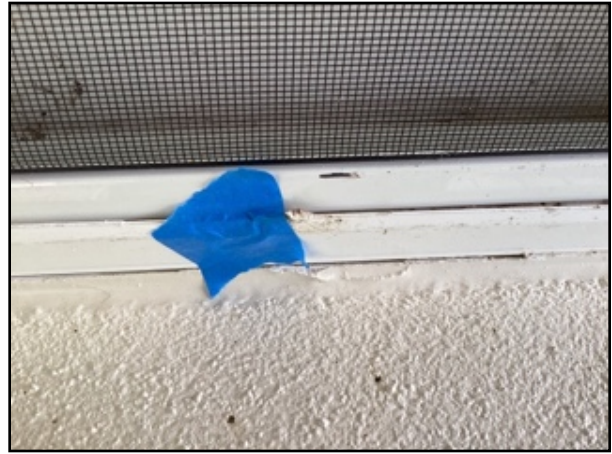
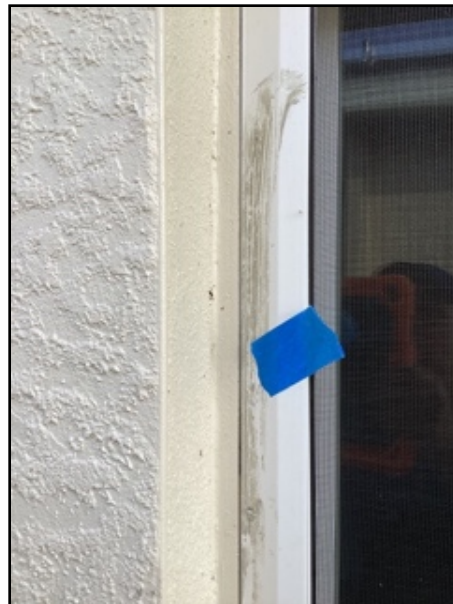
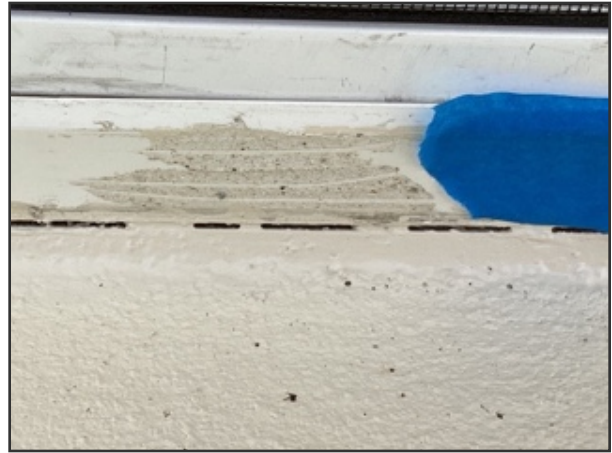
Inspected from Exterior
Condition: Requires Repair

There were several windows that have stucco splatter, caulk, and other residue. This is not a proper representation of a brand new final product. Removal of these residues is recommended on all windows.

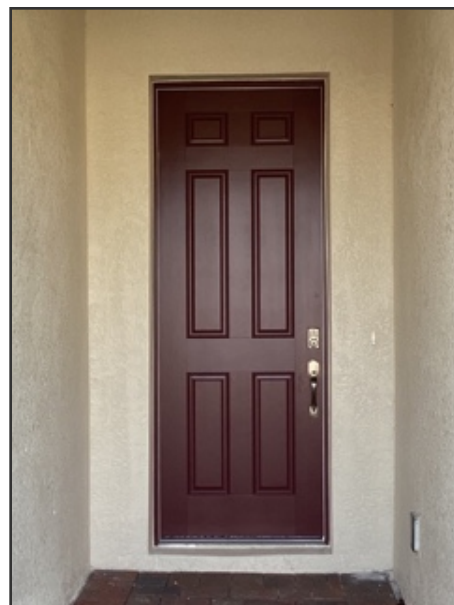
Locks Operating as Intended, Door Hinges not Secured, Door Latches Operating as Intended, Door Thresholds in Acceptable Condition, Weather Stripping Acceptable
Condition: Requires Repair

The main entry door is slightly out of square which causes a larger space between the jam and door on the upper right side. It also causes the door to rub the jamb on the upper left side. In addition some of the hinge pins are not completely set.

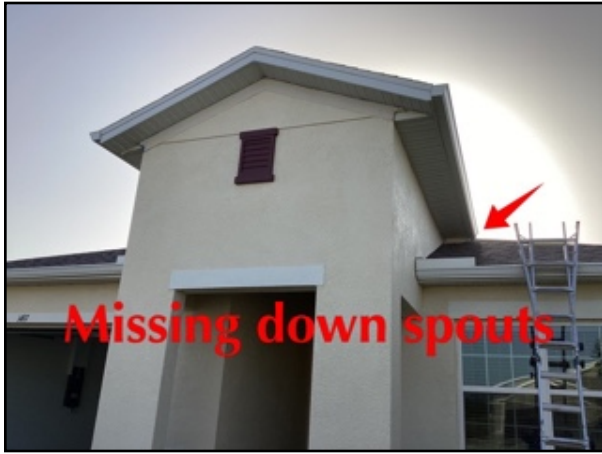
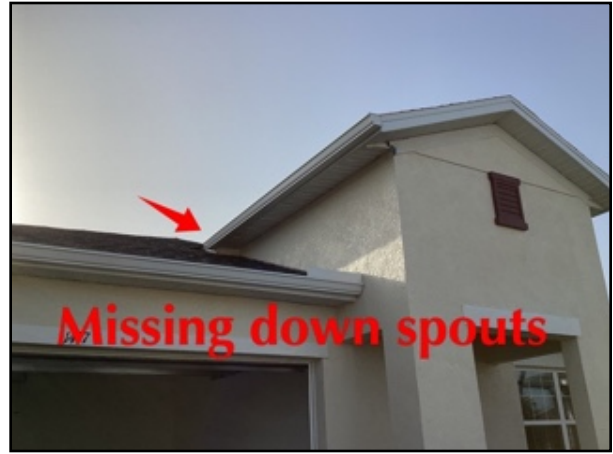
Condition: Requires Repair

The front entryway porch roof gutter system does not have downspouts. This is allowing excessive water to drain near the exterior walls and onto the shingles below which can cause premature failure/wear in those shingles and or water intrusion to the interior.

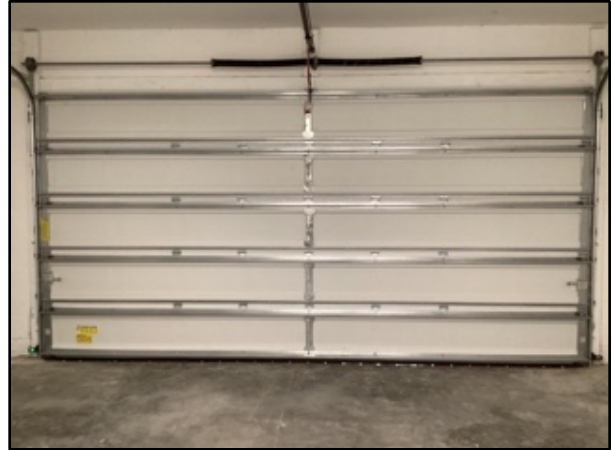
Garage Type: Attached
Garage Size: 2 Car
Non-Automobile Doors: Not Present
Automobile Doors: One, Air Gaps Noted
Condition: Requires Repair

Air gaps were visible at the bottom of the garage door. This can allow water/moisture, warm air or vermin intrusion. It is recommended to contact the builder to make repairs.

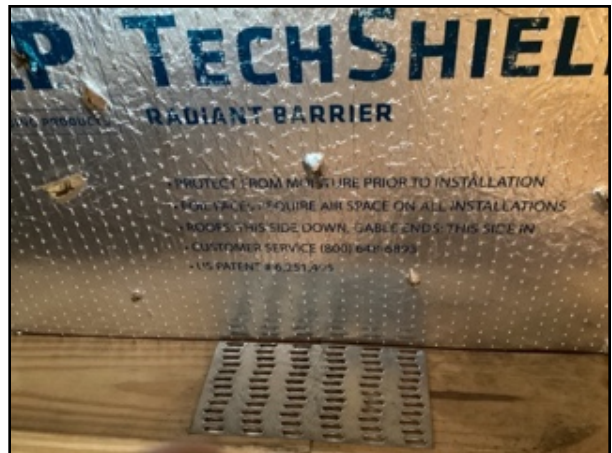
Condition: Requires Repair

A majority of the roof sheathing had radiant barrier. There were several sections of the sheathing that did not have a radiant barrier. A radiant barrier will help reduce attic temperatures however the areas that are missing the radiant barrier can negate the effects and increase the attic temperature. Please refer to the manufactures installation instructions of LP Tech Shield: <https://lpcorp.com/resources/product-literature/installation-instructions/lp-techshield-installation-instructions>.

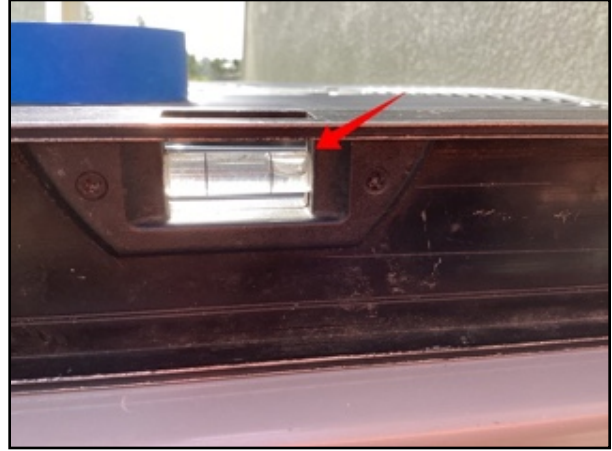
Concrete
Condition: Requires Repair

Day of inspection it was noted that the AC unit was not level. When the unit is not level this can prohibit the proper distribution of the fluids and lubricants causing damage to the compressor. This can also lead to unbalanced loads for any motors or fans, possibly causing the premature wear of bearings in the compressor motor.

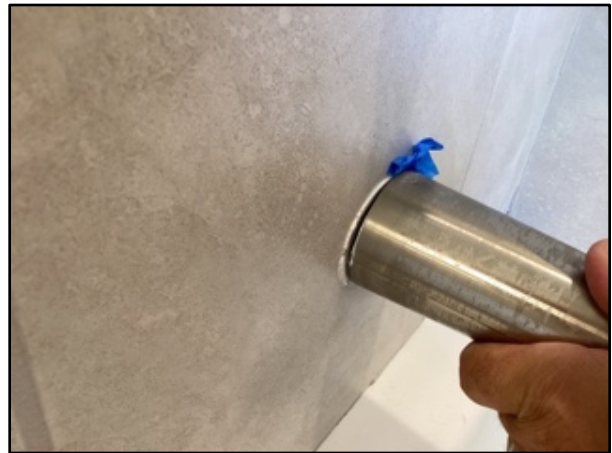
Built in , Staining on Tub
Condition: Requires Repair

There was some stains on the tubs surface, the shower diverter was broken which did not allow water to divert to the shower head and it was not properly sealed to the wall which can allow water to get behind the tile and cause additional concerns.

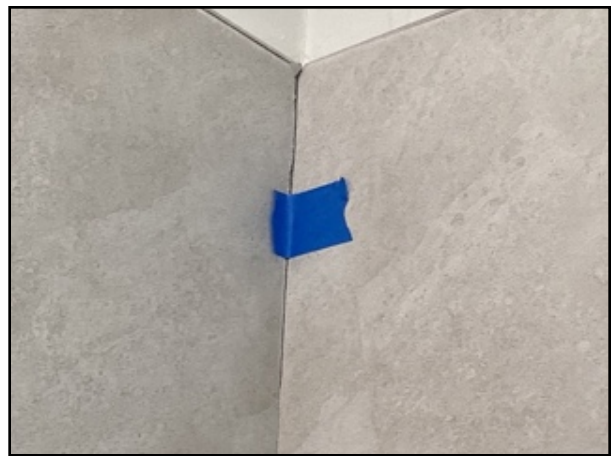
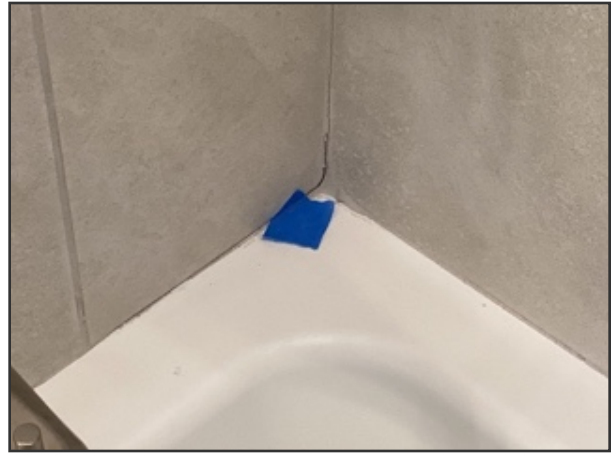
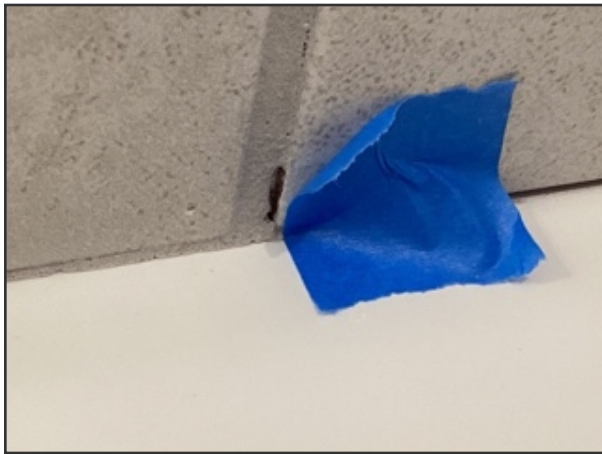
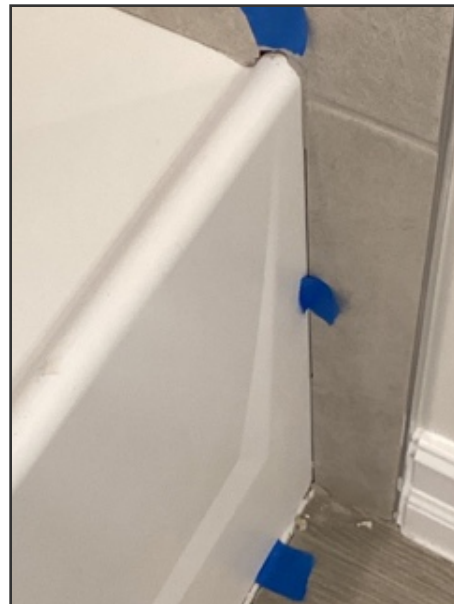
Condition: Requires Repair

There were areas of missing/damaged grout or caulking. This can allow water/moisture to get behind the tile and create additional concerns. Would recommend contacting a licensed contractor to repair.

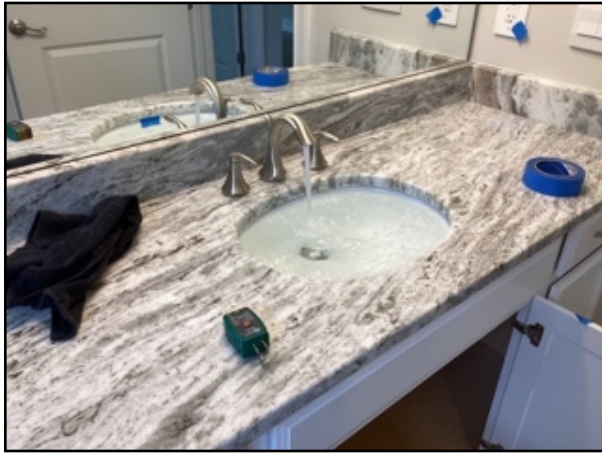
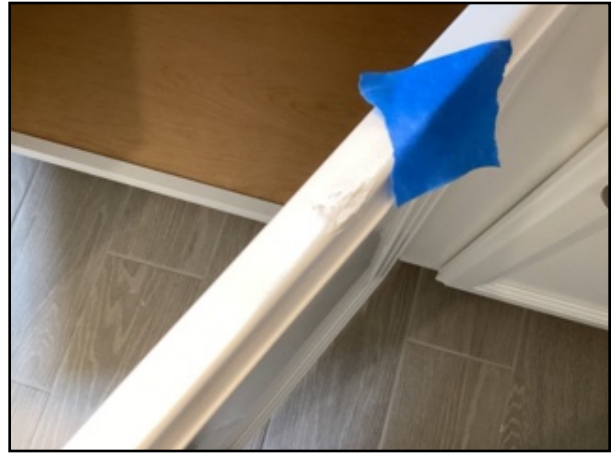
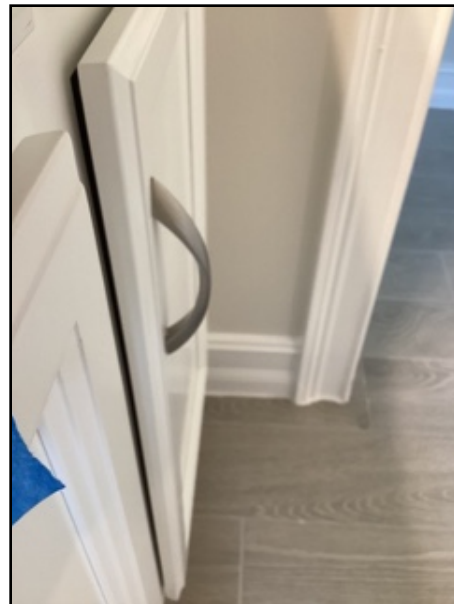
Single Vanity
Condition: Requires Repair

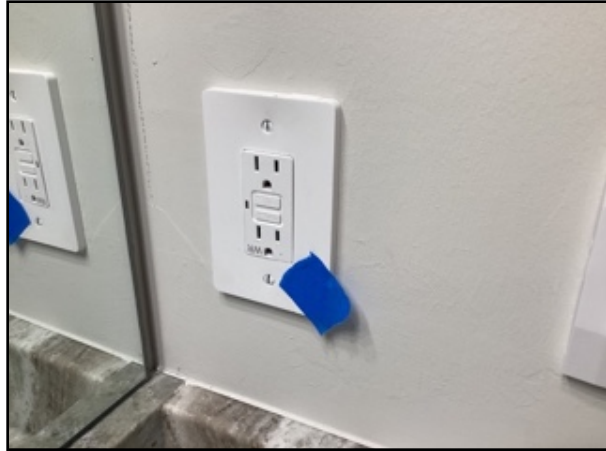
Condition: Loose Outlet Requires Repair

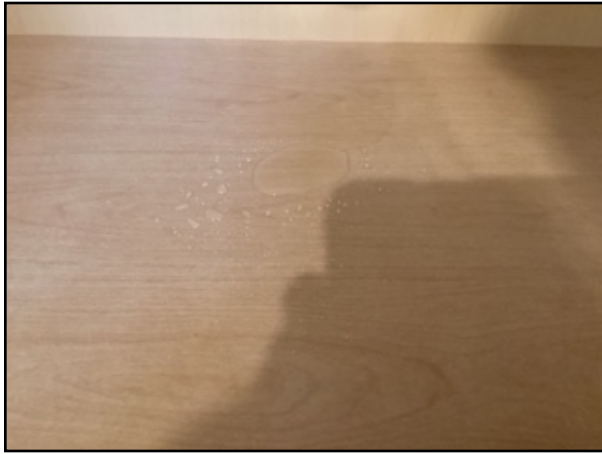
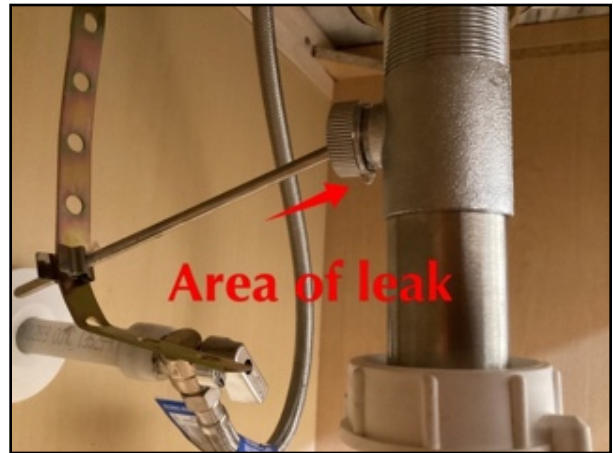
Under sink
Condition: Requires Repair

The sink was filled with water to check the secondary drain and for leaks at the connection of the counter top and sink. During this test a leak was discovered at the drain stop mechanism. It is also noted that there is some small areas of water damage to the veneer on the bottom cabinet shelf from a prior water leak.

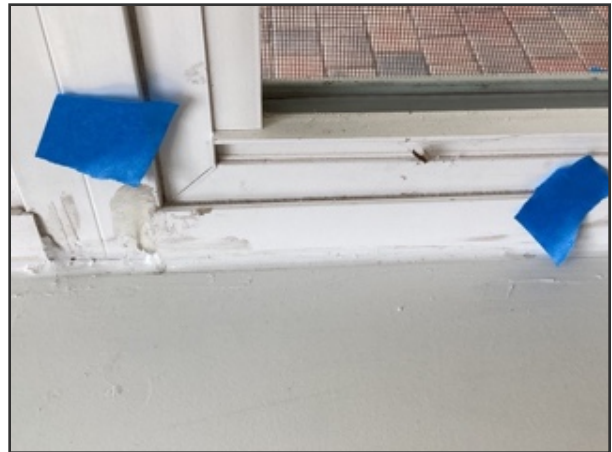
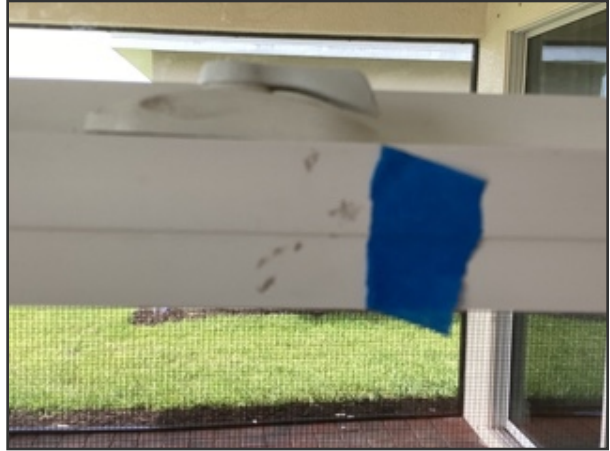
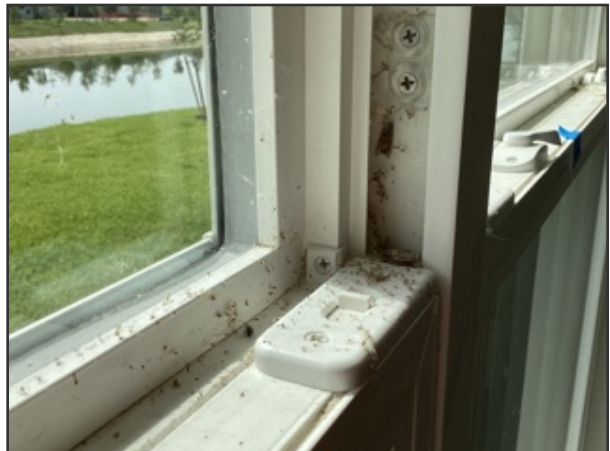
Condition: Requires Repair

All windows were tested for operation and functioned as intended. It was noted that there was caulking, glue and dead flies/residue. These windows are located in the dining room.

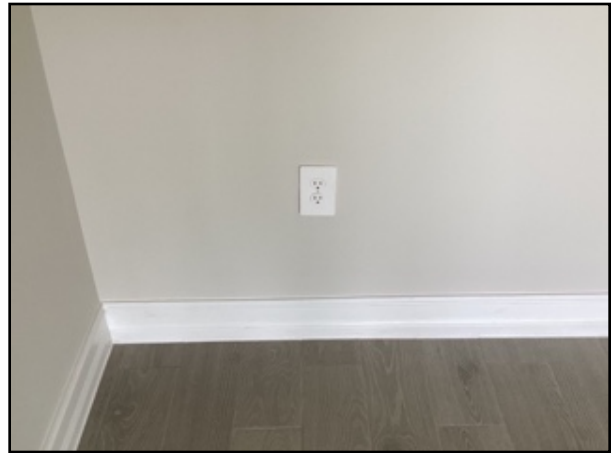
Inspected a Random Number of Switches and Outlets,
Several Outlets are Installed Crooked
Condition: Requires Repair

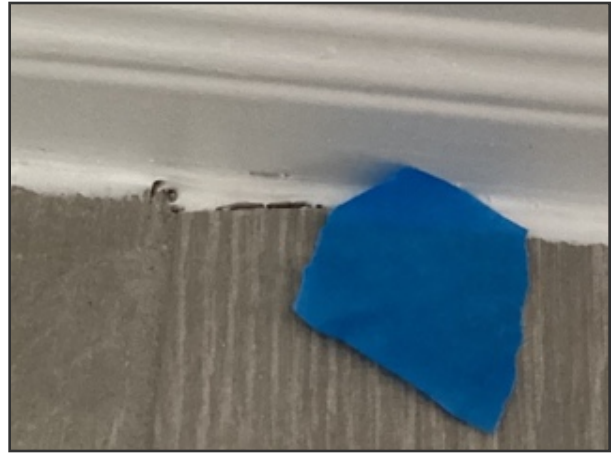
The majority of the ceiling and walls were in acceptable condition with the exception of some blemishes/imperfections in the paint, drywall and some missing caulk on the baseboard trim.

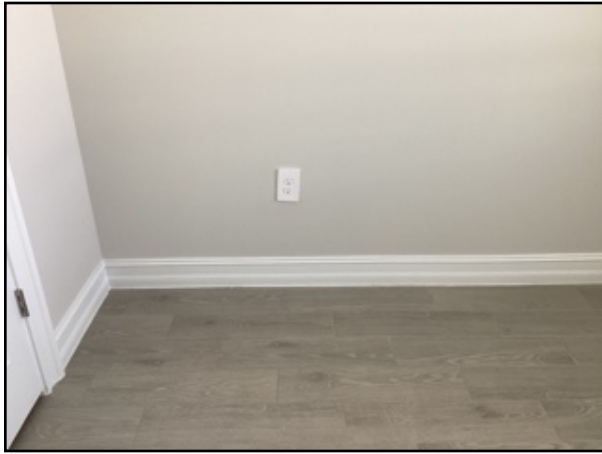
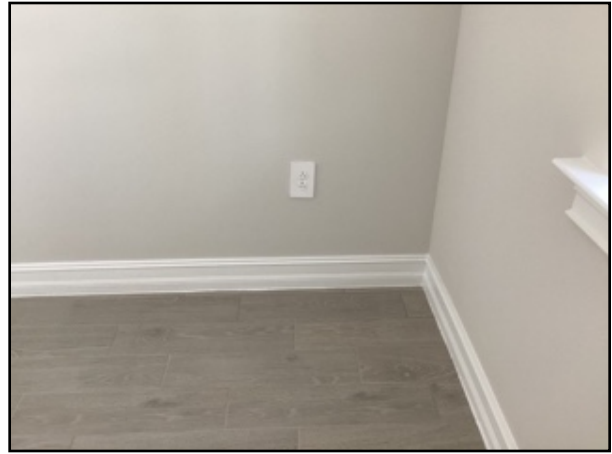
Some Switches and Outlets are Crooked
Condition: Requires Repair

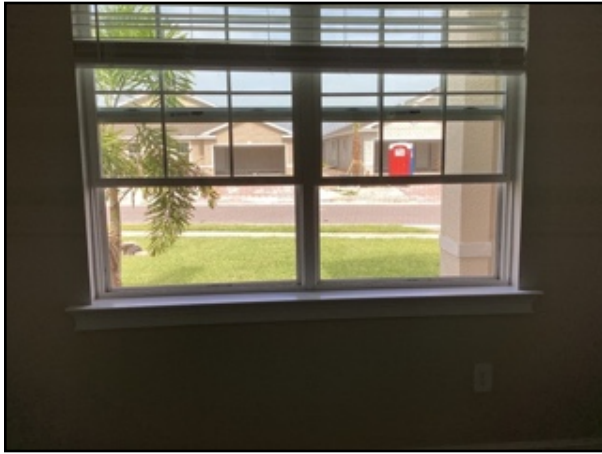
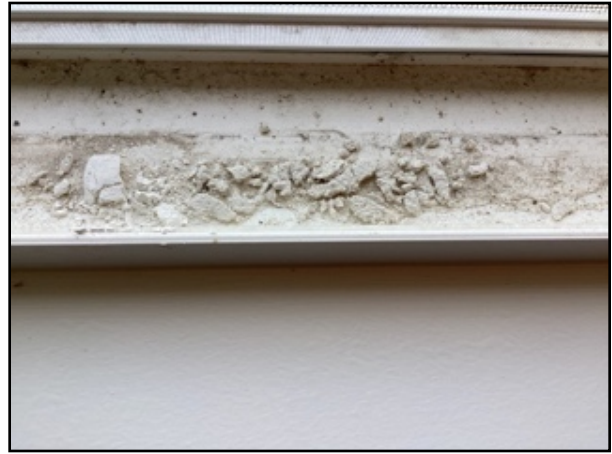
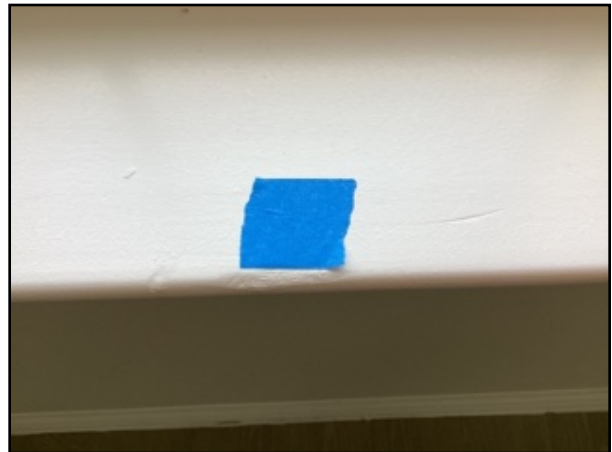
Condition: Requires Repair

Debris was found in the window jams, paint, caulk, glue, and other residue is present on several areas of the windows and an imperfection on the windowsill.

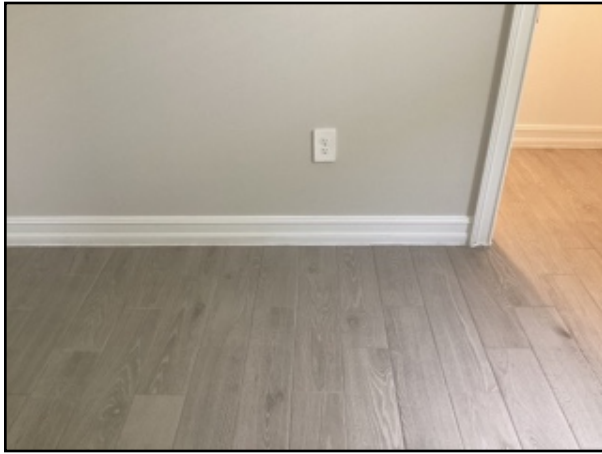
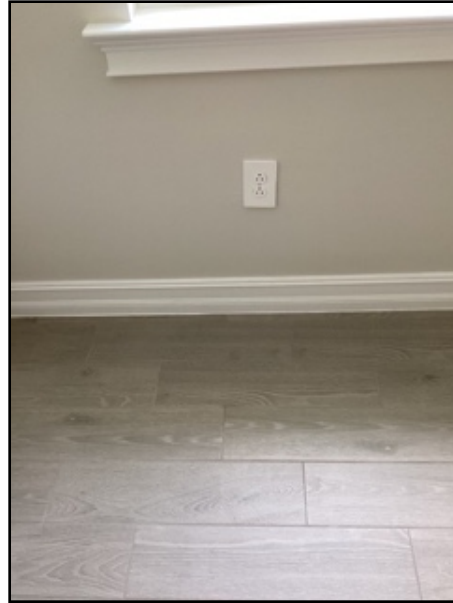
Some Switches and Outlets are Crooked
Condition: Requires Repair

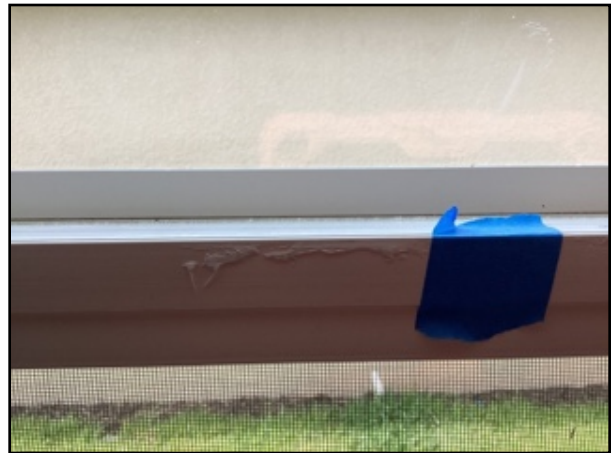
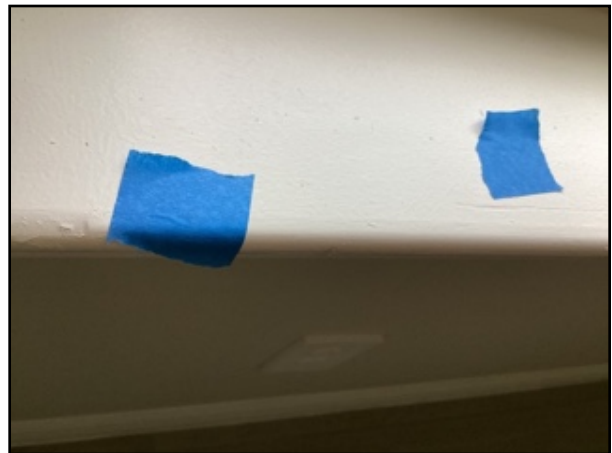
Condition: Requires Repair

Caulking and other residue was found in several areas of the window and the window jam has a couple blemishes/imperfections.

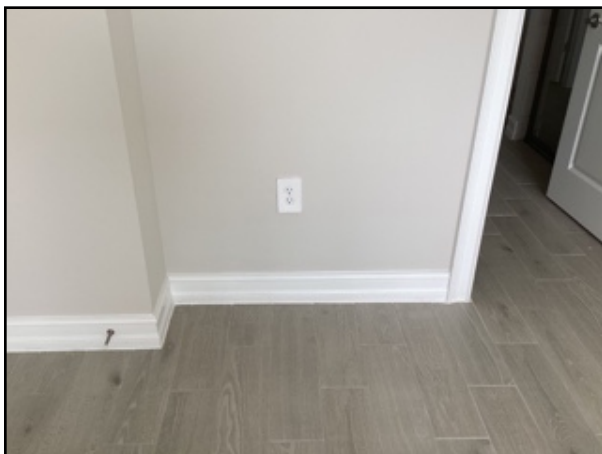
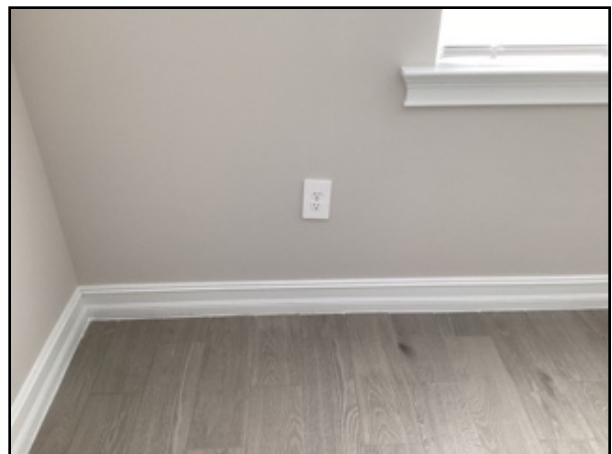
Some Switches and Outlets are Crooked

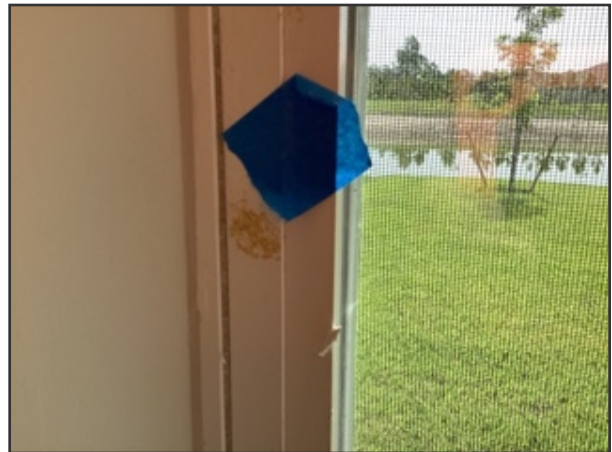
Single Hung
Condition: Requires Repair

Comment 45:
Caulking and other residue was found in several areas of the window.

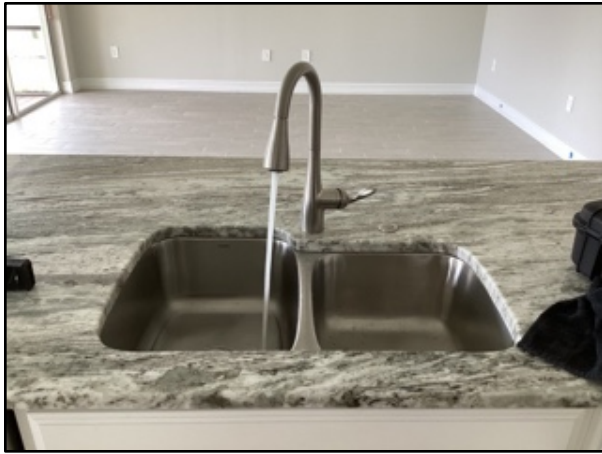
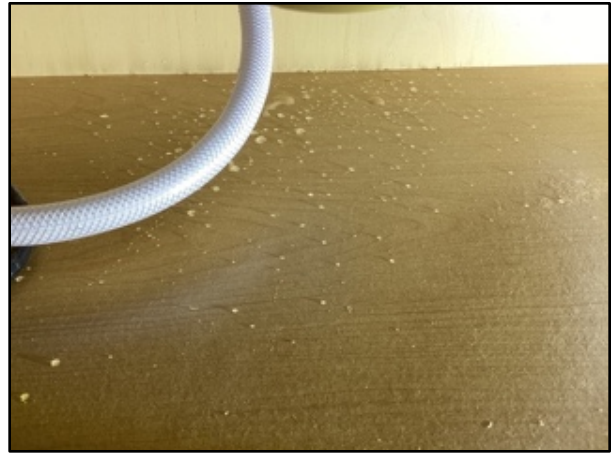
Double, Stainless, Leaks Below the Sink
Condition: Requires Repair

The sink is not properly sealed to the counter top. This is causing water to leak under the sink.

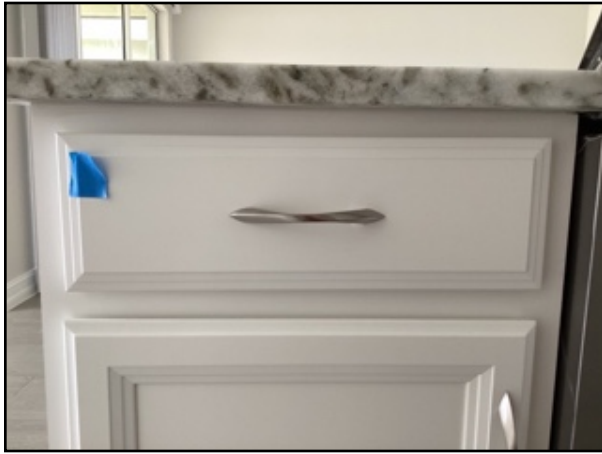
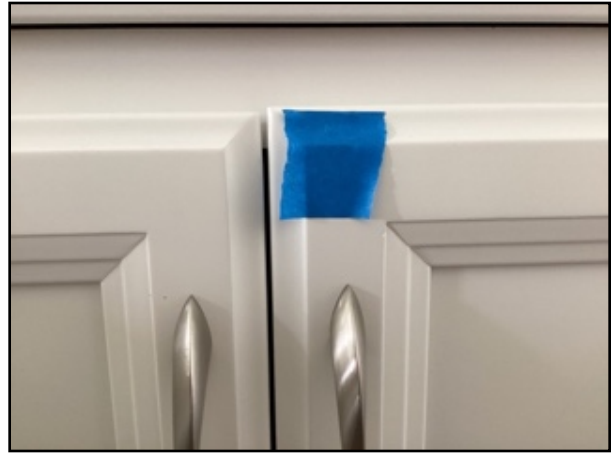
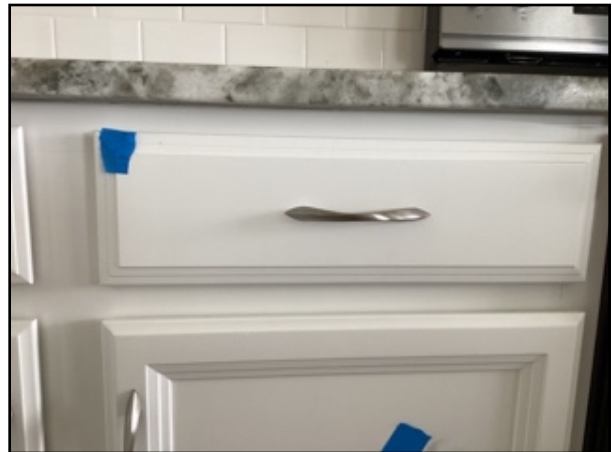
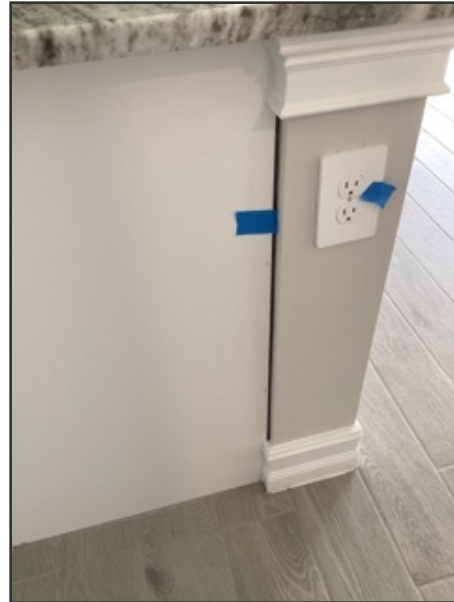
Opened and Closed as Intended
Condition: Requires Repair

There were several defects/deficiencies in regards to the cabinets to include: some doors and drawers are hung uneven, blemishes/imperfections in several areas, and a missing piece of molding was missing.

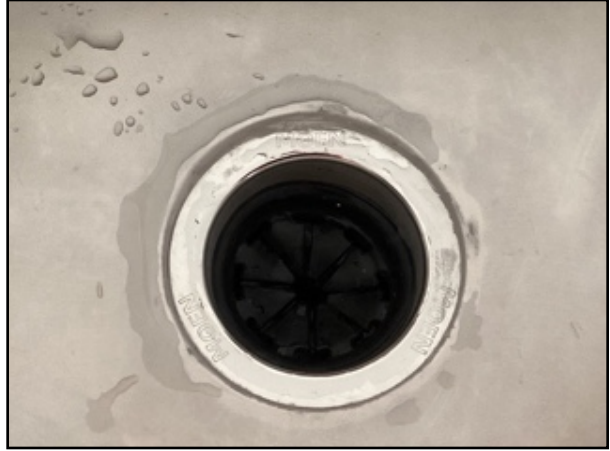
In Sink Erator, Not Operating as Intended
Condition: Requires Repair

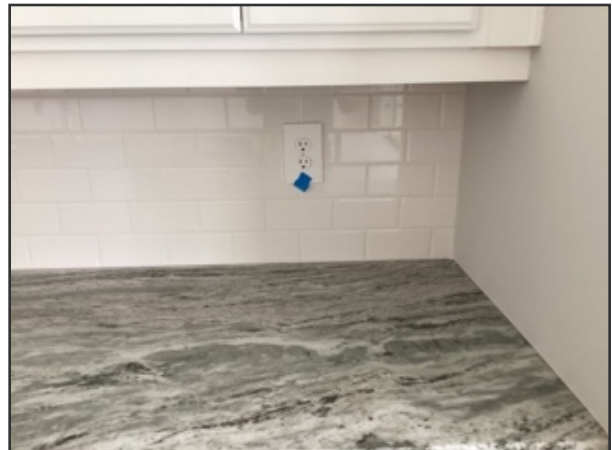
Operating as Intended, Some Outlets are
Crooked
Condition: Requires Repair
