Admirable Home Inspections, LLC

Home Inspection Report

Inspected on Mon, Nov 6 2023 at 3:34 PM

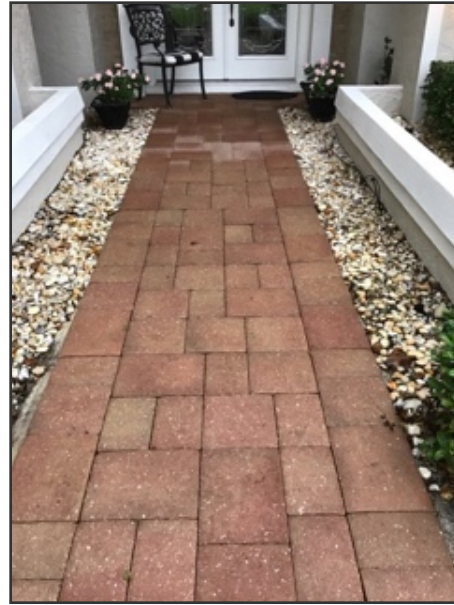
Driveways & Walkways :

Pavers
Condition: Satisfactory

The majority of the driveway and sidewalks were in acceptable condition. There was one small area on the driveway that was beginning to settle and a small crack was noted in the concrete by the non automobile door. It is recommended to monitor the settling and repair if needed and seal the crack in the concrete. This should help prevent water from penetrating and eroding the soil below.

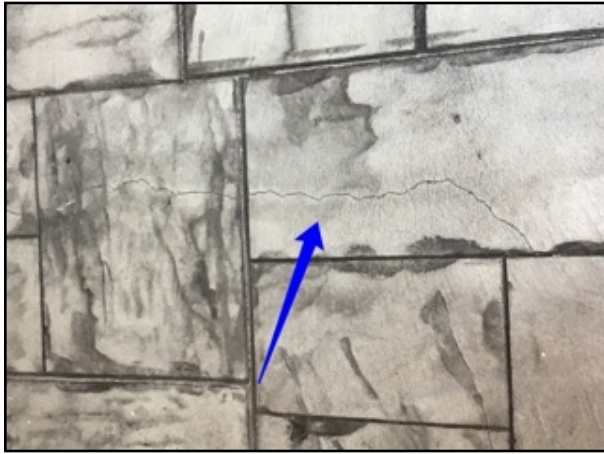
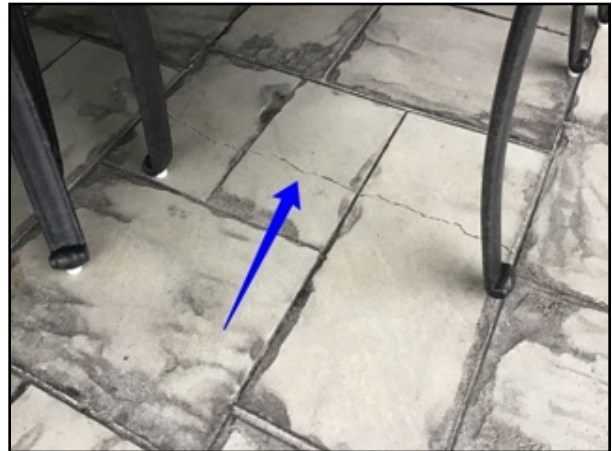
Patios:

Stamped Concrete
Condition: Requires Maintenance

Day of inspection it was noted that there were several areas that have cracks. Cracks can develop from settlement in the soil below due to erosion, natural occurring slab settling, shrinking in the concrete which is typically from the evaporation of the water in the concrete during the curing process or expansion in the concrete due to the exposure to the extreme heat and fluctuations in the temperature. It is recommended to contact a licensed masonry contractor to further evaluate and to make repairs as needed.

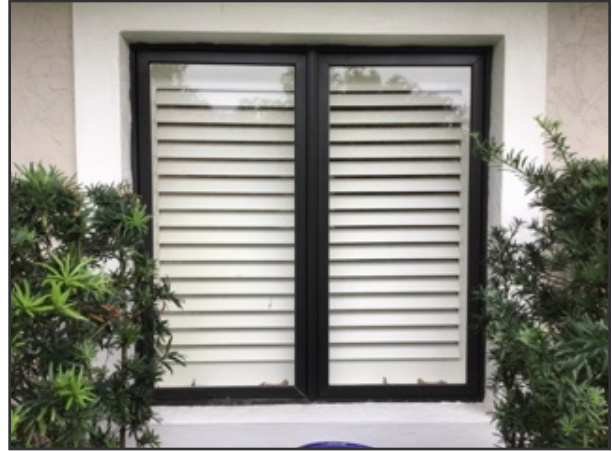
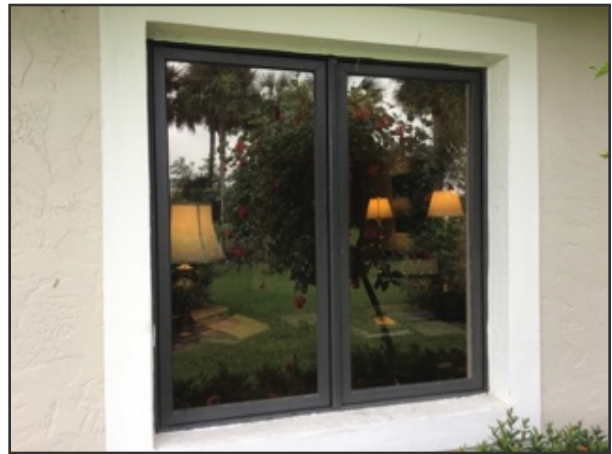
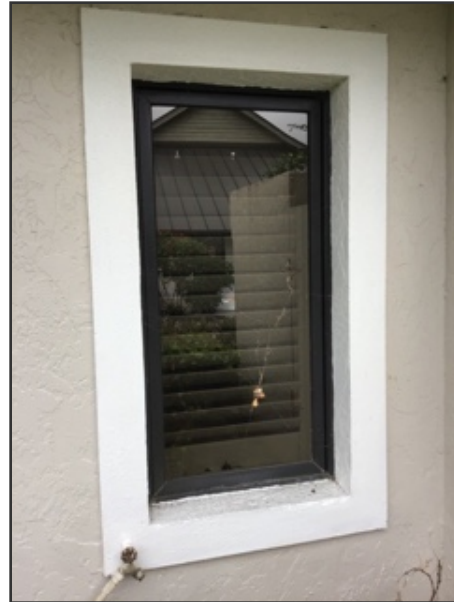
Windows:	Some Windows are Missing Screens
	Condition: Repair or Replace

The majority of the windows were an older style non insulated/energy efficient window. Some windows opened/closed/locked with difficulty. It is recommended to contact a licensed contractor to replace with windows that conform with todays standards.

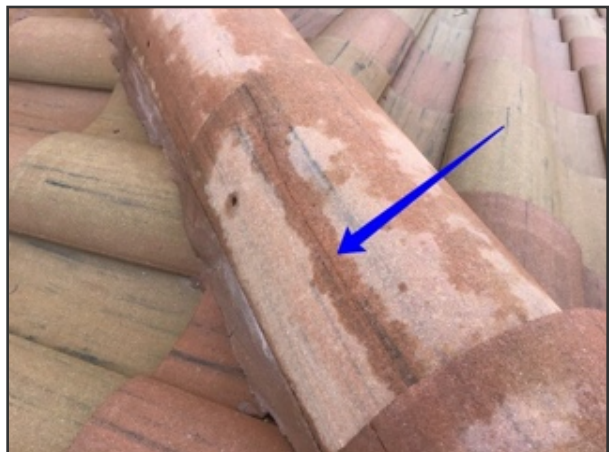
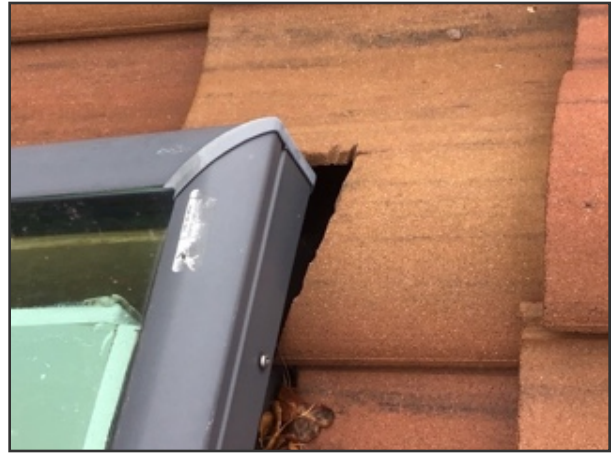
Defects Observed:

Damaged Tile, Debris Collecting in Valleys , Cracking in the Mortar

Condition: Repair or Replace

Day of inspection it was noted that the majority of the roof covering was in acceptable condition. There were a few areas that require repairing and removal of debris. It is recommended to contact a licensed roofing contractor to make repairs as needed.

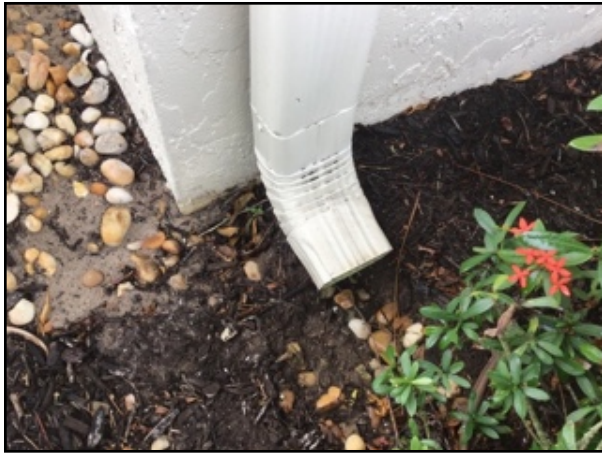
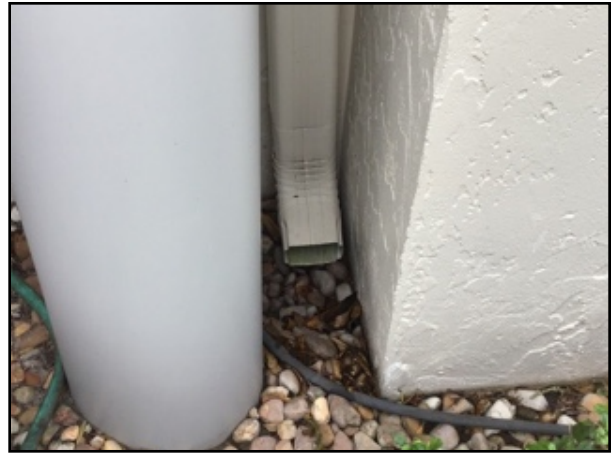
Not Long Enough

Condition: Requires Repair

Day of inspection it was noticed that the downspout extensions in some areas were not long enough. This can lead to additional water draining near the foundation system and components. Would recommend contacting a licensed contractor and repairing or replacing as needed.

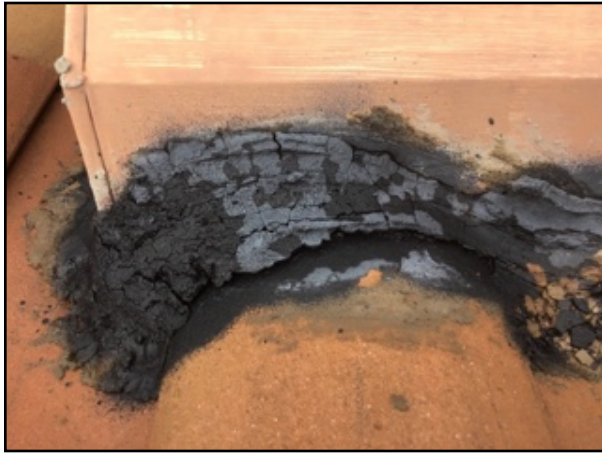
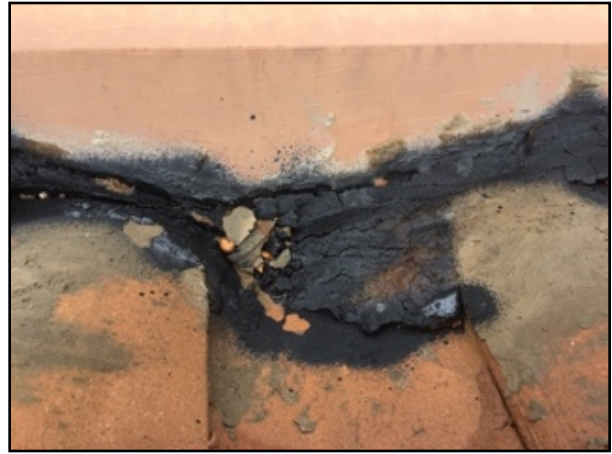
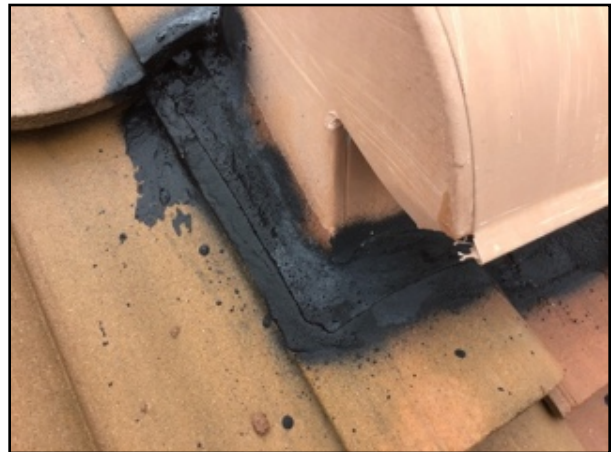
Flashings:

Tar/Caulk

Condition: Requires Repair

Day of inspection it was noted that there were concerns in regards to the flashing around the roof protrusions. If left unattended this can cause water penetration into the attic and create additional concerns. Would recommend contacting a qualified contractor to repair areas as needed.

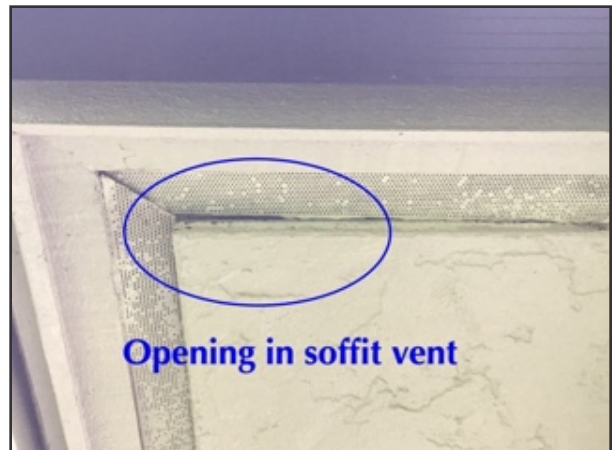
Wood, Stucco

Condition: Requires Further Evaluation and Maintenance

There were openings in areas of the soffits and water was leaking out of one area. This area was near the pool. It was also noted that the gutter in that area was filled with debris and this may be the cause. It is recommended to contact a licensed contractor to further evaluate and make repairs as needed.

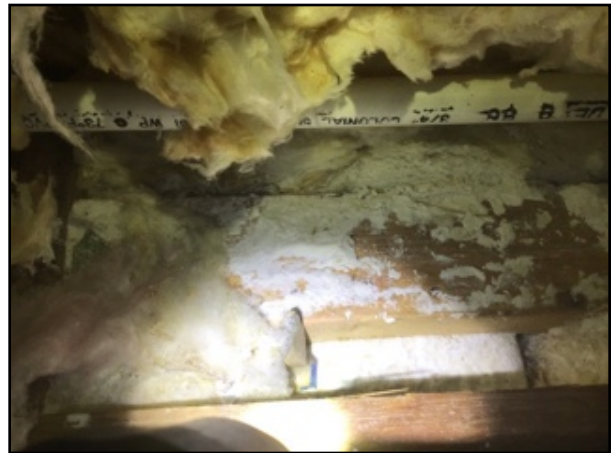
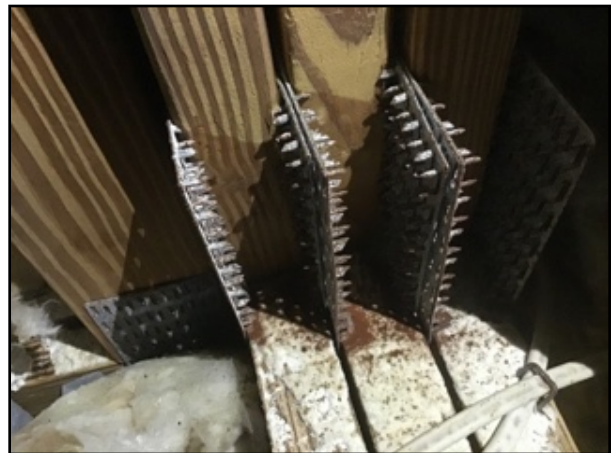
Moisture Penetration:

Noted
Condition: Further Evaluation Required

Day of inspection it was noted that there were signs of moisture in the attic. Several metal connectors/gussets on the trusses and vents were rusting. There was a wet area on the sheetrock and insulation. The probable cause may be from wind driven rain that entered the roof vents. Multiple wood trusses were tested with a moisture meter and indicated that there were high levels of moisture. It was also noted that main air handler was leaking cold air in to the attic. In addition, there may have been evidence of microbial growth. While we will report any substance that appears to be microbial growth, the only true way to confirm is to have a licensed specialist inspect and test the substance. It is recommended to contact a licensed contractor to further evaluate and make repairs as needed.

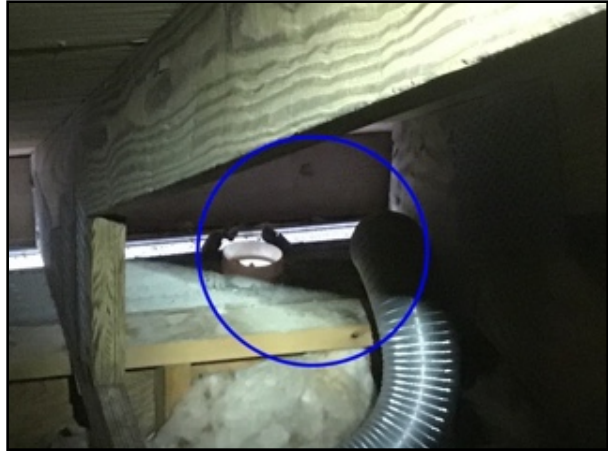
Bathroom Vent Ductwork :

Noted but Does Not Extend to Outside
Condition: Repair or Replace

One of the bathroom vents did not vent to the outside. This can allow additional moisture into the attic area. It would be recommended to repair.

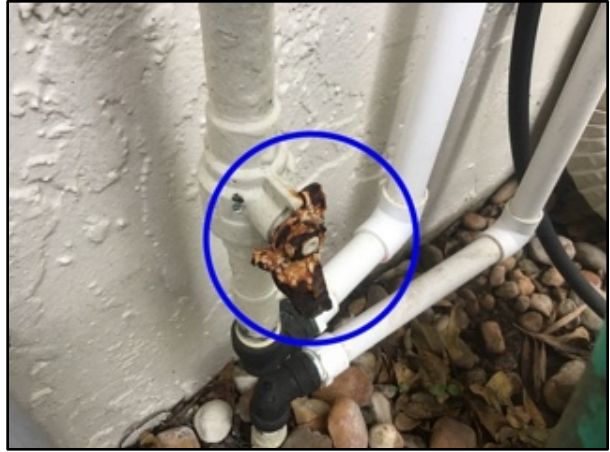
Damaged and Corrosion was Noted

Condition: Recommend Replacing

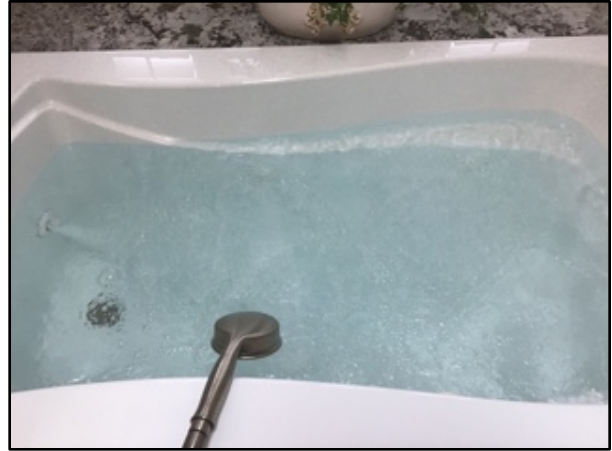
Built in

Condition: Further Evaluation Required

Day of inspection it was noted that the bath tub drained slowly. This can be from a lack of air in the waste pipes. It is recommended to contact a licensed plumber to further evaluate and make repairs as needed.

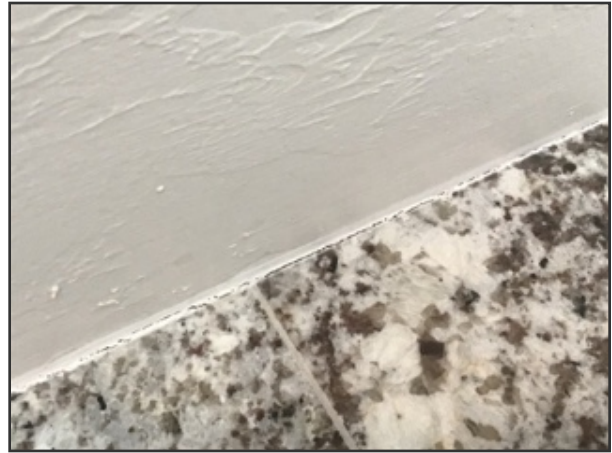
Dry Wall, Cracked/ Damaged Caulking

Condition: Requires Maintenance

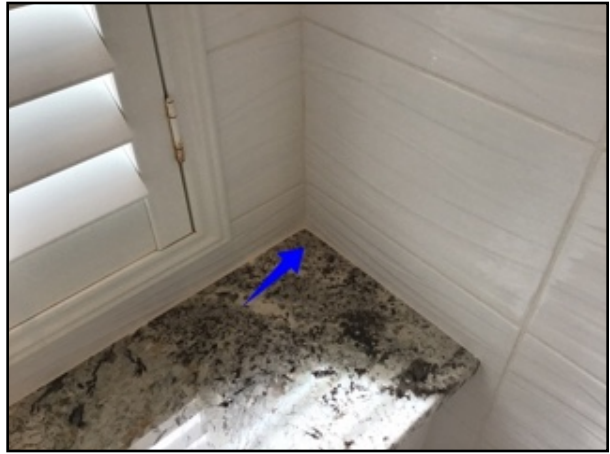
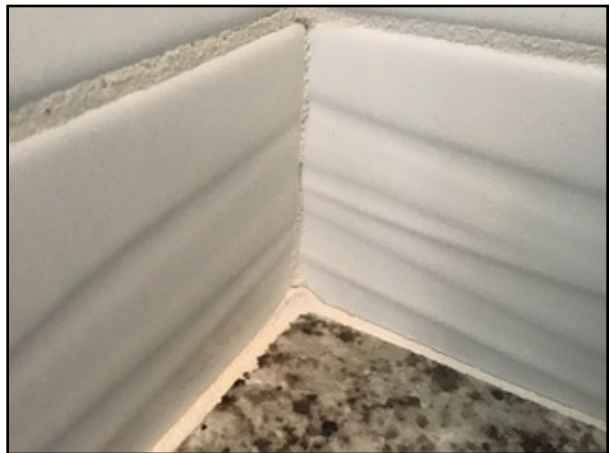
Shower Walls:

Tile, Cracked/Damaged Caulking/Grout
Condition: Requires Maintenance

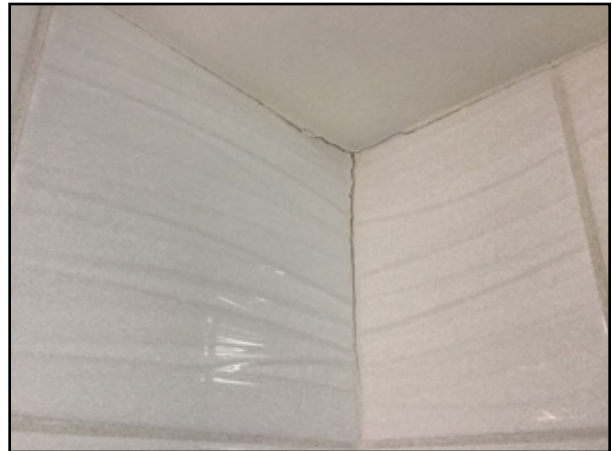
Missing/Damaged Caulking/ Grout
Condition: Requires Maintenance

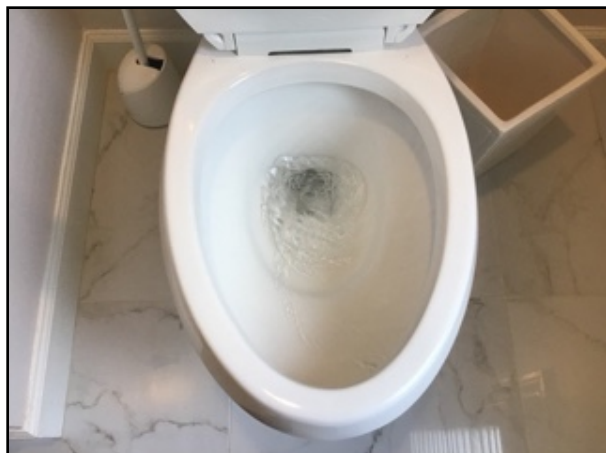
Toilet:

Standard Tank, Flushed and Functioned Properly, Not Properly Fastened or Loose at the Floor Connection
Condition: Requires Repair

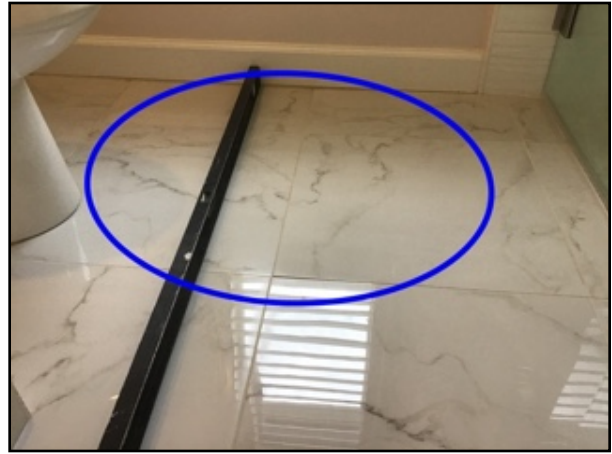
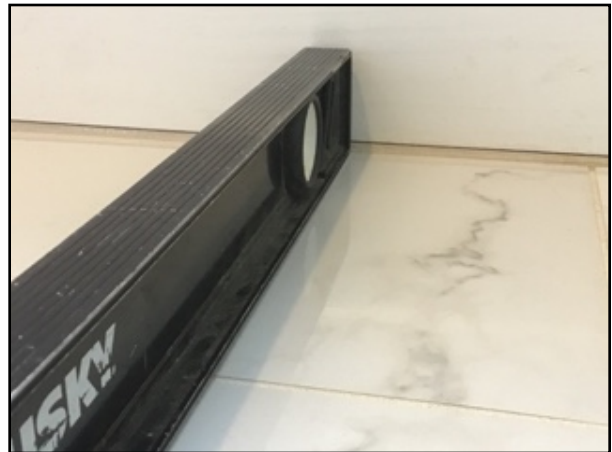
Floor:

Tile

Condition: Further Evaluation Required

The floor appeared to be out of level. This was located in front of the toilet. This should be further evaluated by a licensed contractor and repaired.

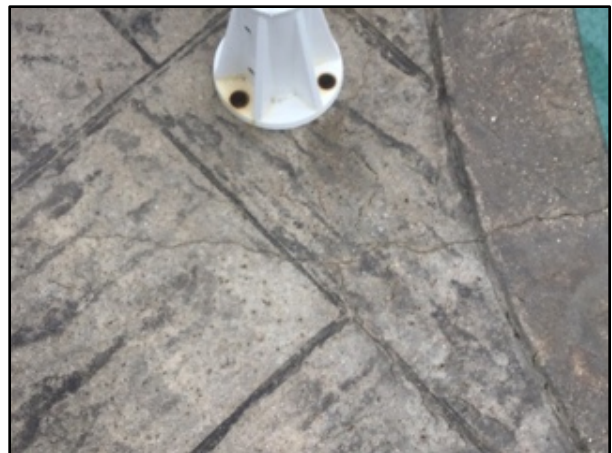
Stamped Concrete

Condition: Further Evaluation Required

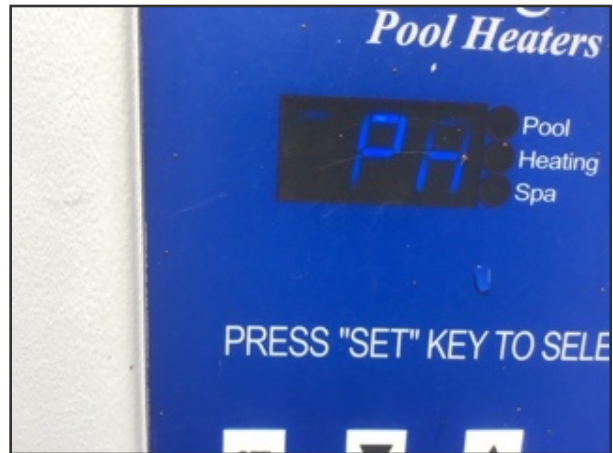
Day of inspection it was noted the the equipment may have been the original equipment. The pump and filters were functioning as intended. The heater did not operate when tested. It is recommended to contact a licensed pool maintenance company to thoroughly evaluate the equipment and further evaluate the heater.

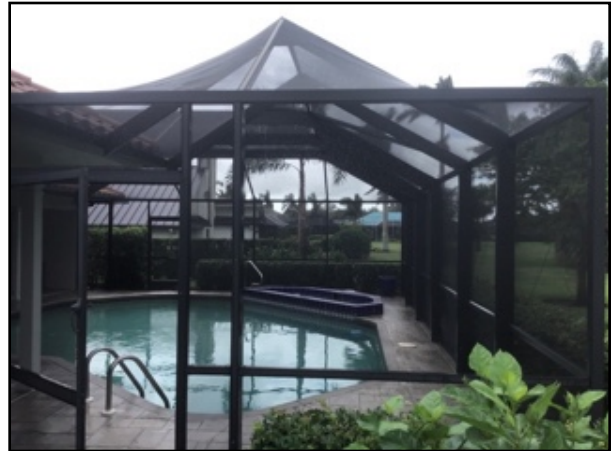
Screen Enclosure

Condition: Requires Maintenance

The majority of the screen enclosure was in acceptable condition. There was one screen rail that was loose. It is recommended to repair as needed.
