# Admirable Home Inspections, LLC

## Home Inspection Report

Inspected on Mon, Nov 6 2023 at 3:43 PM

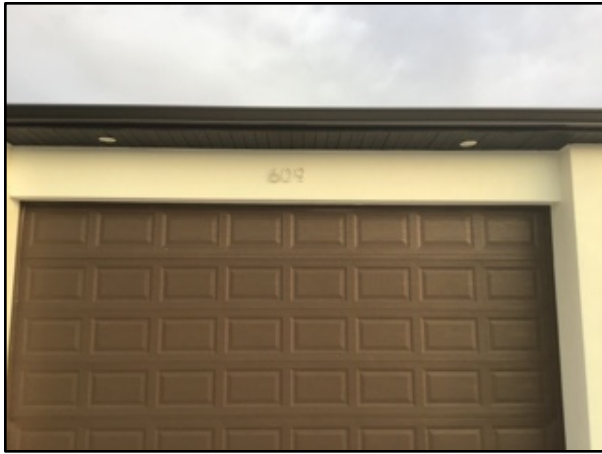
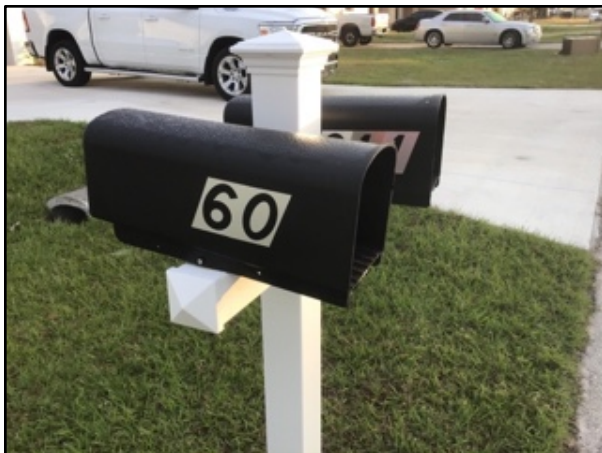
One of the mailboxes are missing the correct address numbering and doors are missing on both boxes. Recommend adding the correct address number and installing the doors.

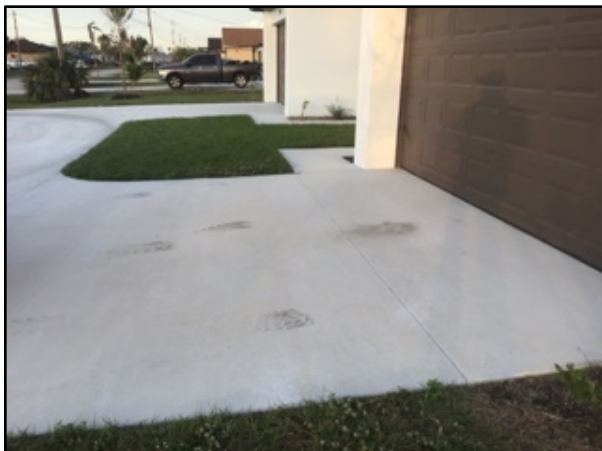
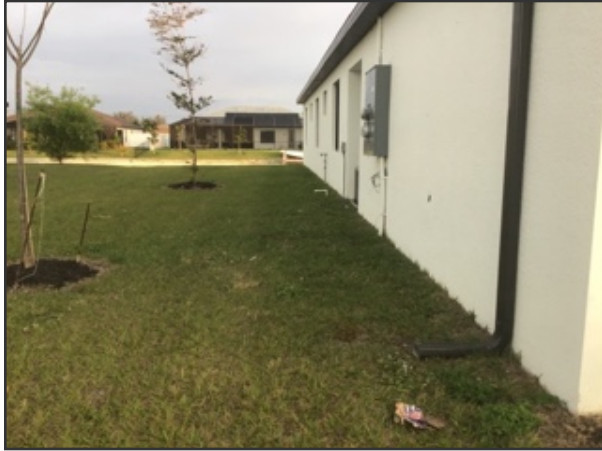
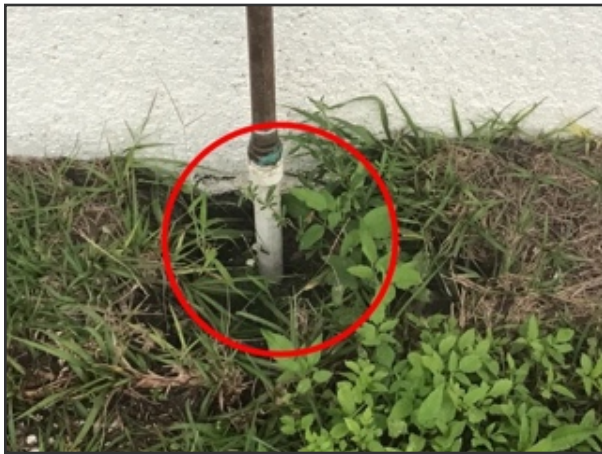
The majority of the site grading was in acceptable condition. There was one small depression by the main water line on the side of unit 609. This is collecting water and should be filled to meet the existing grade.

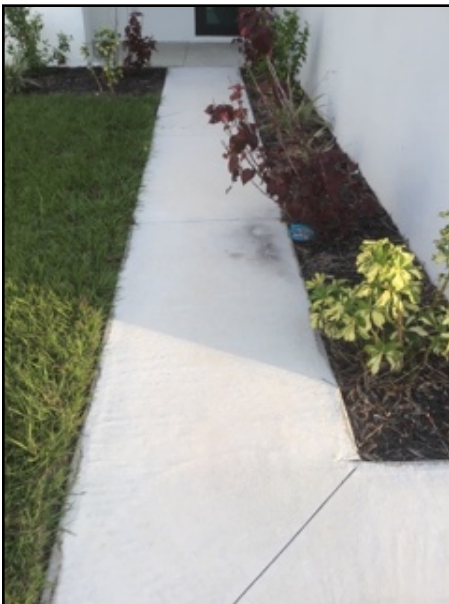
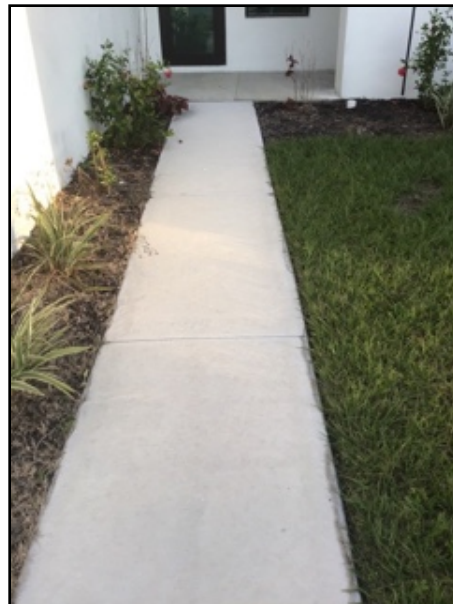
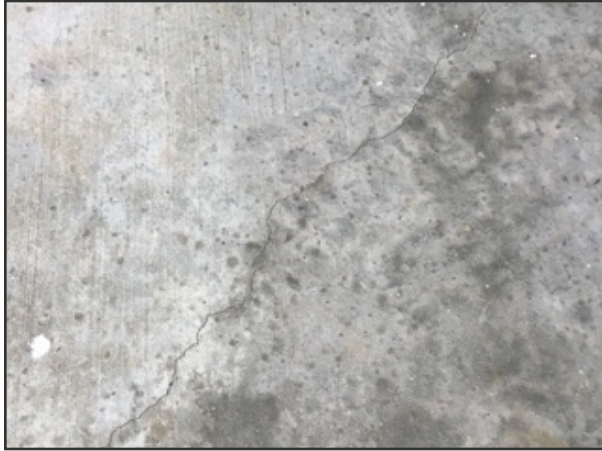
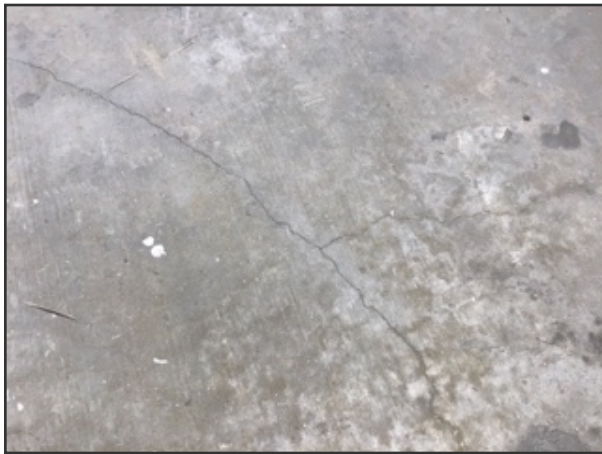
The driveways were in acceptable condition. Both walkways directly in front of the entryways have cracks. Cracks can develop from settlement in the soil below due to erosion, natural occurring slab settling, shrinking in the concrete which is typically from the evaporation of the water in the concrete during the curing process or expansion in the concrete due to the exposure to the extreme heat and fluctuations in the temperature. It is recommended to contact the contractor/builder to repair or replace as needed.

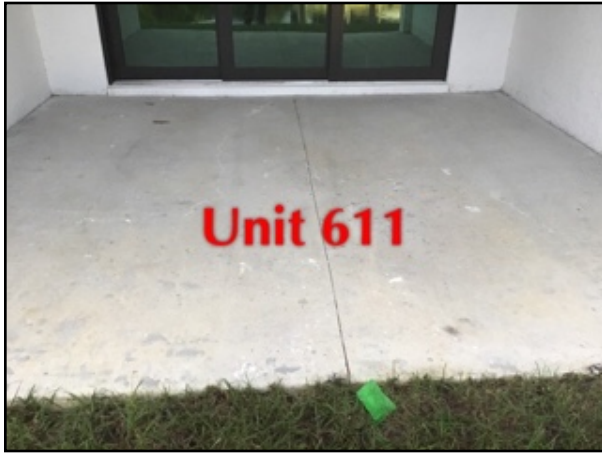
There was a crack in the concrete patio on unit 611. Cracks can develop from settlement in the soil below due to erosion, natural occurring slab settling, shrinking in the concrete which is typically from the evaporation of the water in the concrete during the curing process or expansion in the concrete due to the exposure to the extreme heat and fluctuations in the temperature. It is recommended to contact the contractor/builder to repair.

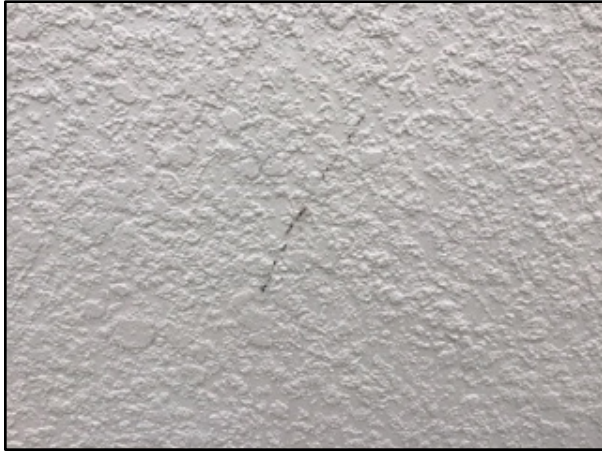
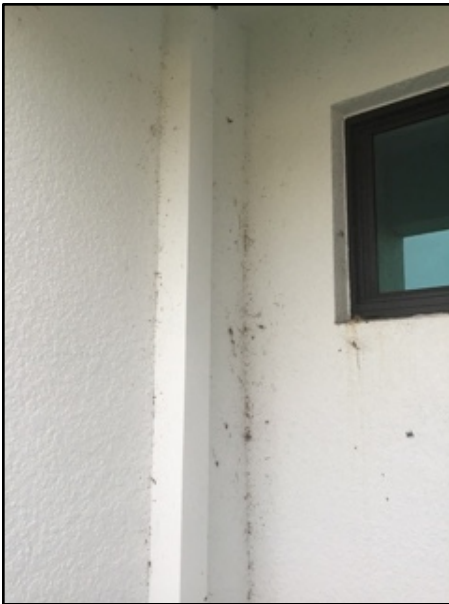
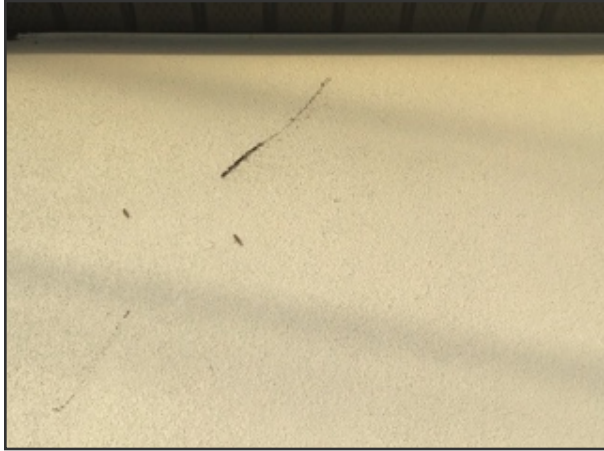
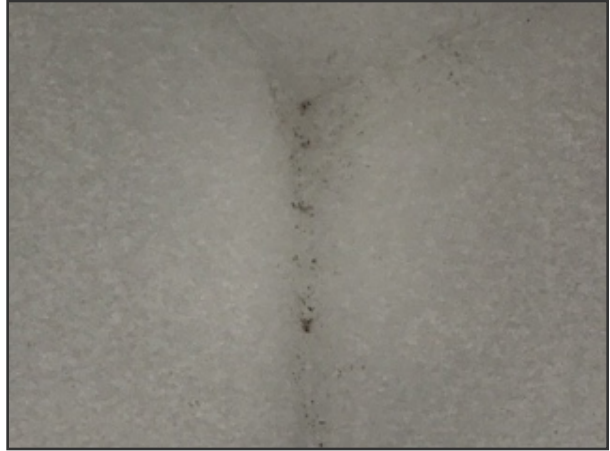
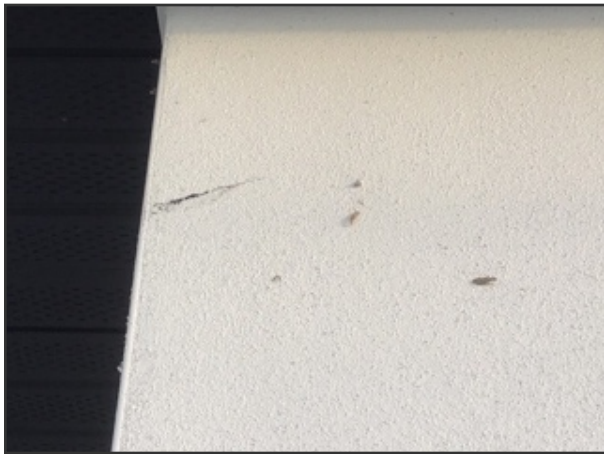
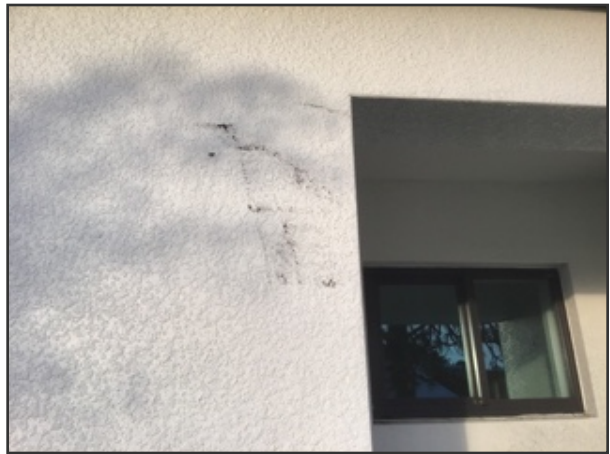
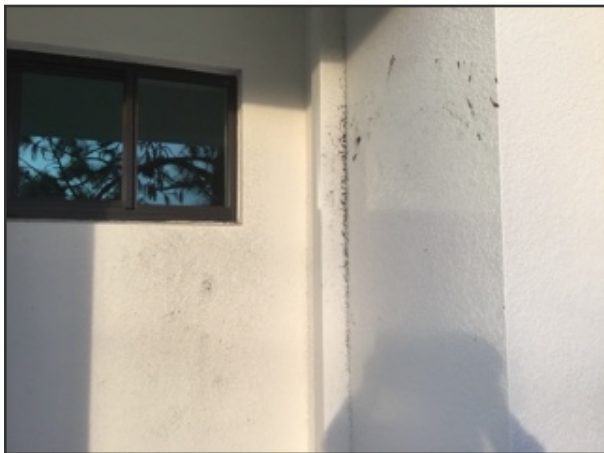
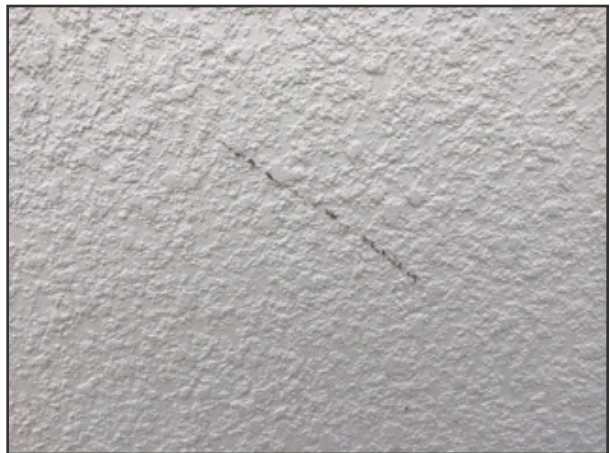
Stucco, Holes in Wall Covering, Scuff Marks in Areas

The majority of the exterior covering was in acceptable condition. There were multiple areas that have scuff marks, scratches, dirt, insect debris and one hole. It is recommended to pressure wash and repair any scratches in the stucco.

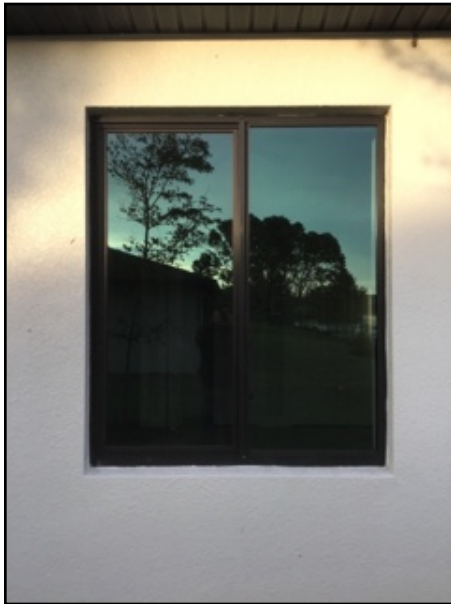
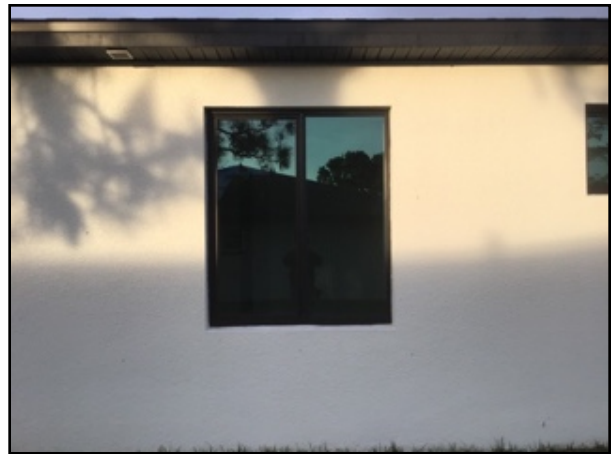
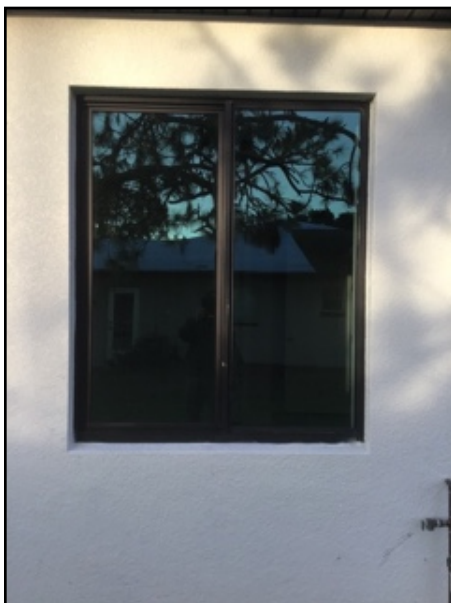
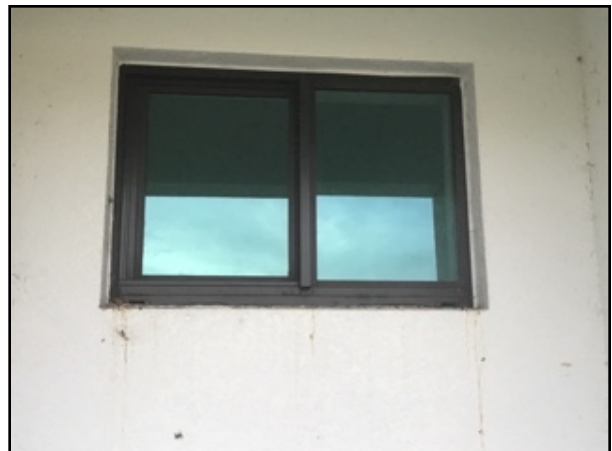
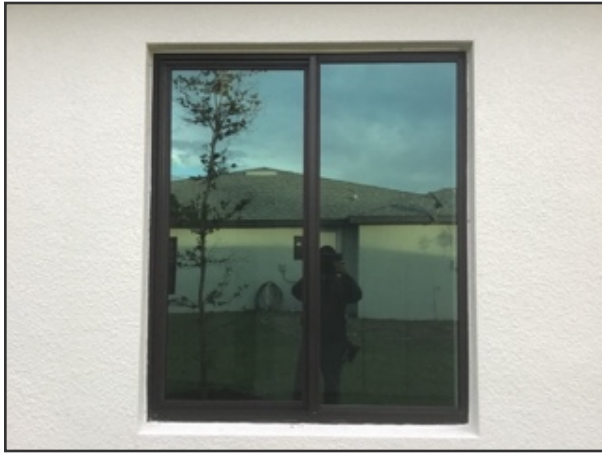
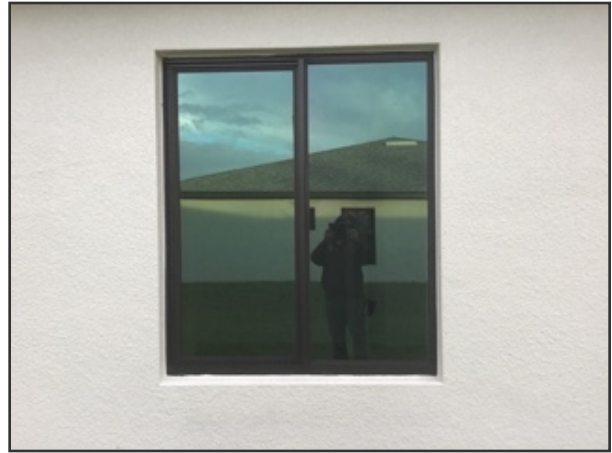
Missing Screens

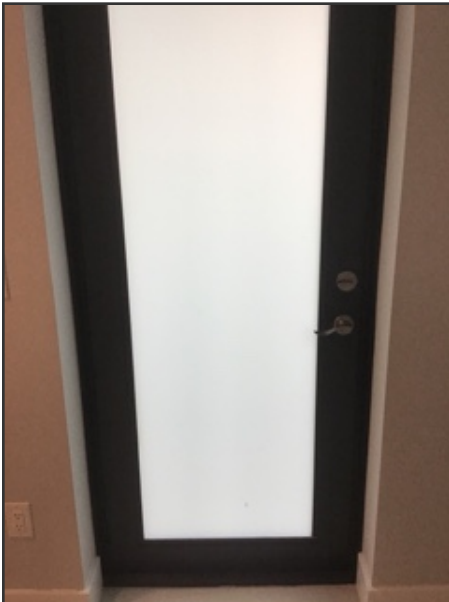
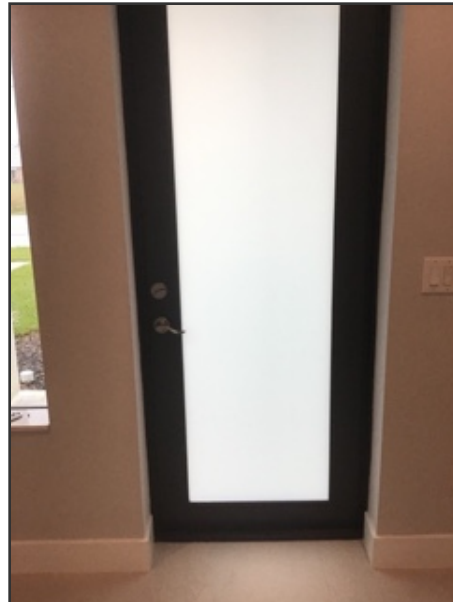
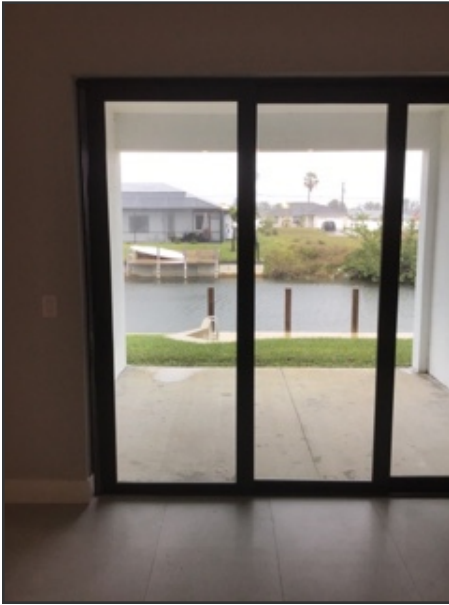
The deadbolts on both main entry doors do not operate as intended. The sliding glass door in unit 609 does not operate as intended also. It is recommended to contact the contractor/builder to repair or replace the locks.

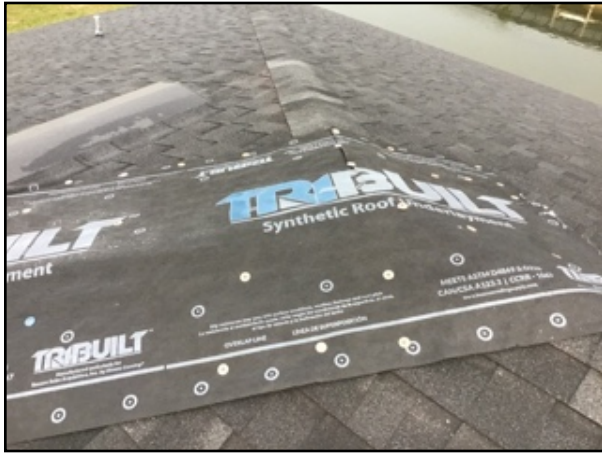
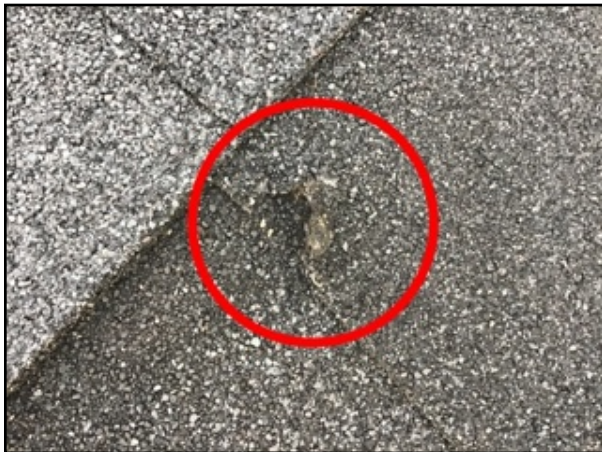
There were a few damaged shingle tabs and a section of hip cap shingles were missing. It is recommended to contact the contractor/builder to repair as needed. It is also noted that the temporary covering on the ridge caps have been nailed through the face of the existing shingles. Nails/holes should never be in the shingles that are "in the weather" Those shingles should be replaced.

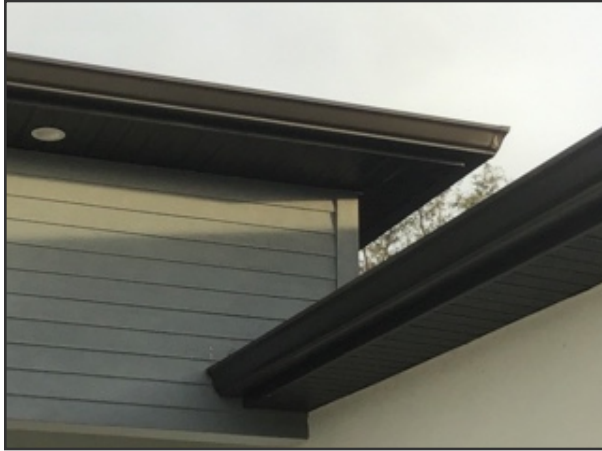
**Comment 8:**

Day of inspection it was noted that some of the roof system had no gutters. Gutters help deflect water away from the foundation systems and components when accompanied with proper downspouts and extensions. Would recommend contacting a licensed or qualified contractor to install gutters, downspouts and extensions where needed.

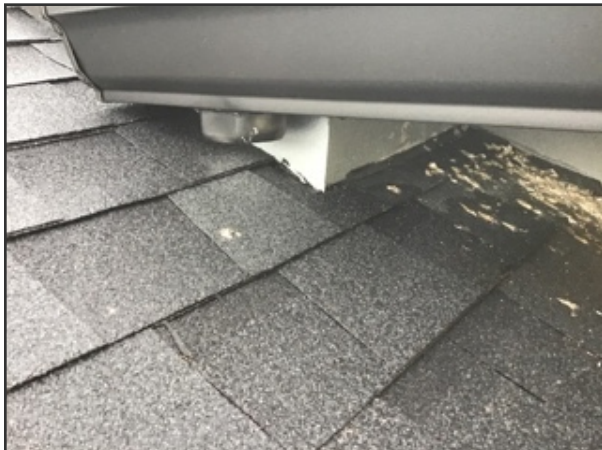
These sections of gutters do not have downspouts. This is allowing the gutter system to drain water directly on the shingles. This can cause premature wear in the shingles. It is recommended to contact the contractor/builder to install downspouts that drain directly to an existing gutter or the ground.

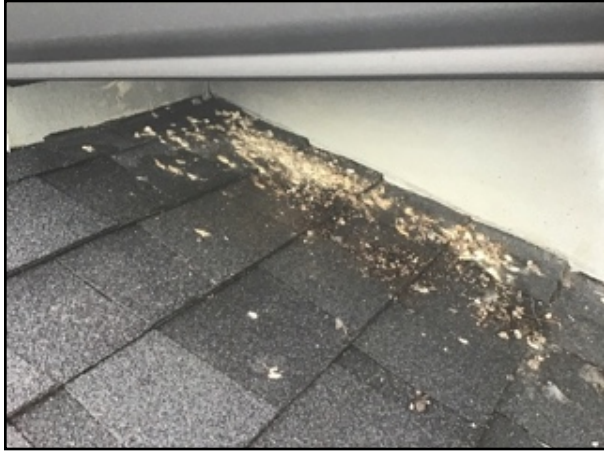
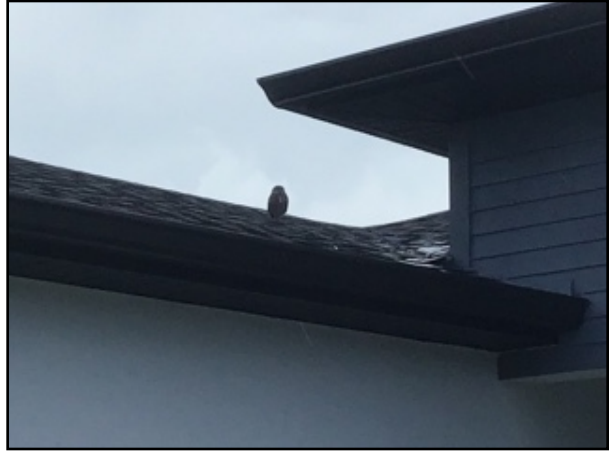
Bird are nesting under one of the soffits. It is recommended to contact a licensed pest management company to remove and implement a remedy from nesting to reoccur.

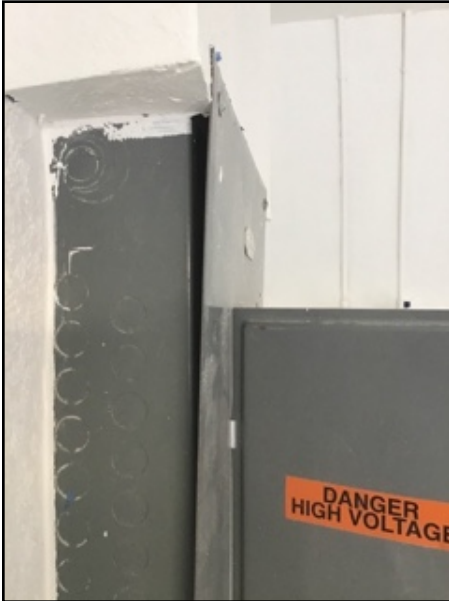
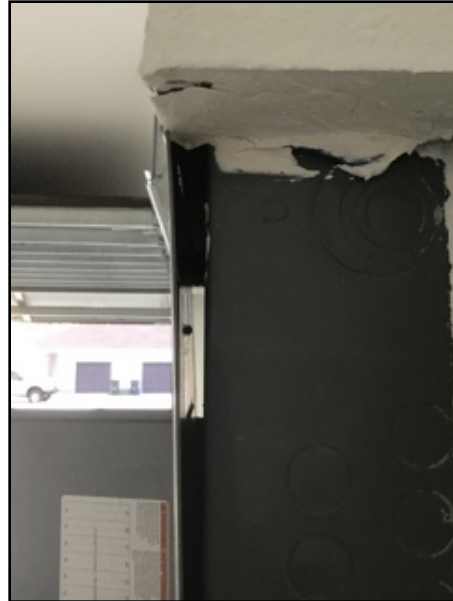
Comment 11:

The service panel cover is not installed properly leaving an opening in the top corners. This can be a safety concern. It is recommended to contact the contractor/builder to have repaired.

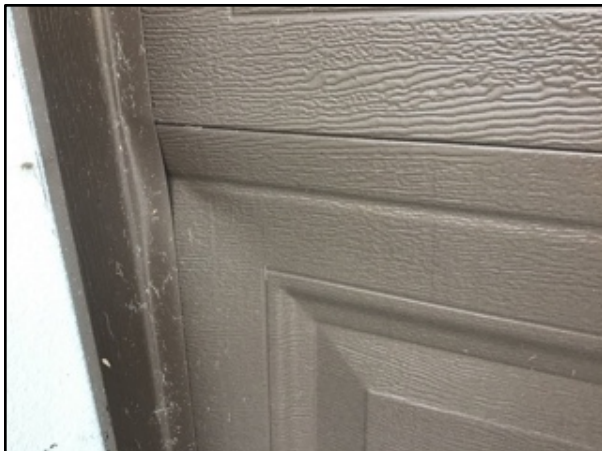
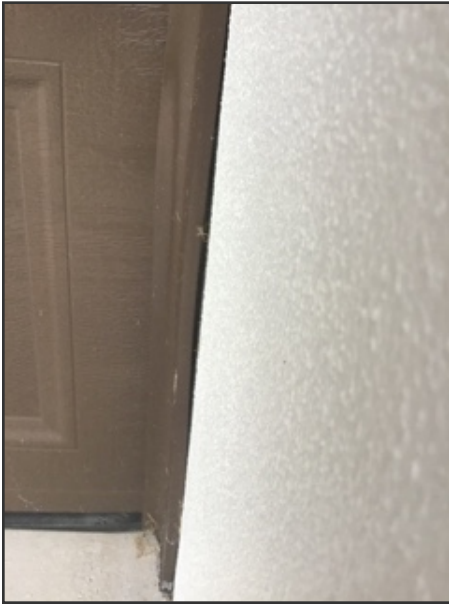
Comment 14:

There were a couple of dents on the garage door. This does not affect the operation of the garage door however is creating the door to not seal completely against the weatherstripping. It was also noted that the weatherstripping was not fastened properly in some areas. Both concerns can allow hot air, water/moisture intrusion in the garage. It is recommended to contact the contractor/builder to replace the damaged section of doors.

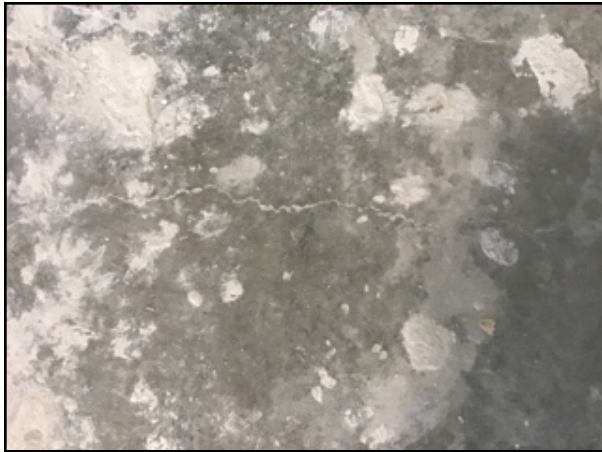
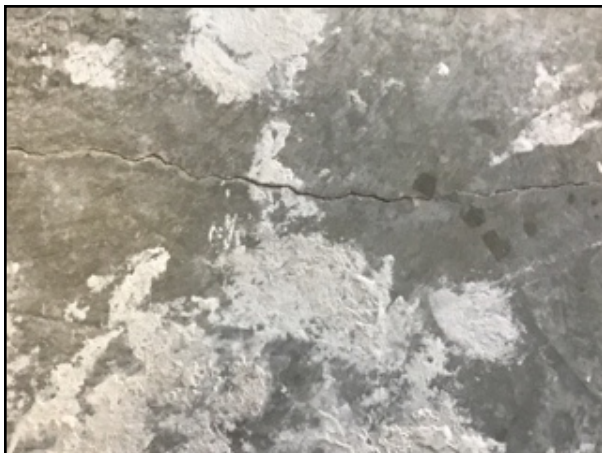
There were a few cracks in the garage floor. Cracks can develop from settlement in the soil below due to erosion, natural occurring slab settling, shrinking in the concrete which is typically from the evaporation of the water in the concrete during the curing process or expansion in the concrete due to the exposure to the extreme heat and fluctuations in the temperature. It is recommended to contact the contractor/builder to repair or replace as needed.

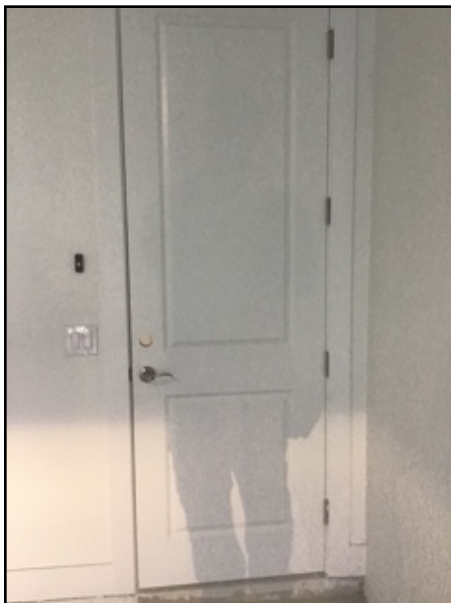
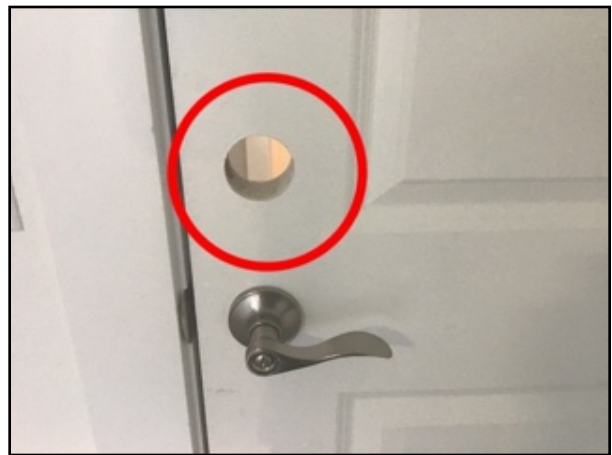
Day of inspection it was noted that the entry way door leading into living space did not self close. Doors that separate the living space and the garage should be self closing. Would recommend contacting the contractor/builder to repair as necessary.

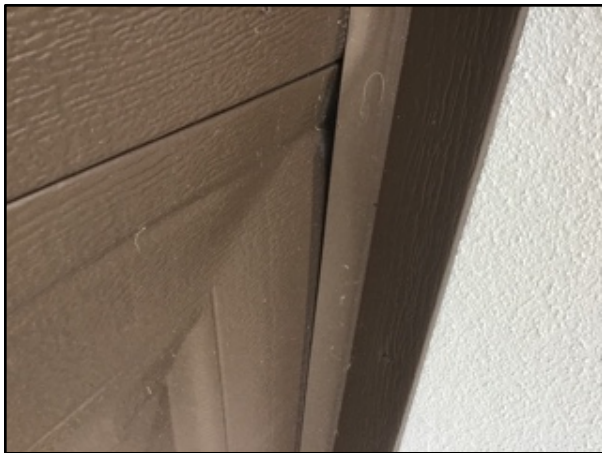
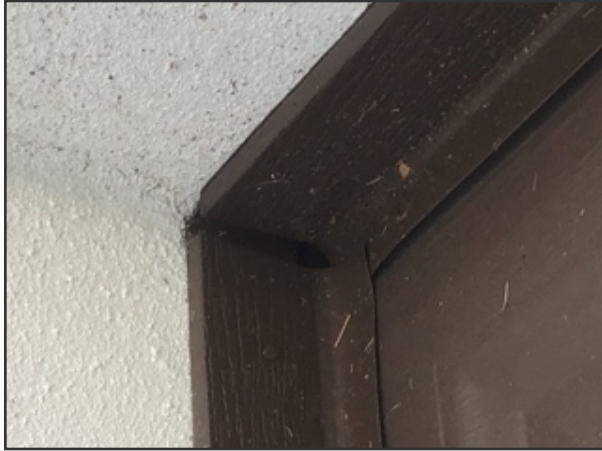
**Comment 18:**

There were a couple of dents on the garage door. This does not affect the operation of the garage door however is creating the door to not seal completely against the weatherstripping. It was also noted that the weatherstripping has openings at the top corners. The weatherstripping was not installed properly. Both concerns can allow hot air, water/moisture intrusion in the garage. It is recommended to contact the contractor/builder to replace the damaged section of doors and replace the weatherstripping.

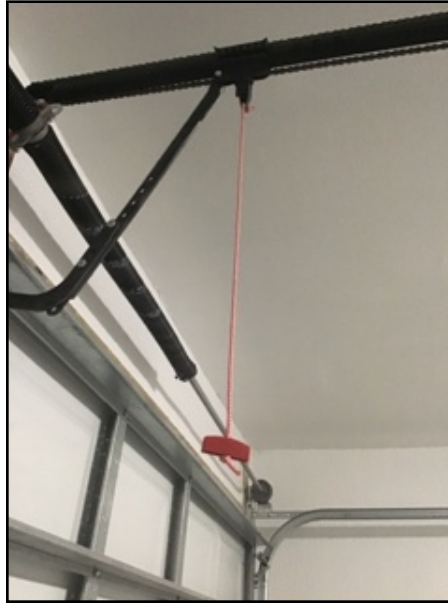
Photo Electric Device :

Light Beam

Condition: Further Evaluation Required

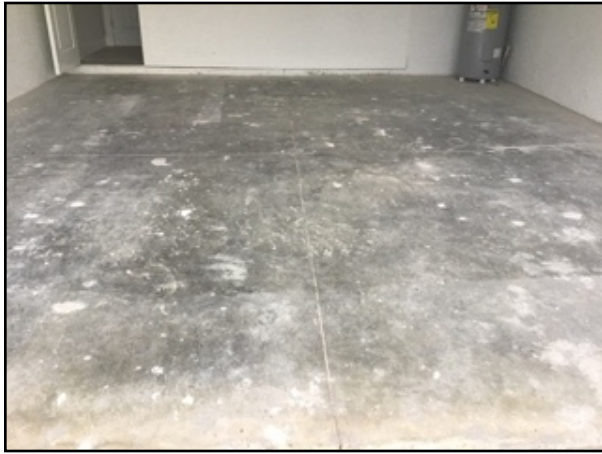
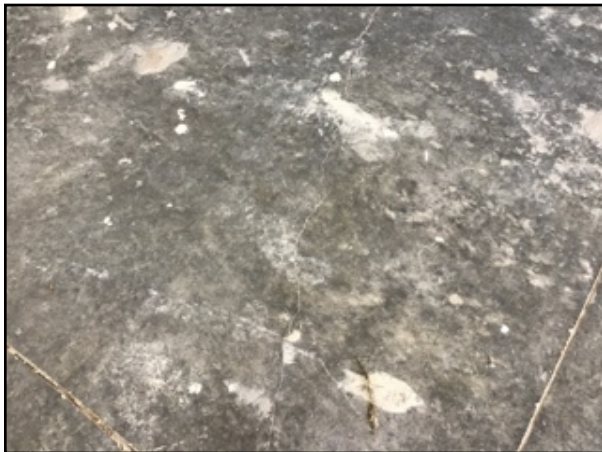
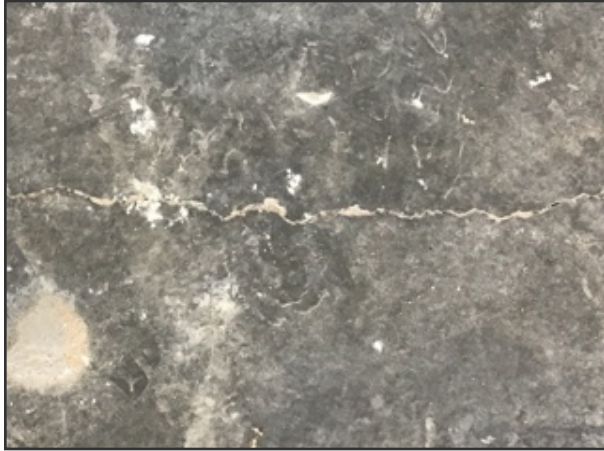
Comment 20:

Concrete

Condition: Repair or Replace

There were a few cracks in the garage floor. Cracks can develop from settlement in the soil below due to erosion, natural occurring slab settling, shrinking in the concrete which is typically from the evaporation of the water in the concrete during the curing process or expansion in the concrete due to the exposure to the extreme heat and fluctuations in the temperature. It is recommended to contact the contractor/builder to repair or replace as needed.

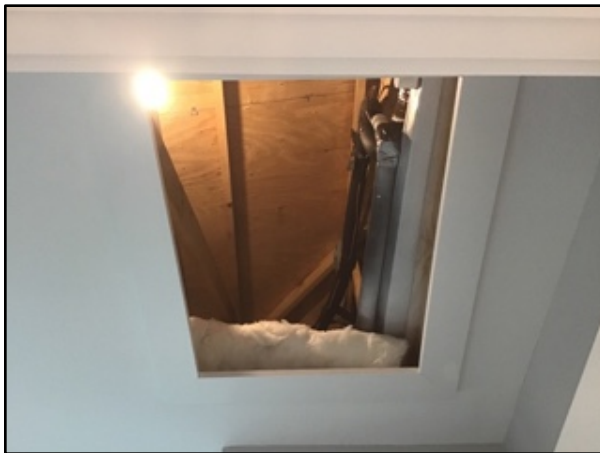
Comment 23:

Ceiling Access

Condition: Repair or Replace

Unit 611 was missing the attic hatch cover. It was also noted that the attic hatch in unit 609 does not completely close. This can allow conditioned air to enter the attic. It is recommended to contact the contractor/builder to make repairs.

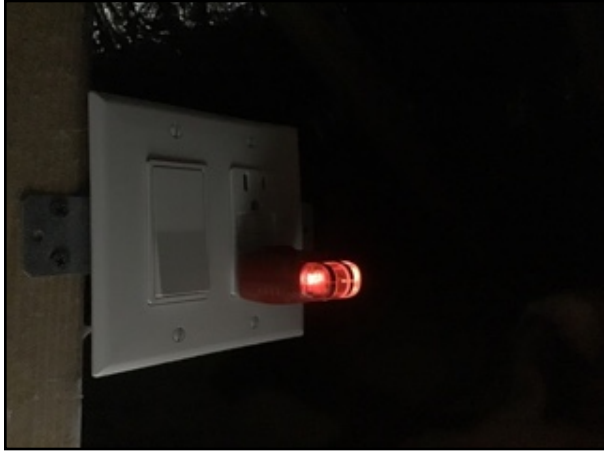
Figure 25-1

The outlet located in the attic in unit 609 was not wired properly. It has a hot neutral wires reversed. It is recommended to contact the contractor/builder to repair.

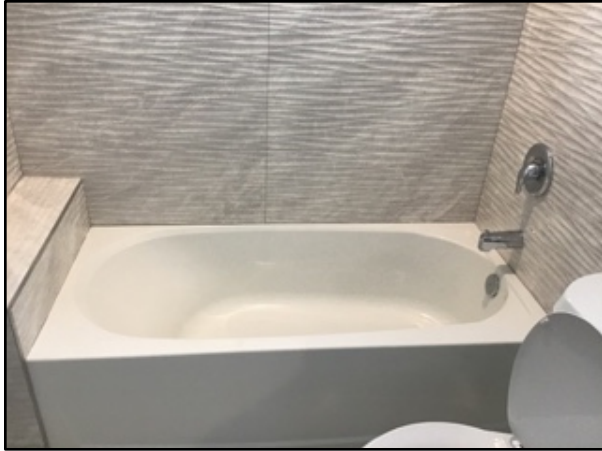
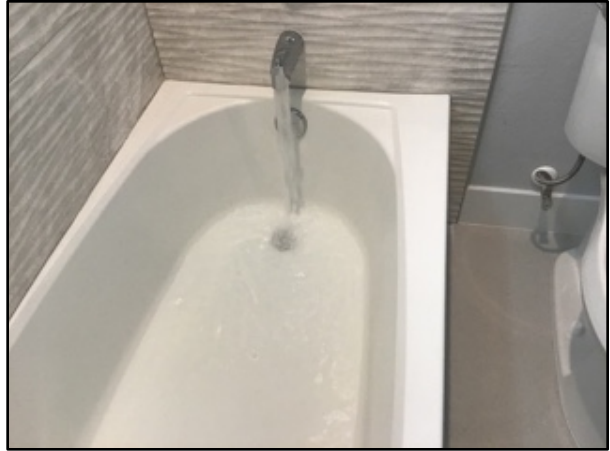
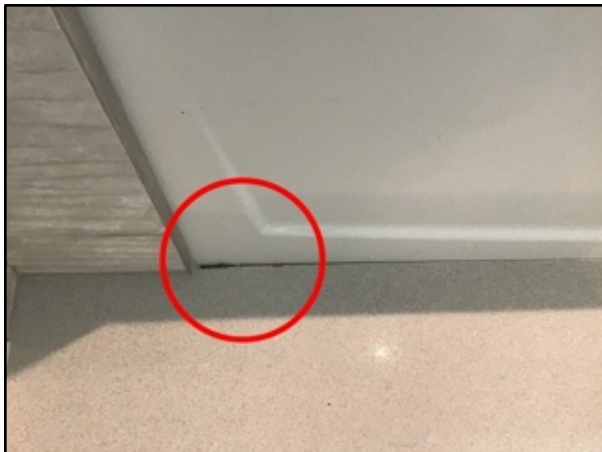
Bath Tub:

Built in , Missing/Damaged Caulking  
Condition: Repair or Replace

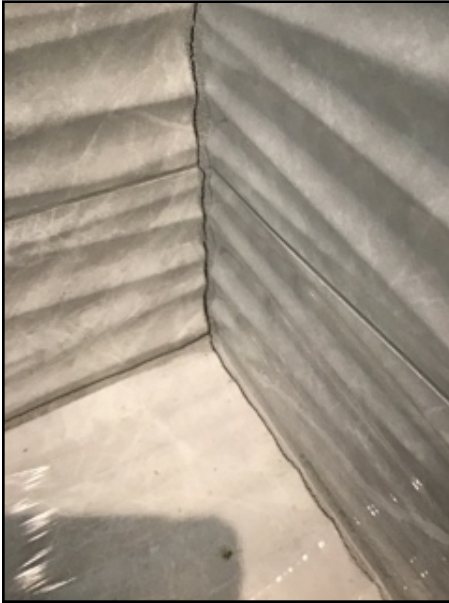
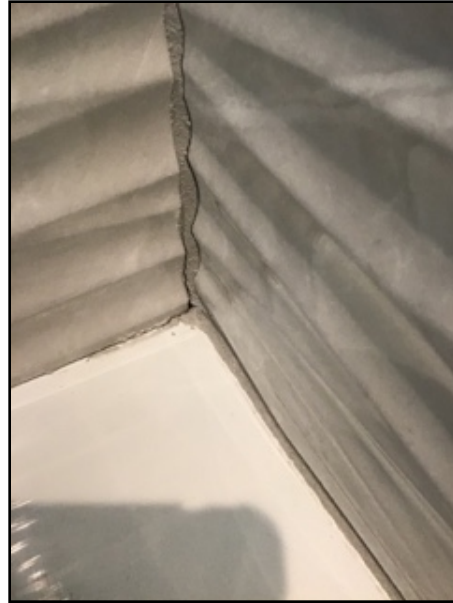
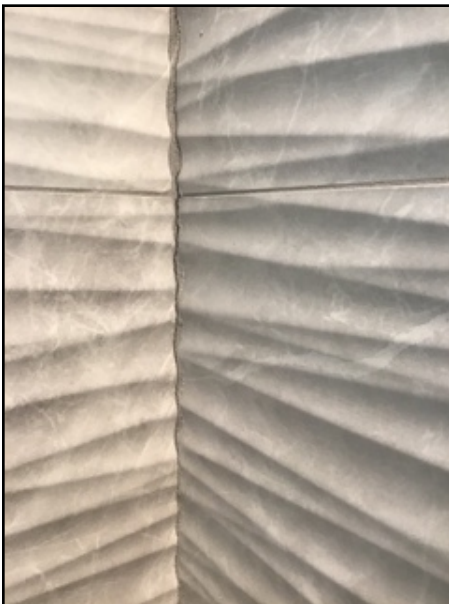
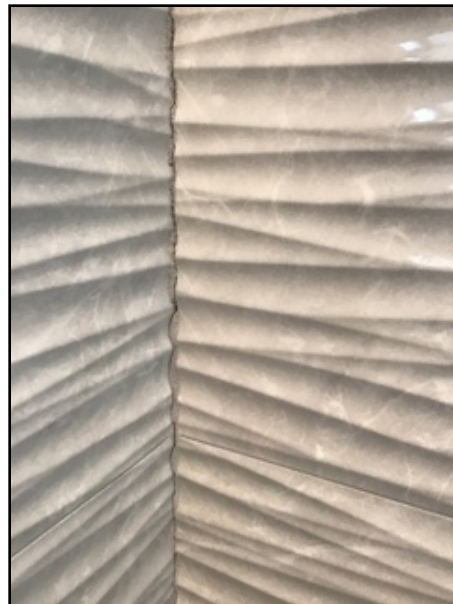
Shower Walls:

Tile, Missing/Damaged Caulking  
Condition: Repair or Replace

Day of inspection it was noted that there were areas of cracked/missing grout. This can allow water/moisture to get behind the tile and create additional concerns. Would recommend contacting the contractor/builder to repair as needed.

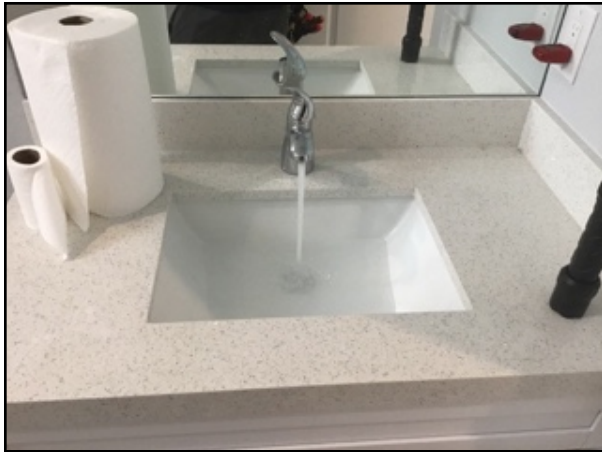
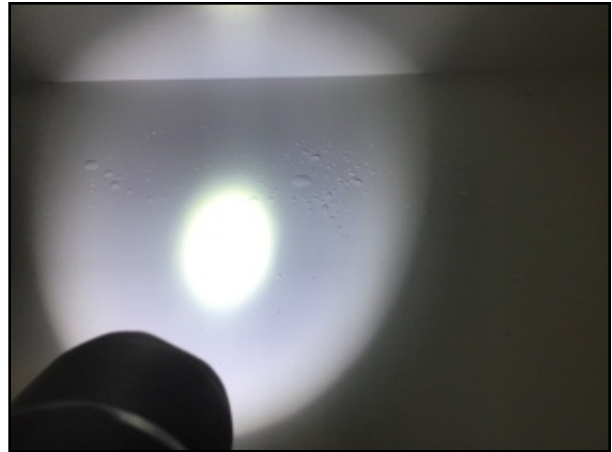
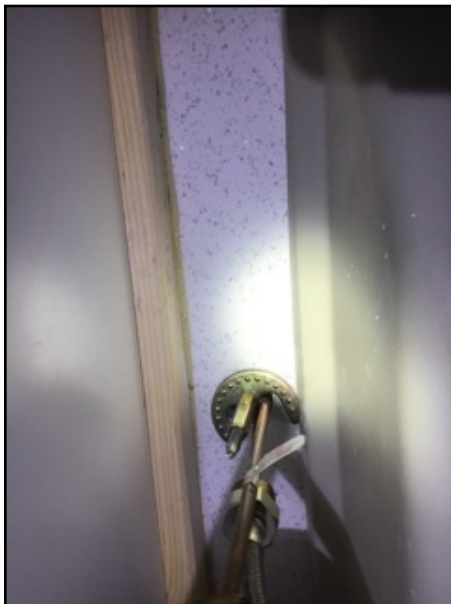
Condition: Repair or Replace

The sink was not sealed properly to the counter. This was causing a leak in the vanity. It is recommended to contact the contractor/builder to repair.

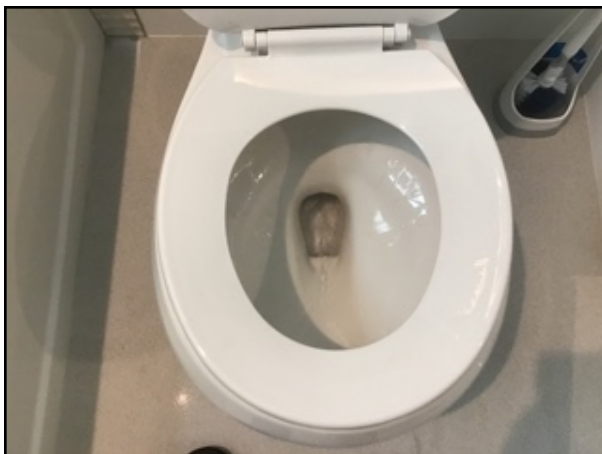
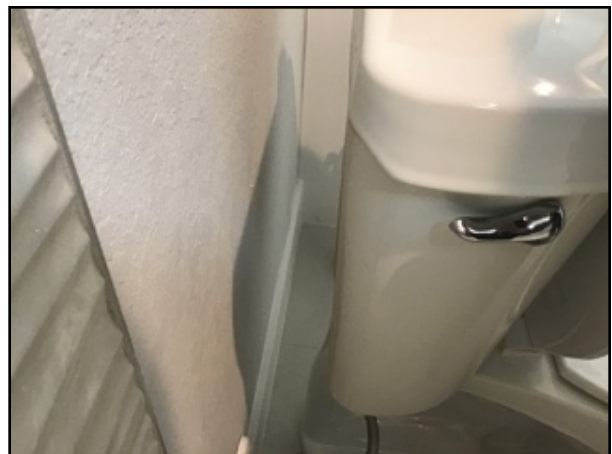
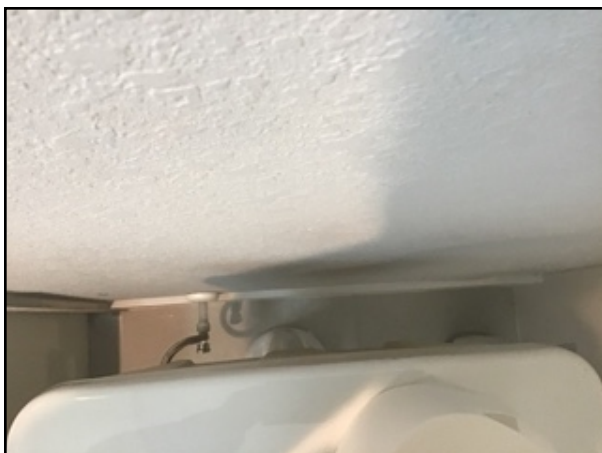
Condition: Repair or Replace

The toilet was placed to far from the wall. This is allowing to much space between the tank and the wall. The tank cover did not fit properly which is prohibiting the seat and cover to stay up. It is recommended to contact the contractor/builder to install the toilet properly and install the proper tank cover.

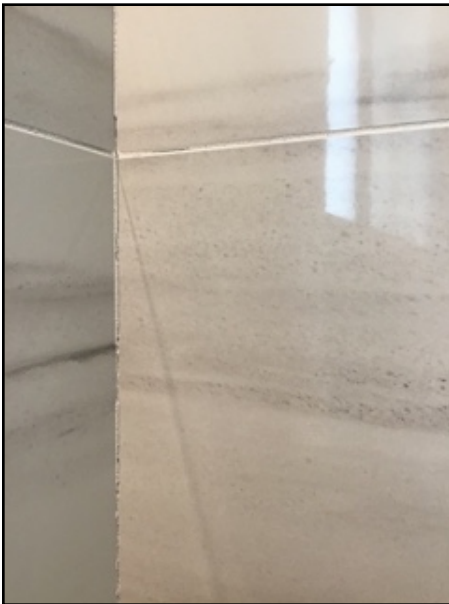
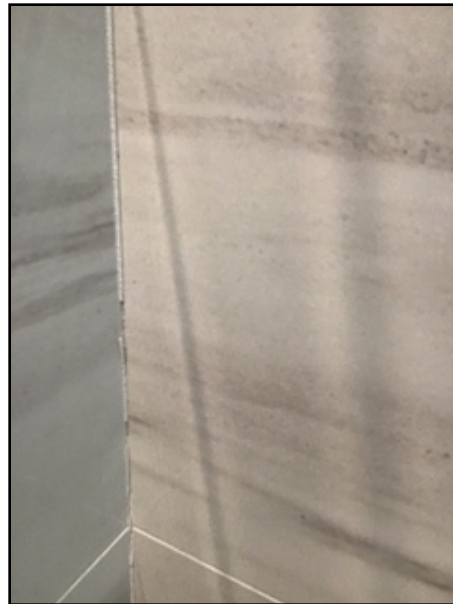
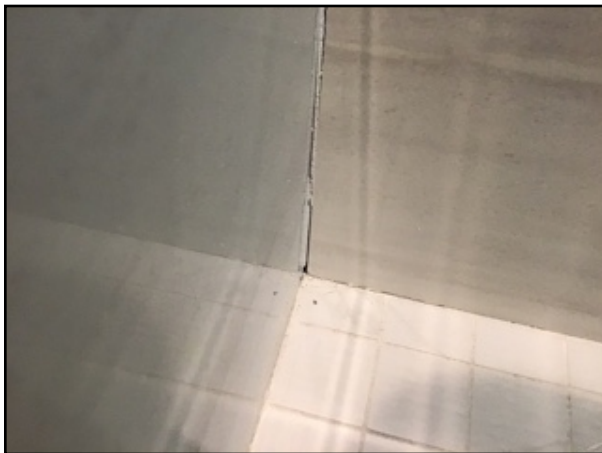
Shower Walls:

Tile, Missing/Damaged Caulking  
Condition: Repair or Replace

Day of inspection it was noted that there were areas of cracked/missing grout. This can allow water/moisture to get behind the tile and create additional concerns. Would recommend contacting a licensed contractor to repair as needed.

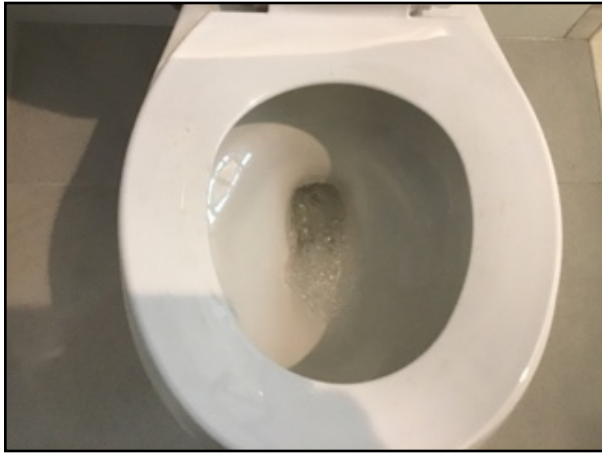
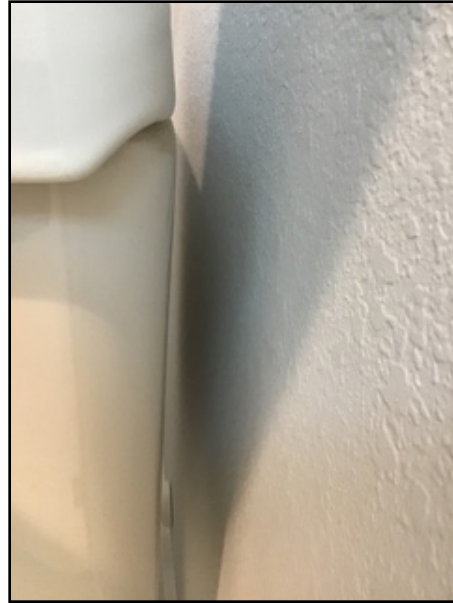
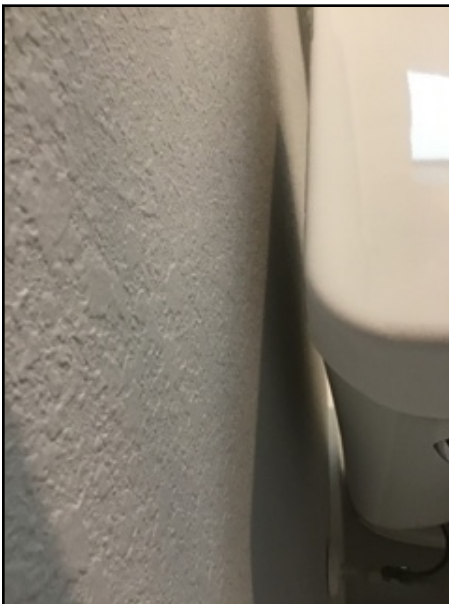
Toilet:

Standard Tank  
Condition: Repair or Replace

The toilet was placed to far from the wall. This is allowing to much space between the tank and the wall. The tank cover did not fit properly which is prohibiting the seat and cover to stay up. It is recommended to contact the contractor/builder to install the toilet properly and install the proper tank cover.

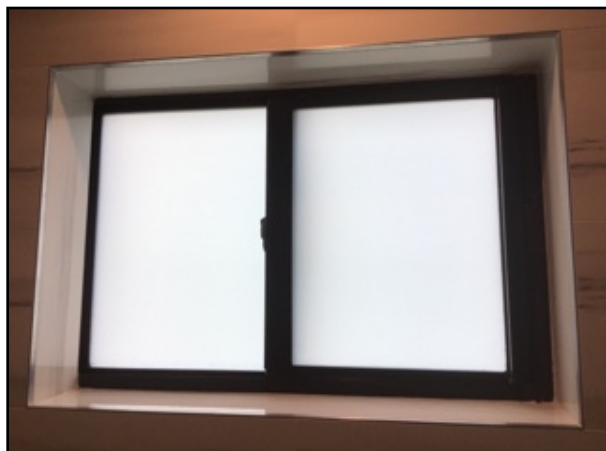
Ventilation Type:

Condition: Repair or Replace

The window was difficult to open and close. It is recommended to contact the contractor/builder to repair.

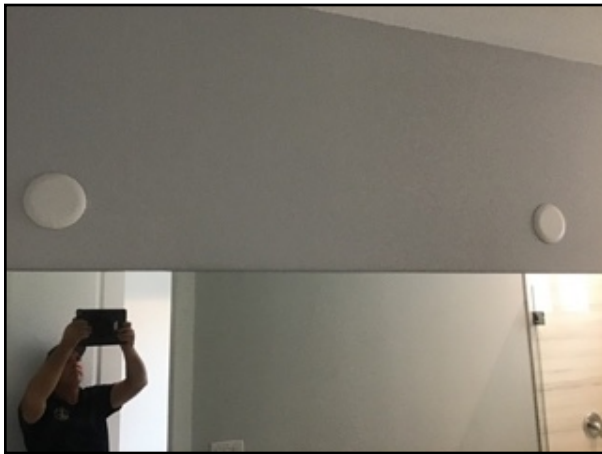
Figure 44-1

The vanity lights were missing. vanity lights were installed in other bathrooms. It is recommended to contact the contractor/builder to install vanity lights.

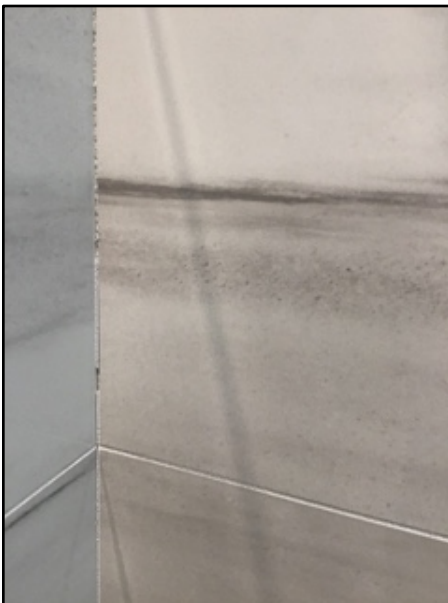
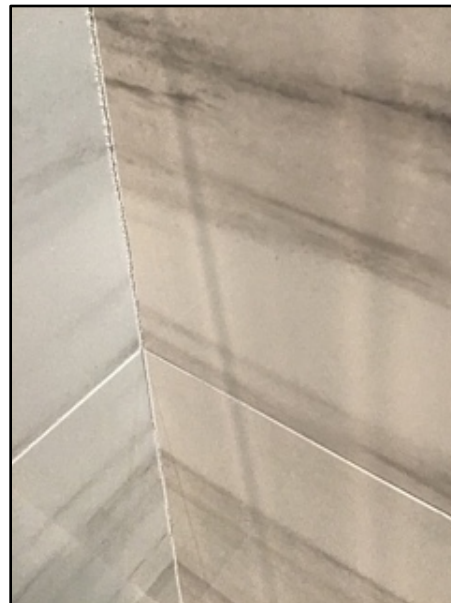
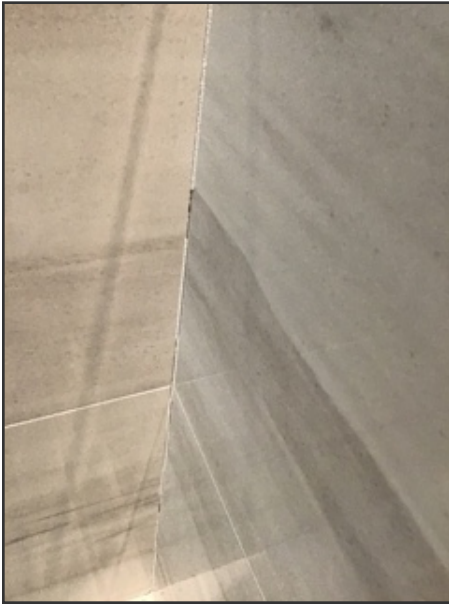
Shower Walls:

Tile, Missing/Damaged Caulking

Condition: Repair or Replace

Day of inspection it was noted that there were areas of cracked/missing grout. This can allow water/moisture to get behind the tile and create additional concerns. Would recommend contacting a licensed contractor to repair as needed.

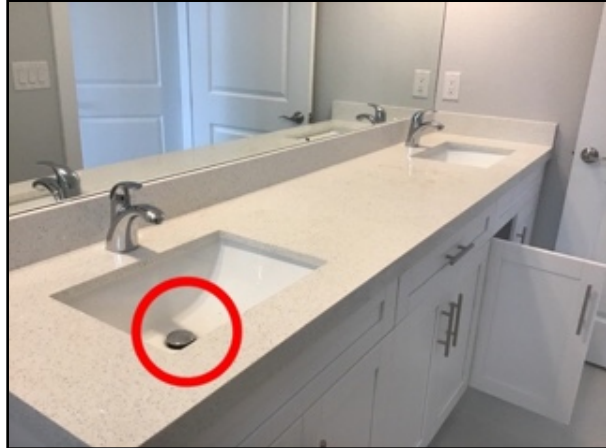
Double Vanity, Drain Stop not Operating or Missing

Condition: Repair or Replace
