# Admirable Home Inspections, LLC

## Home Inspection Report

Inspected on Mon, Nov 6 2023 at 3:43 PM

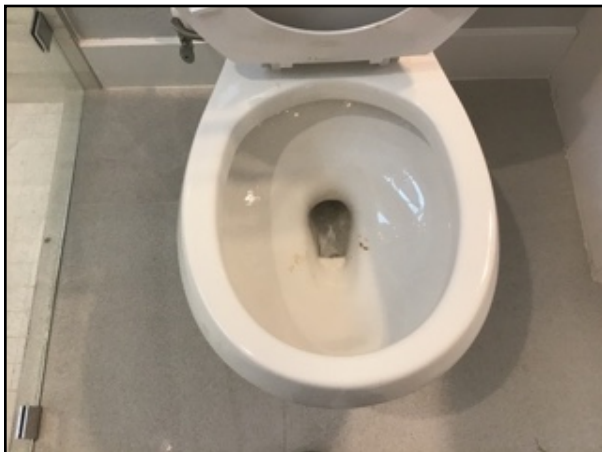
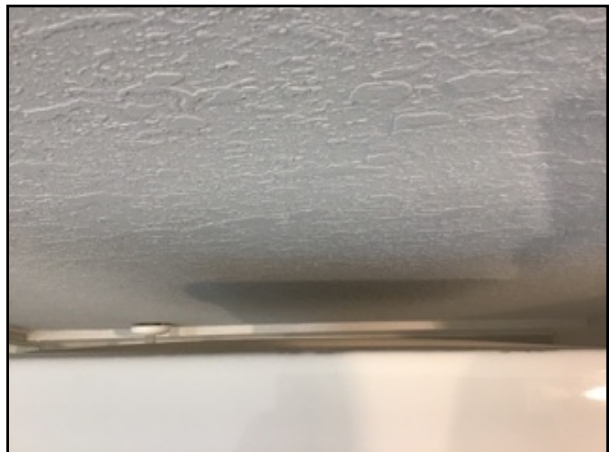
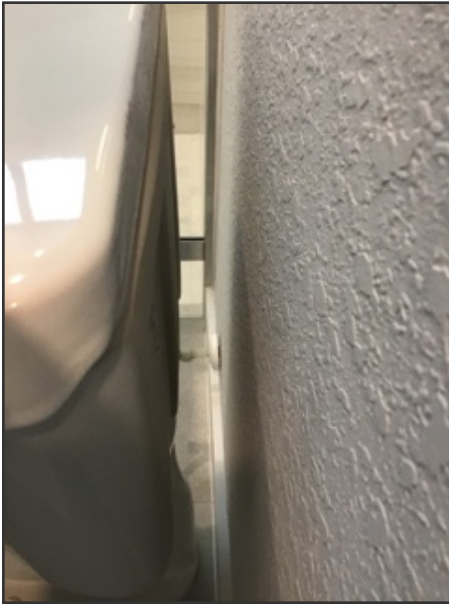
Condition: Repair or Replace

The toilet was placed too far from the wall. This is allowing too much space between the tank and the wall. The tank cover did not fit properly which is prohibiting the seat and cover to stay up. It is recommended to contact the contractor/builder to install the toilet properly and install the proper tank cover.

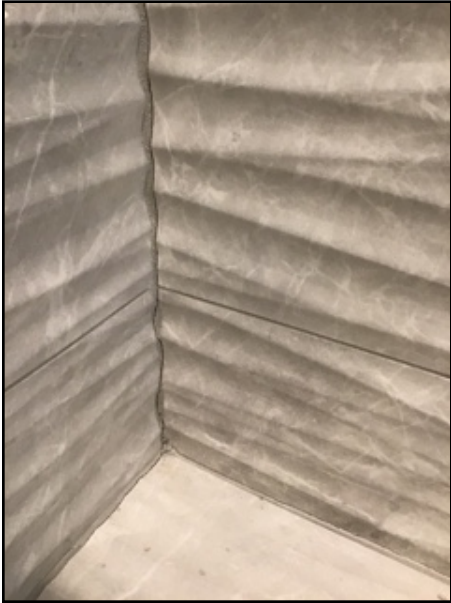
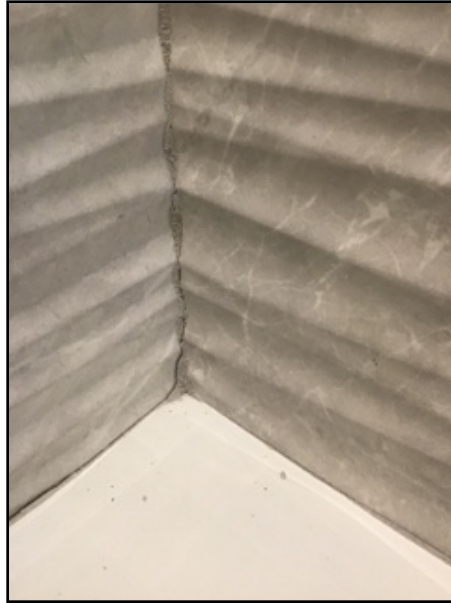
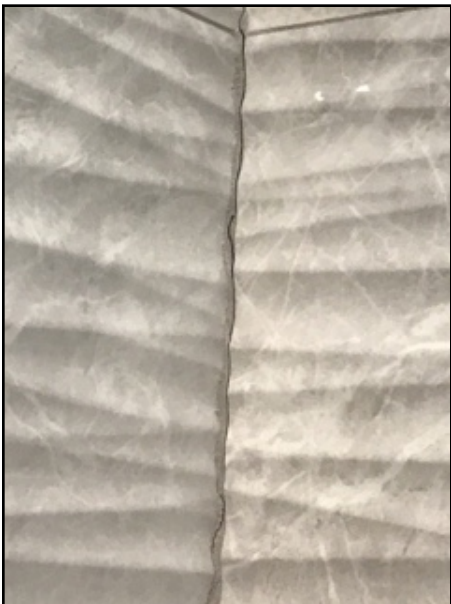
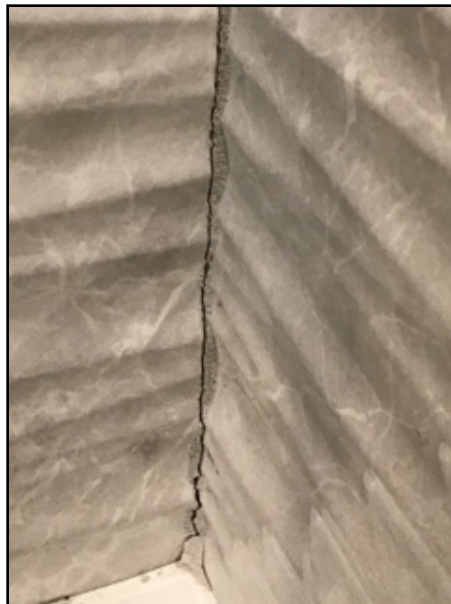
Shower Walls:

Tile, Missing/Damaged Caulking  
Condition: Repair or Replace

Day of inspection it was noted that there were areas of cracked/missing grout. This can allow water/moisture to get behind the tile and create additional concerns. Would recommend contacting a licensed contractor to repair as needed.

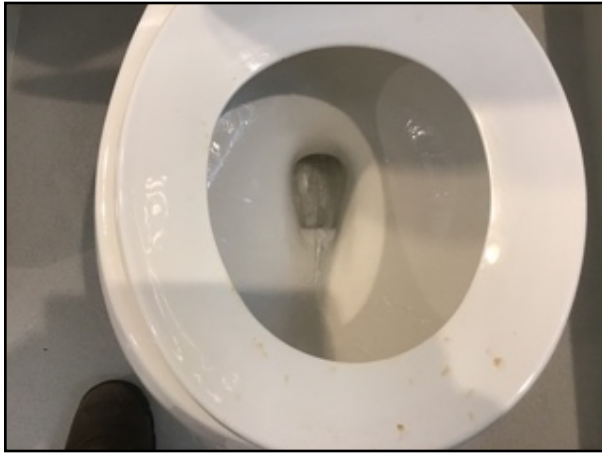
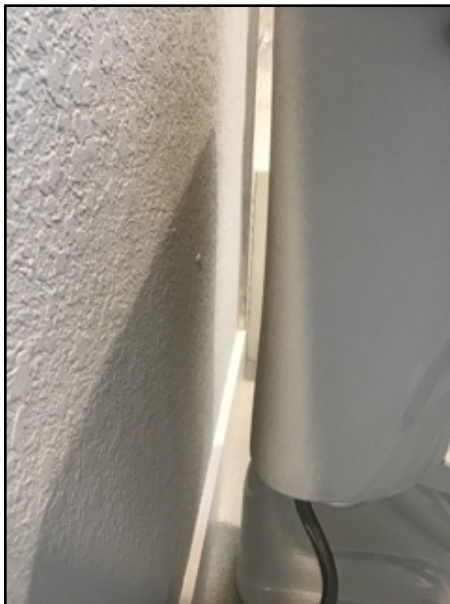
Condition: Repair or Replace

The toilet was placed too far from the wall. This is allowing too much space between the tank and the wall. The tank cover did not fit properly which is prohibiting the seat and cover to stay up. It is recommended to contact the contractor/builder to install the toilet properly and install the proper tank cover.

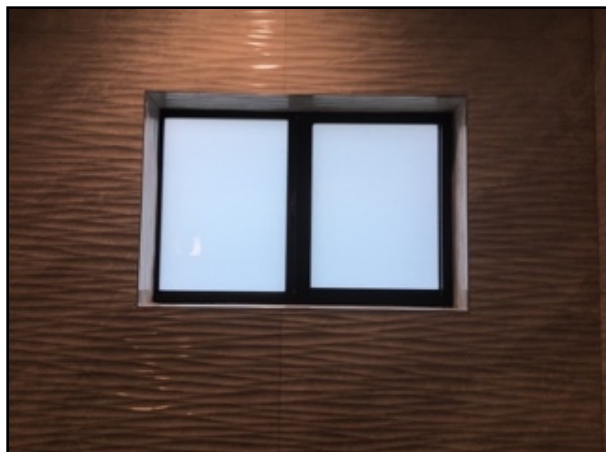
Condition: Repair or Replace

The window was difficult to open and close. It is recommended to contact the contractor/builder to repair.

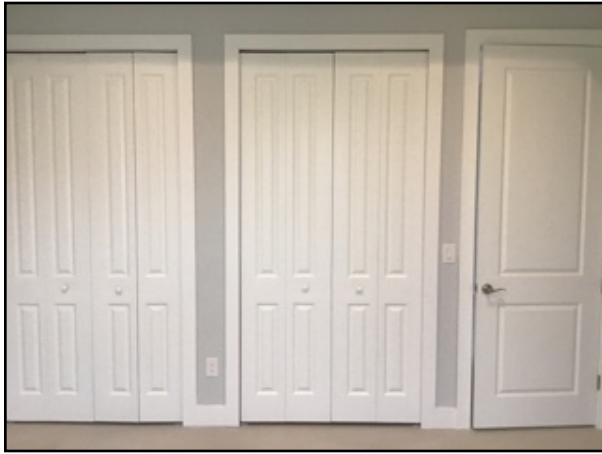
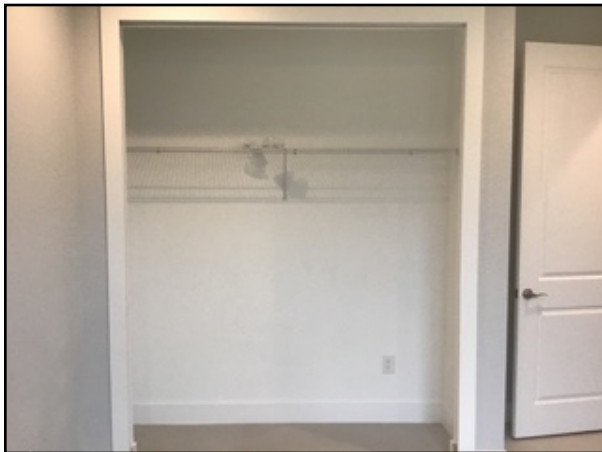
Missing in one room  
Condition: Repair or Replace

The bifold closet doors were not installed. It is recommended to contact the contractor/builder to install.

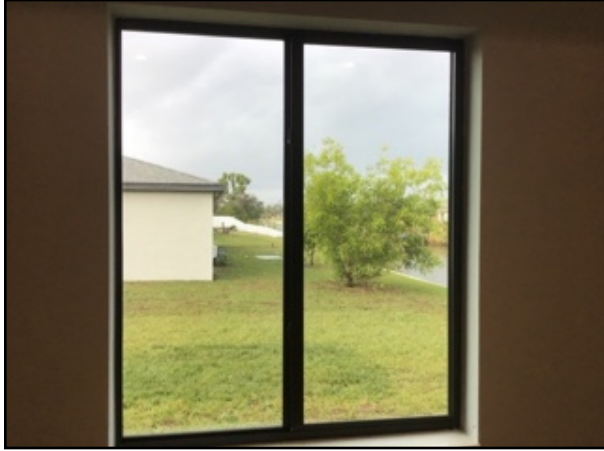
Some are Not Operating as Intended  
Condition: Repair or Replace

Some of the windows are difficult to open and close. It was also noted that some of the locks were difficult to operate. One of the windows has some damaged drywall near the window sill. it is recommended to contact the contractor/builder to make repairs.

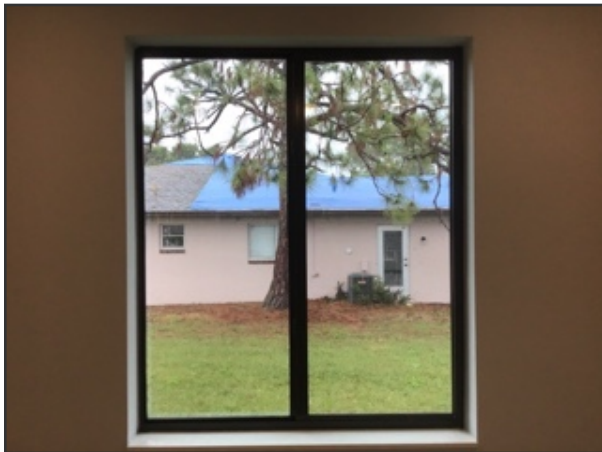
Comment 55:

Some are Not Operating as Intended  
Condition: Repair or Replace

Some of the windows are difficult to open and close. It was also noted that some of the locks were difficult to operate. It is recommended to contact the contractor/builder to make repairs.

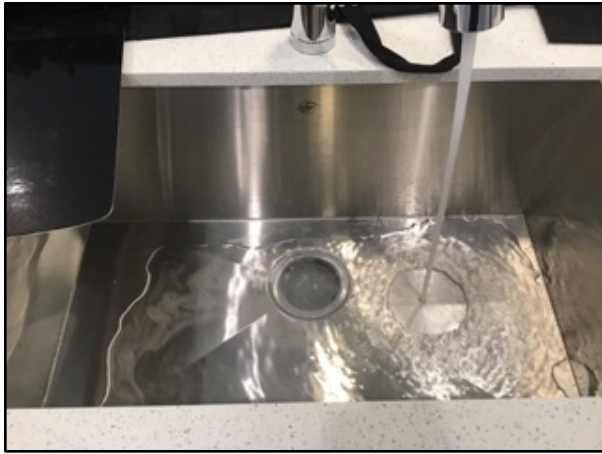
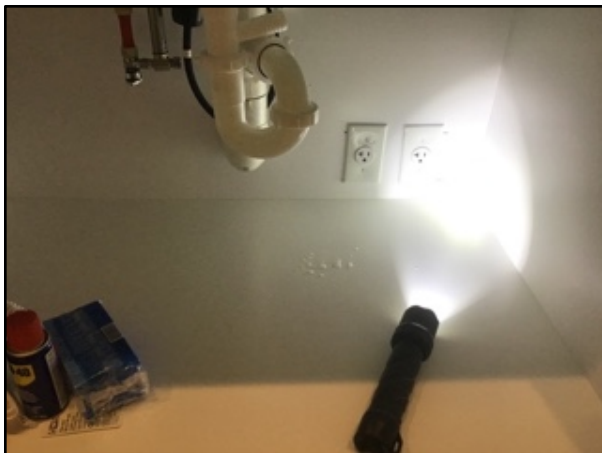
Comment 56:

Single, Stainless, Leaks Below the Sink  
Condition: Repair or Replace

The sink was not sealed properly to the counter. This was causing a leak in the cabinet below. It is recommended to contact the contractor/builder to repair.

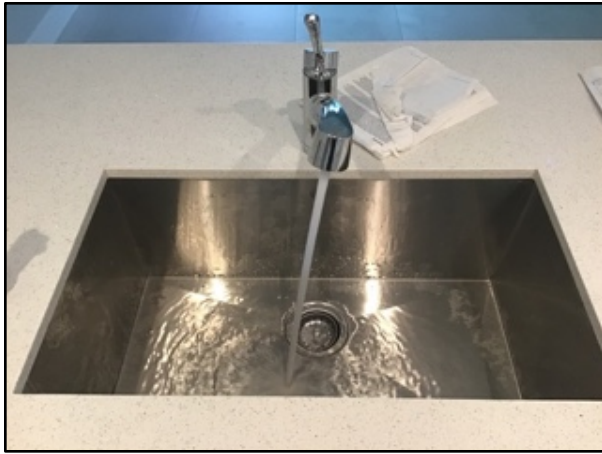
Comment 57:

Single, Stainless, Leaks Below the Sink  
Condition: Repair or Replace

The sink was not sealed properly to the counter. This was causing a leak in the cabinet below. It is recommended to contact the contractor/builder to repair.

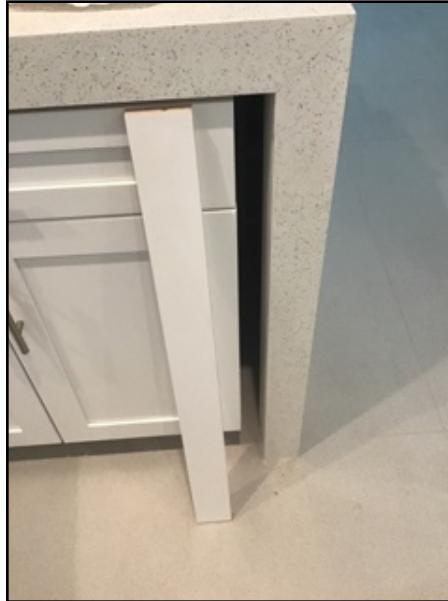
Comment 58:

A section of the cabinet trim was not installed. It is recommended to contact the contractor/builder to install.

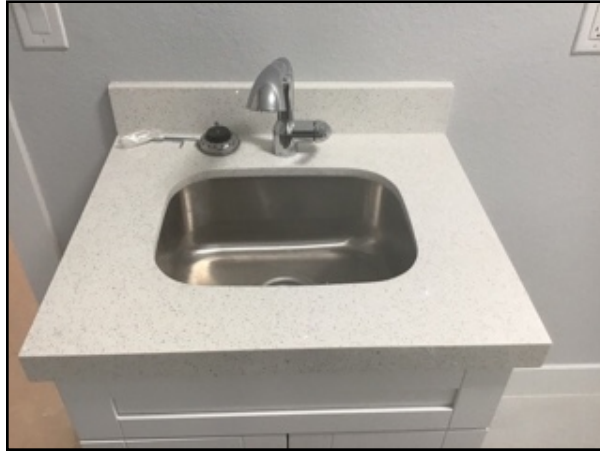
Vanity top not securely fastened to the cabinet  
Condition: Repair or Replace

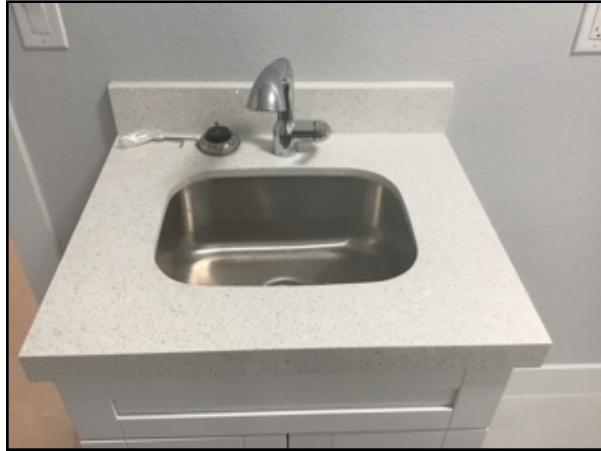
Vanity top not securely fastened to cabinet  
Condition: Repair or Replace

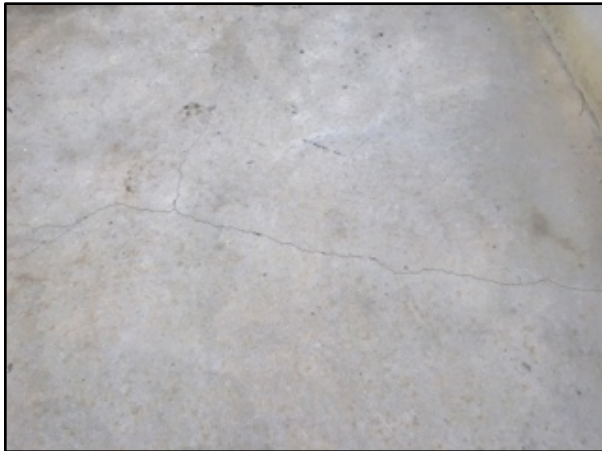
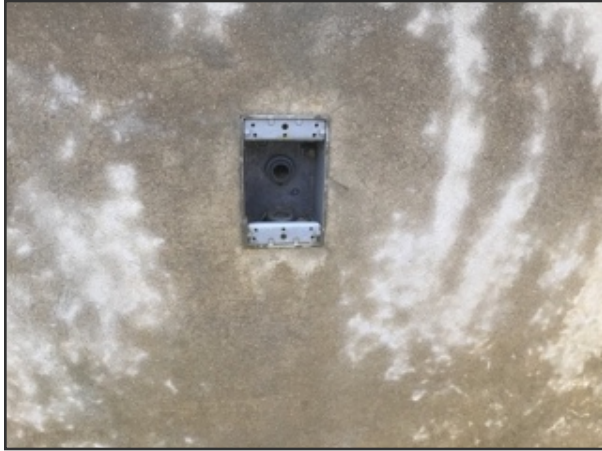
Comment 59:

Condition: Repair or Replace

There was a crack in the concrete, an electrical outlet is missing and two of the wooden support columns have movement. It is recommended to contact the contractor/builder to make repairs.
