Admirable Home Inspections, LLC

Home Inspection Report

Inspected on Wed, Oct 25 2023 at 8:30 AM

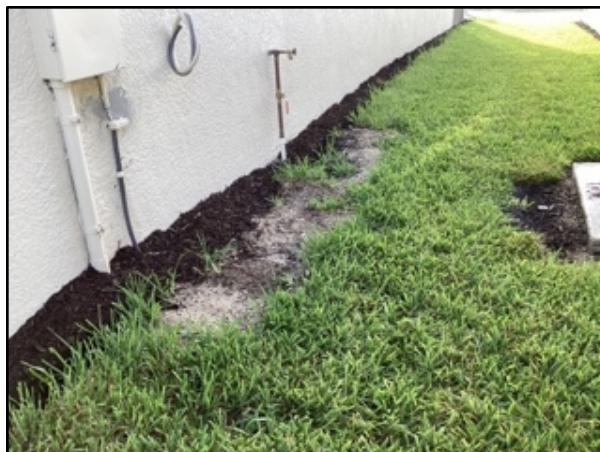
Generally Maintained, Missing Sod

The majority of the vegetation was in acceptable condition with the exception of one area that requires additional sod.

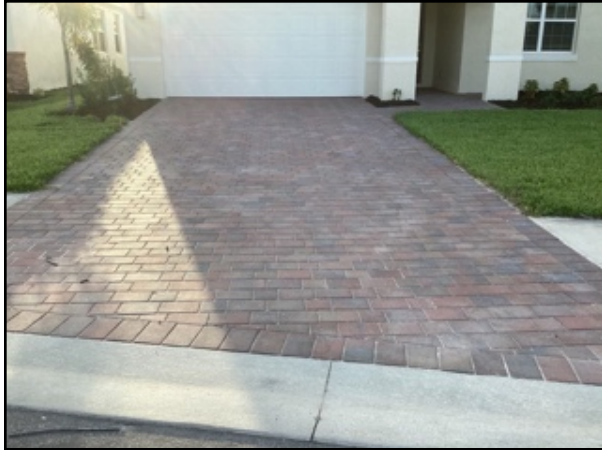
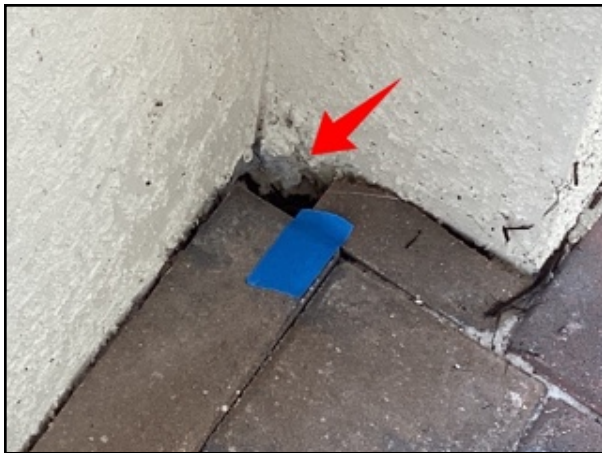
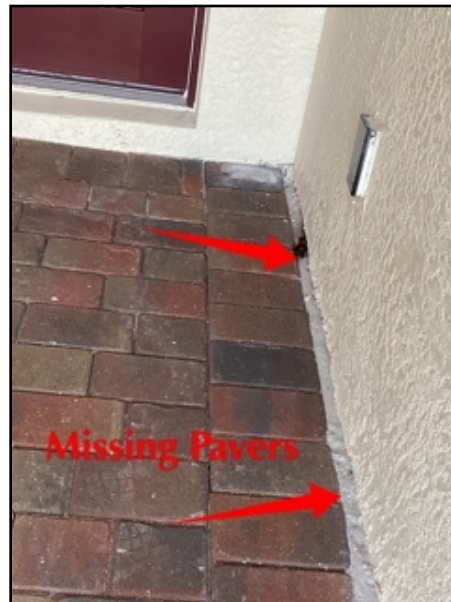
The majority of the pavers were in acceptable condition. There was an area to the right side of the walkway that has a large sand joint. Pavers should be added in this area. If left unattended the sand will eventually erode and cause shifting, settling and or displacement in the pavers. It was also noted that there were a few smaller pavers missing and some defected pavers. It is recommended to add additional paver sand where needed. Paver sand will help secure the pavers from movement. In addition, the pavers then should be sealed. This will help the water run off of the pavers instead of draining down through the paver joints. If the water continues to drain through the paver joints this will allow additional disturbance of the soil below and cause the pavers to settle, shift, displace or become loose.

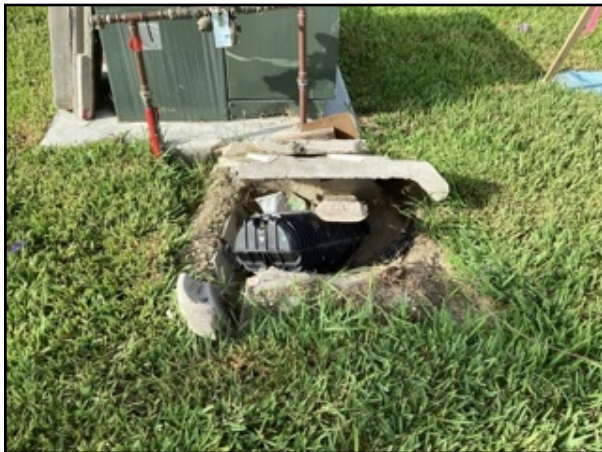
Figure 4-1

A damaged utility barrier was located at the front right side of the property. This can be a safety concern and should be repaired.

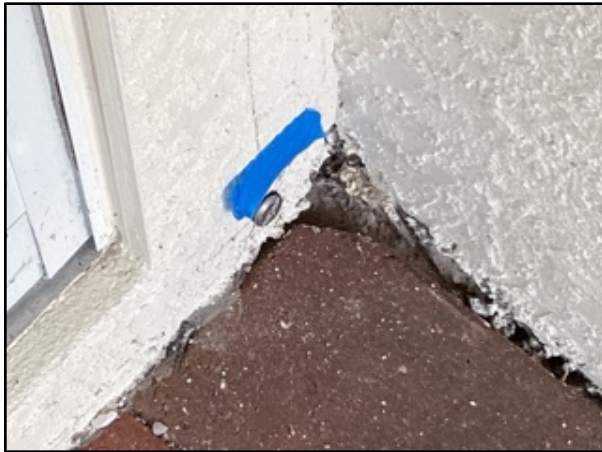
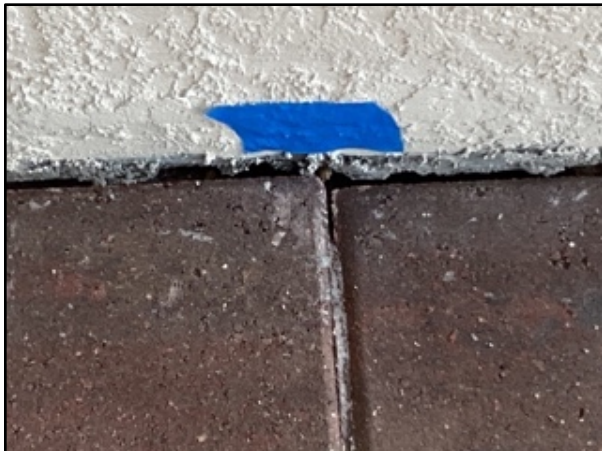
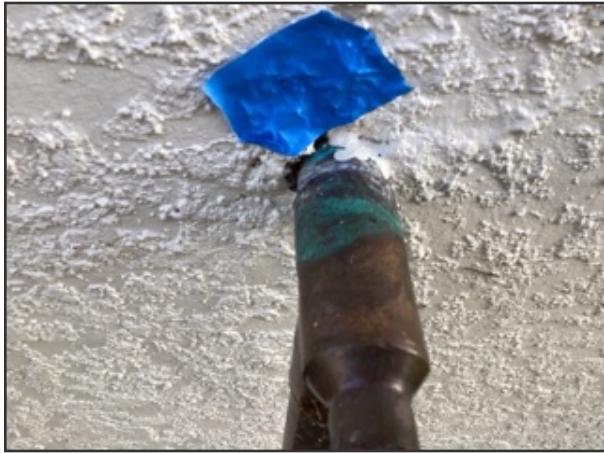
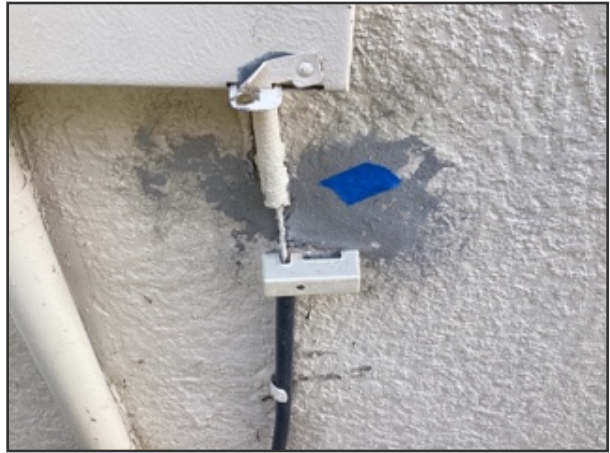
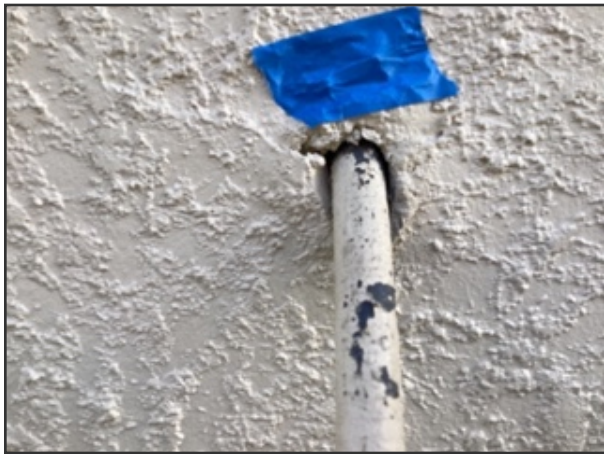
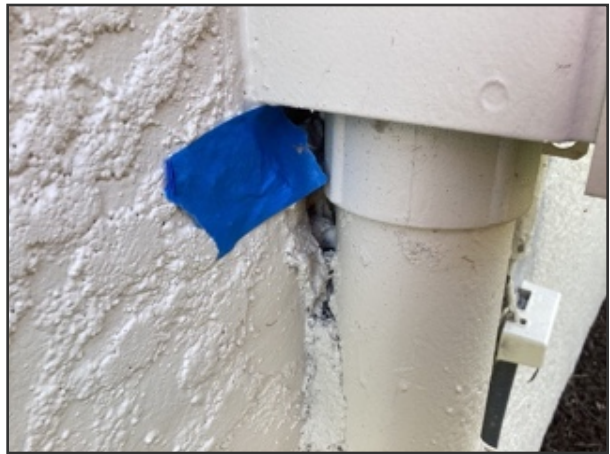
There were several areas of the exterior covering that require immediate repair. These concerns include unfinished stucco application, damaged and or missing paint, improperly sealed protrusions.

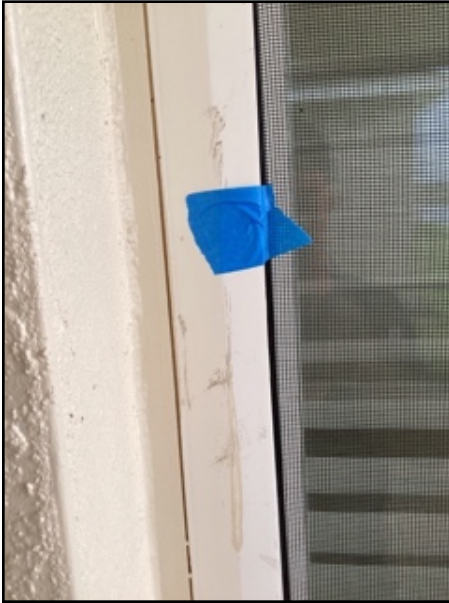
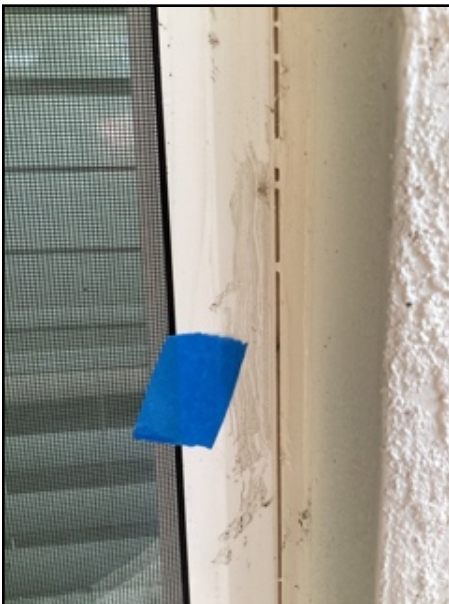
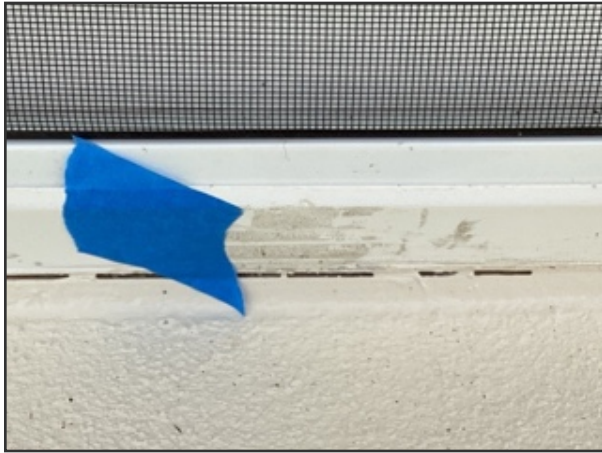
There were several windows that have stucco splatter, caulk, and other residue. This is not a proper representation of a brand new final product. Removal of these residues is recommended on all windows.

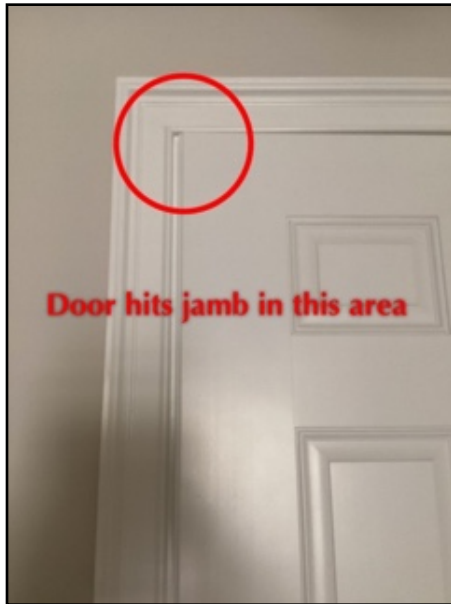
Figure 7-1

The main entry door is slightly out of square which causes a larger space between the jam and door on the upper right side. It also causes the door to rub the jamb on the upper left side. In addition some of the hinge pins are not completely set.

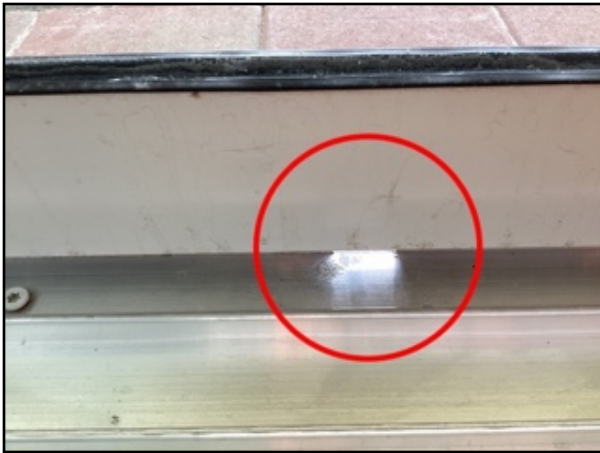
Figure 8-1

Weather stripping is missing in several areas of the sliding glass doors. This will allow water/moisture, warm air, insect and or small vermin intrusion.

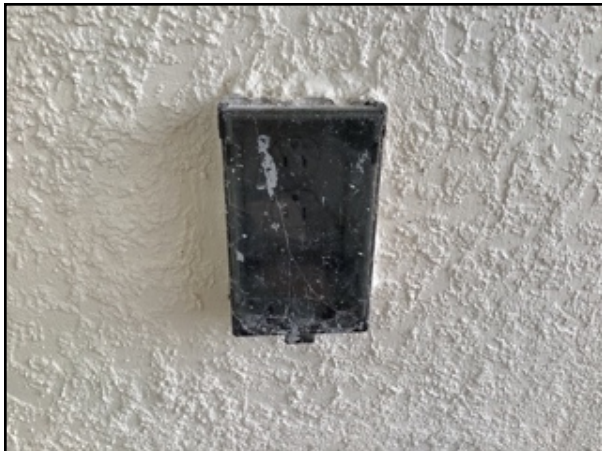
Figure 13-1

Some of the electrical outlet covers have stucco splatter, or other residue. This is not a proper representation of a brand new final product. Removal of these residues is recommended on all outlet covers.

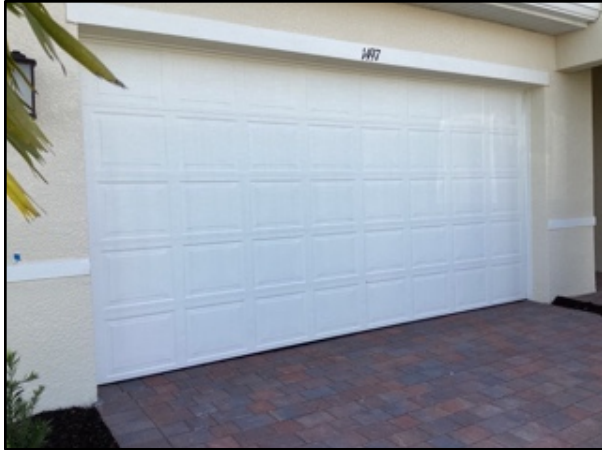
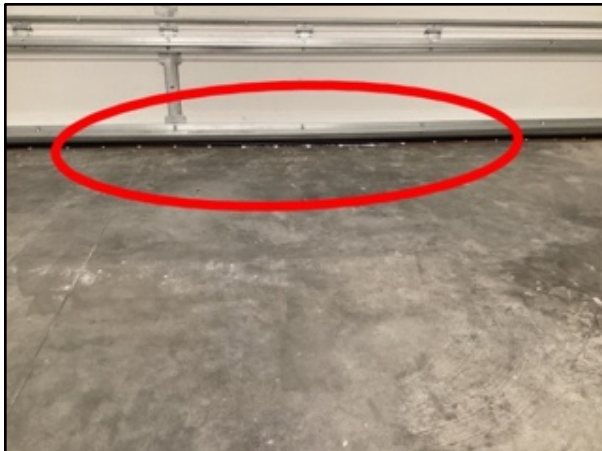
Comment 14:

Garage Type: Attached
Garage Size: 2 Car
Non-Automobile Doors: Not Present
Automobile Doors: One, Air Gaps Noted
Condition: Requires Repair

Air gaps were visible at the bottom of the garage door. This can allow water/moisture, warm air or vermin intrusion. It is recommended to contact the builder to make repairs.

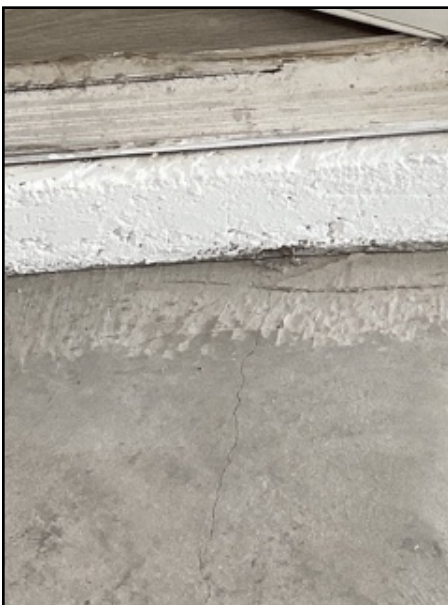
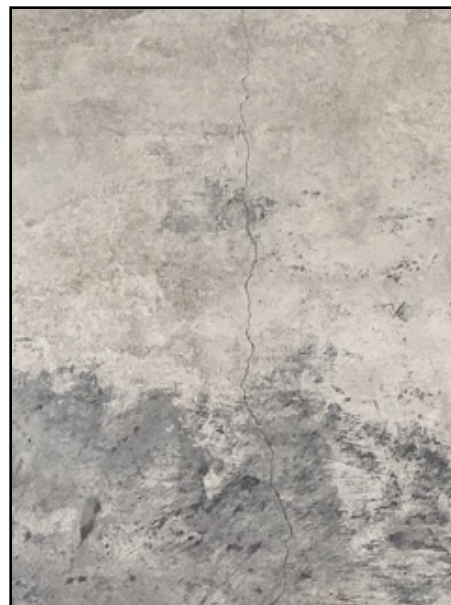
Floor Condition :

Small Cracks

Condition: Further Evaluation Required

Cracks are developing on the garage floor. Cracks can develop from settlement in the soil below due to erosion, natural occurring slab settling, shrinking in the concrete which is typically from the evaporation of the water in the concrete during the curing process or expansion in the concrete due to the exposure to the extreme heat and fluctuations in the temperature.

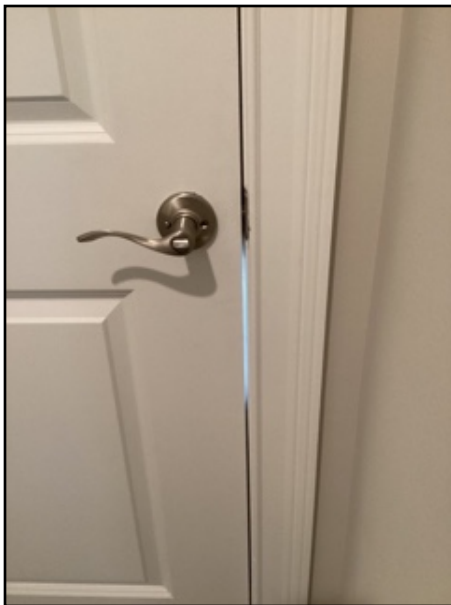
Figure 17-1

Air gaps were visible around the perimeter of the garage door. This can allow heat and moisture to enter the conditioned living space.

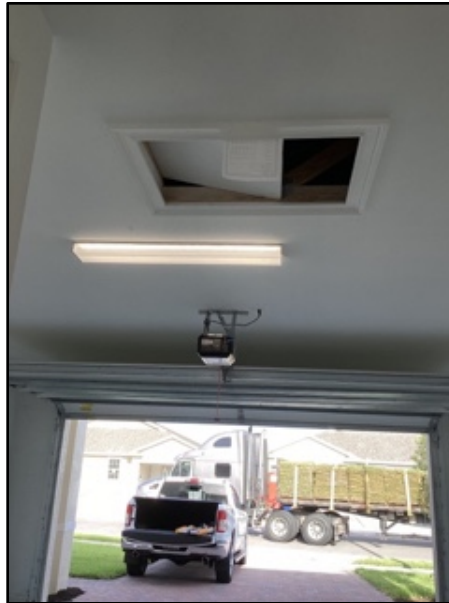
Limited Viewing
Condition: Further Evaluation Required

The builder did not grant full access to the attic. The attic was observed from the scuttle. The inspector was unable to evaluate 100 % of the attic area and components which may include but not limited to the roof framing, roof decking material, moisture, ventilation, soffit vents, insulation, bathroom & HVAC duct work ect.... Areas that were accessible appeared to be in acceptable condition. It is recommended to further evaluate areas that were not accessible.

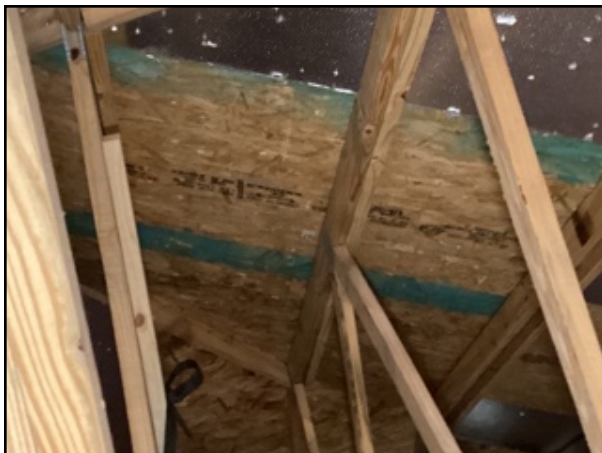
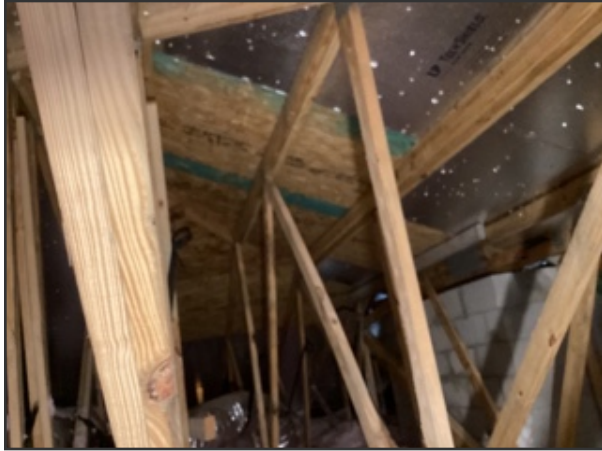
Comment 19:

Condition: Requires Repair

A majority of the roof sheathing had radiant barrier. There were several sections of the sheathing that did not have a radiant barrier. A radiant barrier will help reduce attic temperatures however the areas that are missing the radiant barrier can negate the effects and increase the attic temperature. Please refer to the manufactures installation instructions of LP Tech Shield: <https://lpcorp.com/resources/product-literature/installation-instructions/lp-techshield-installation-instructions>.

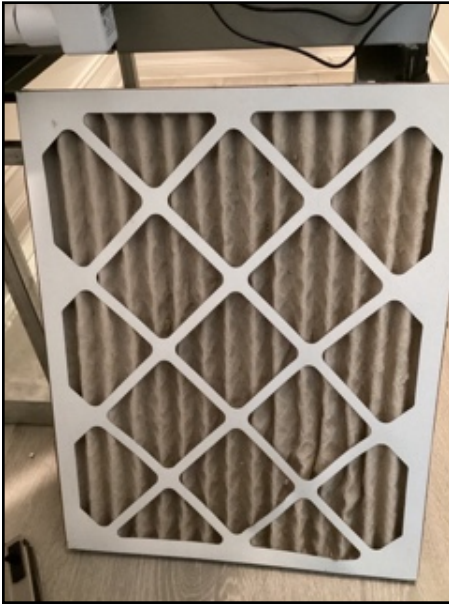
Figure 20-1

Day of inspection it was noted that the filter requires replacement. It is also recommended to have the HVAC system serviced and filters replaced by a licensed HVAC company based on the manufactures suggestions. This can help increase the life expectancy and efficiency of the system and system components.

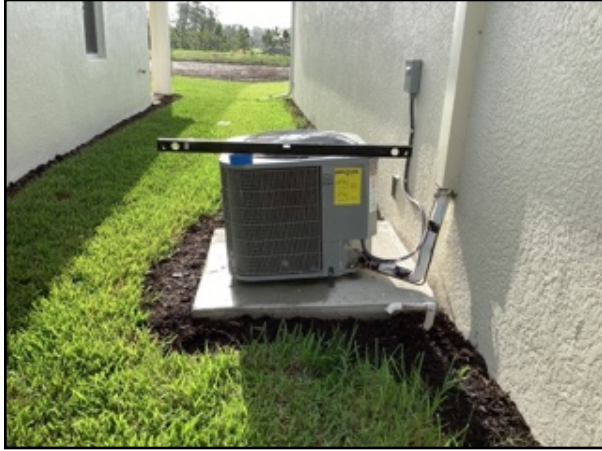
Comment 21:

Concrete
Condition: Requires Repair

Day of inspection it was noted that the AC unit was not level. When the unit is not level this can prohibit the proper distribution of the fluids and lubricants causing damage to the compressor. This can also lead to unbalanced loads for any motors or fans, possibly causing the premature wear of bearings in the compressor motor.

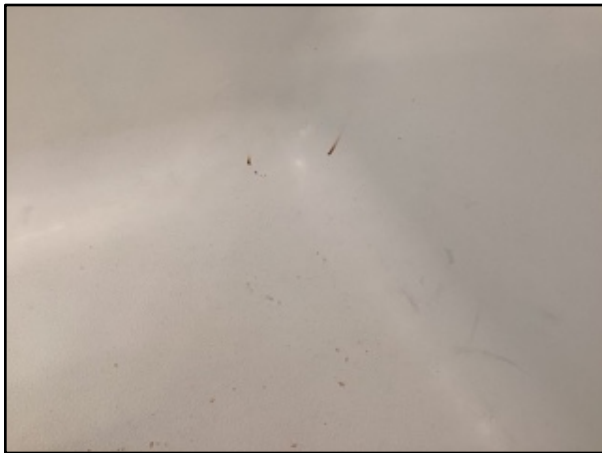
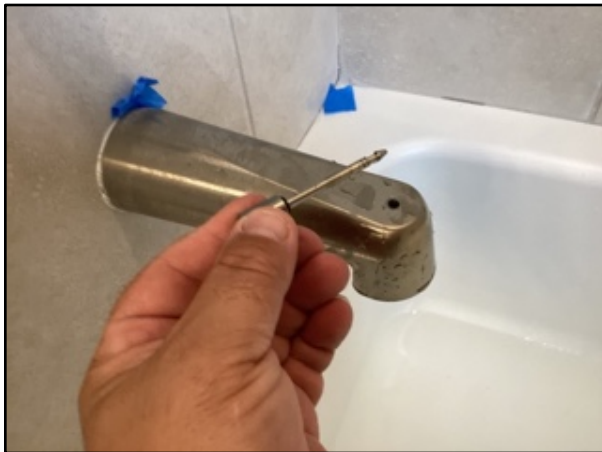
Built in , Staining on Tub
Condition: Requires Repair

There was some stains on the tubs surface, the shower diverter was broken which did not allow water to divert to the shower head and it was not properly sealed to the wall which can allow water to get behind the tile and cause additional concerns.

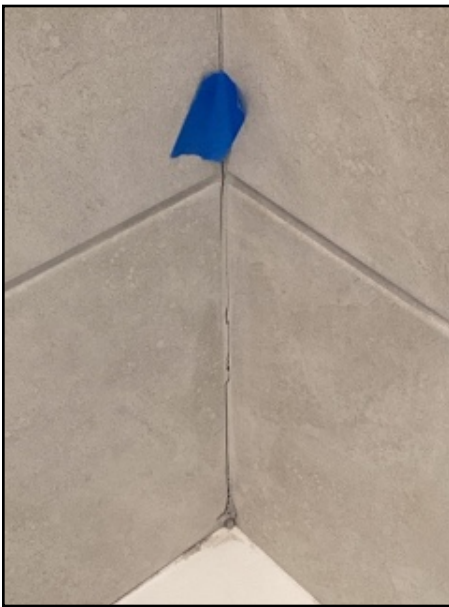
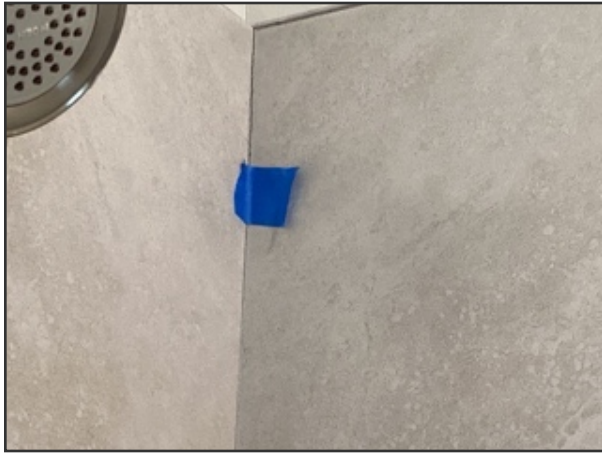
Condition: Requires Repair

There were areas of missing/damaged grout or caulking. This can allow water/moisture to get behind the tile and create additional concerns. Would recommend contacting a licensed contractor to repair.

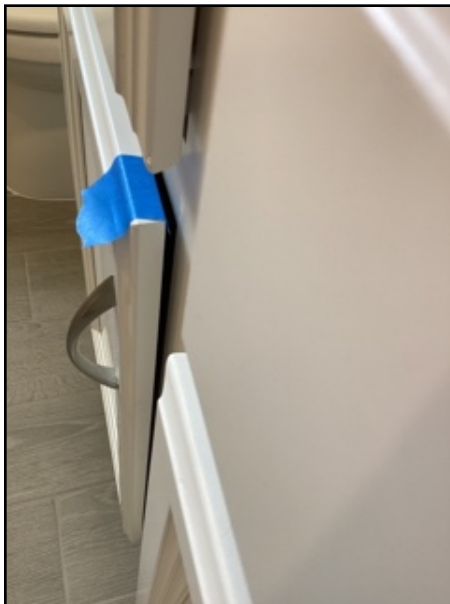
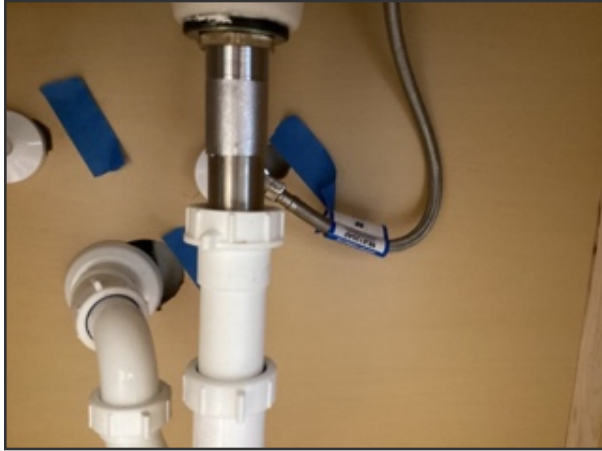
Single Vanity
Condition: Requires Repair

There were a few concerns in regards to the sink/vanity to include: warped doors that do not close properly, caulking, glue or other residue in several areas, small imperfections on the vanity and the holes under the vanity to accommodate the supply and waste lines were not cut accurately. This is not a proper representation of a brand new final product.

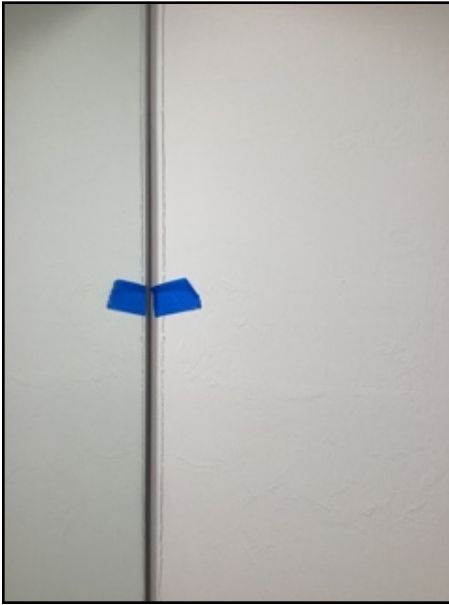
Figure 32-1

Some minor imperfections in the paint and caulk was missing on the baseboard in closet were noted. Repairs are recommended.

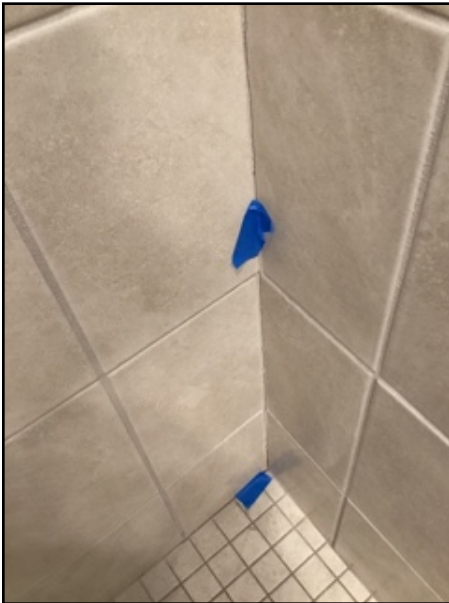
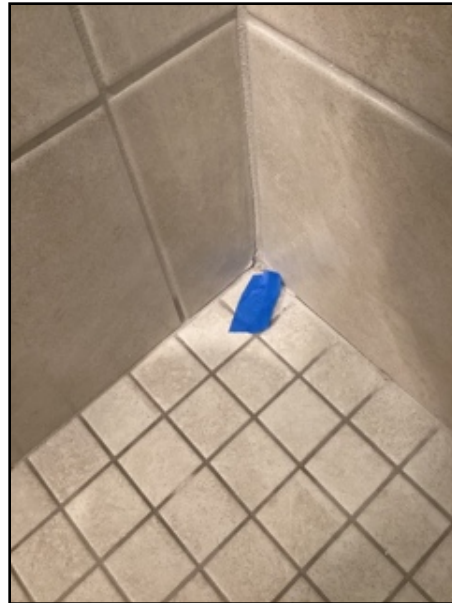
Condition: Requires Repair

There were areas of missing/damaged grout or caulking. This can allow water/moisture to get behind the tile and create additional concerns.

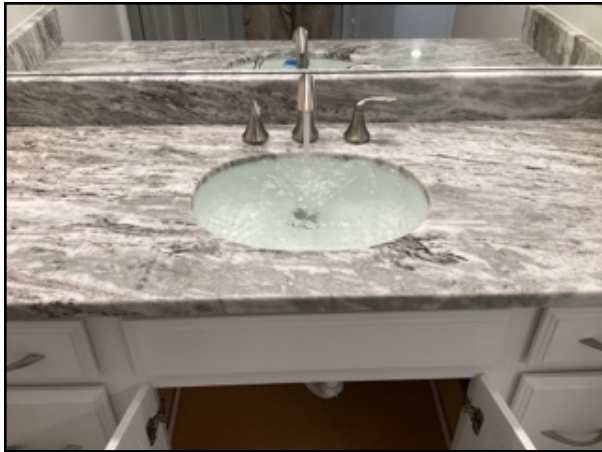
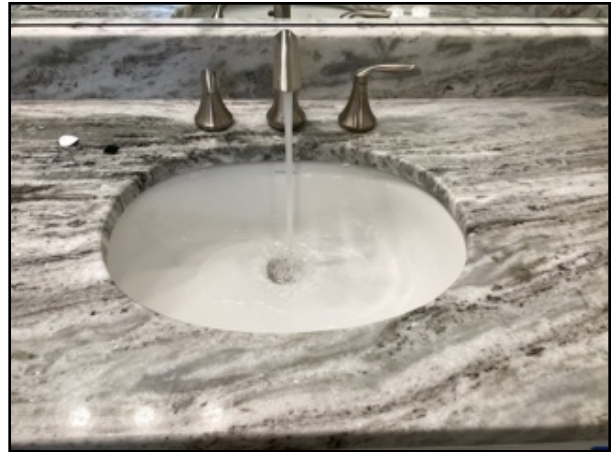
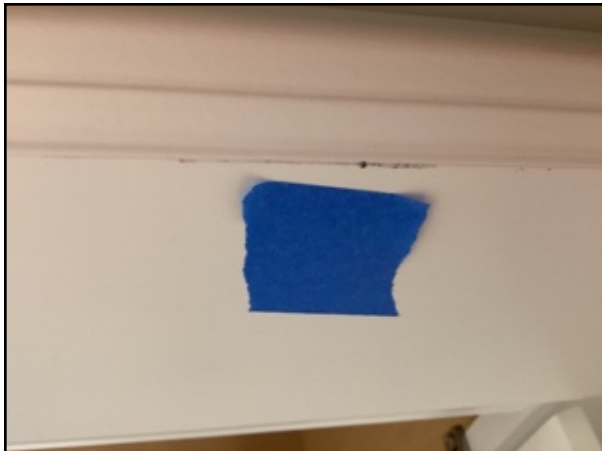
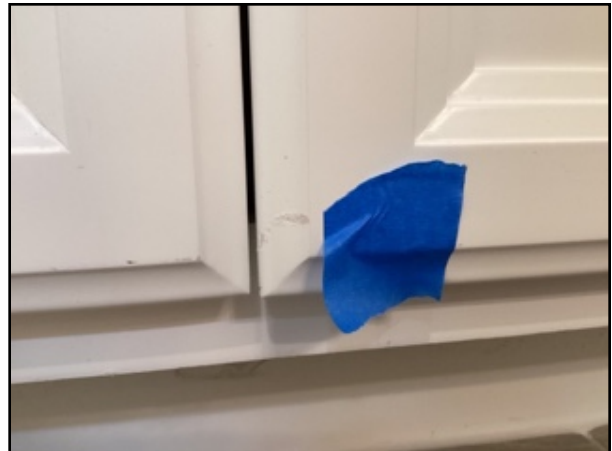
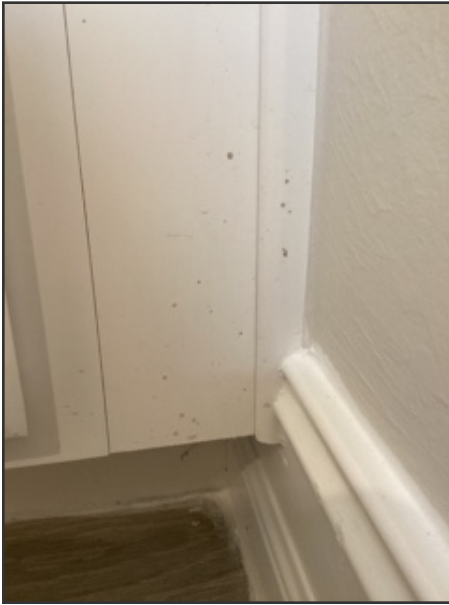
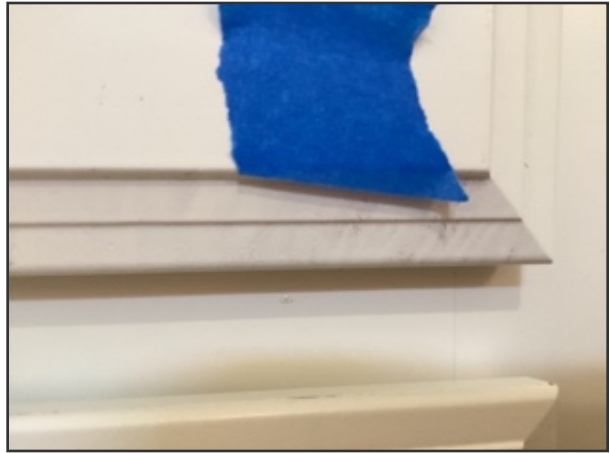
Condition: Requires Repair

There are imperfections on the sink/vanity such as some light scuffs/scratches/imperfections, paint overspray and splatter and drawers that are not sliding as intended.

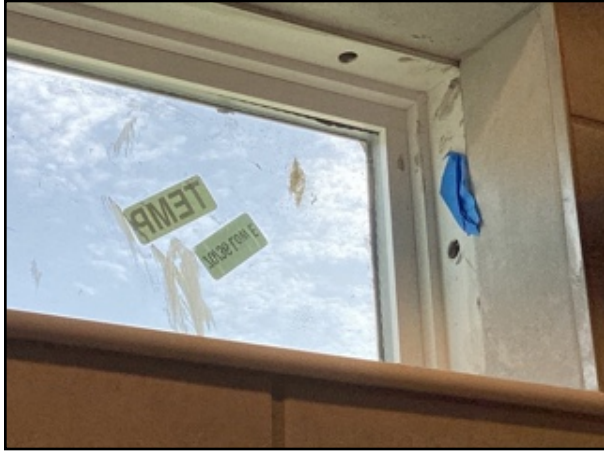
Figure 36-1

Paint, caulk and other residues were noted on the window. Minor imperfections in the paint and drywall were noted. The vanity lights are hung crooked and the half wall by the vanity next to the shower is not square. This is not a proper representation of a brand new final product. Repairs are recommended.

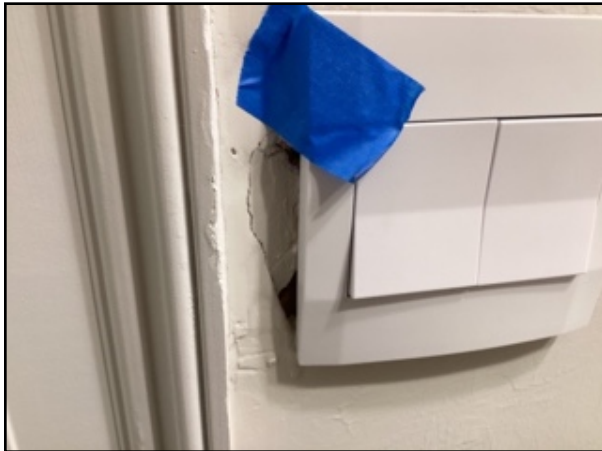
Figure 37-1

Imperfections were found in the drywall and paint in several areas. Repairs are recommended.

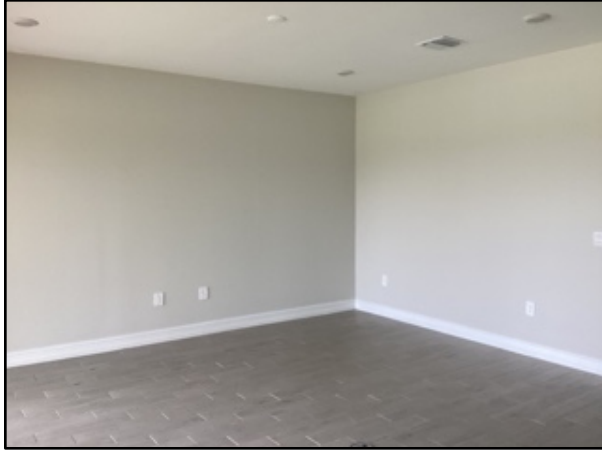
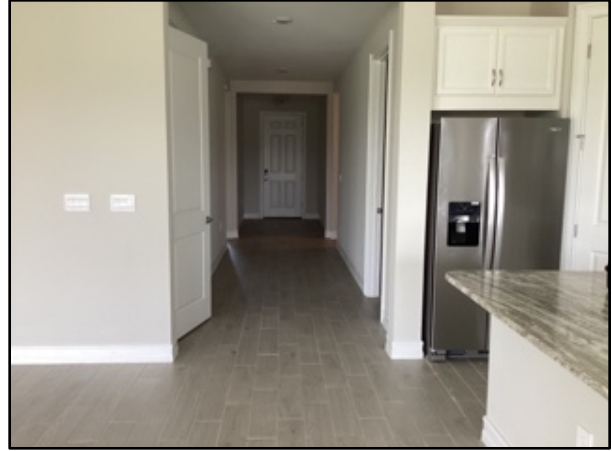
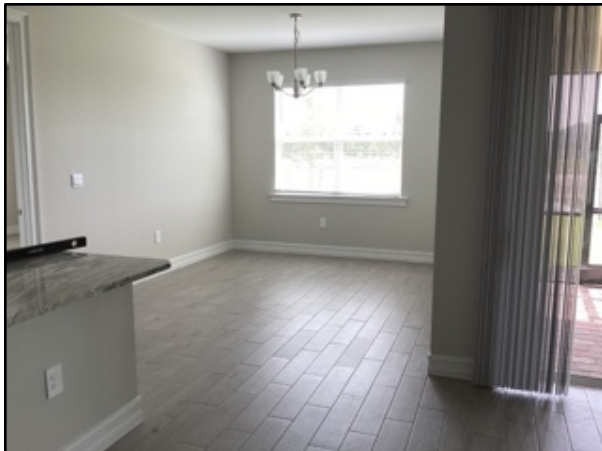
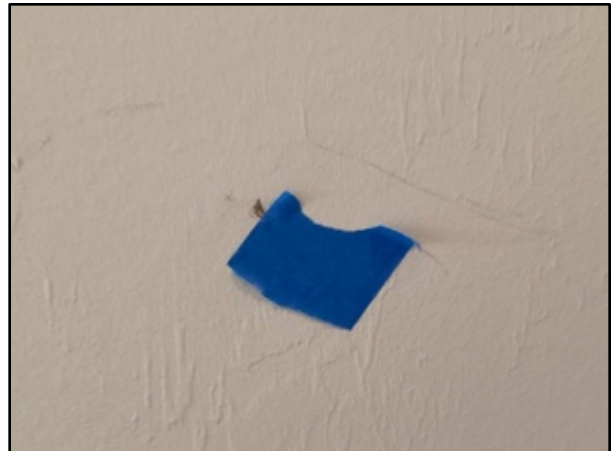
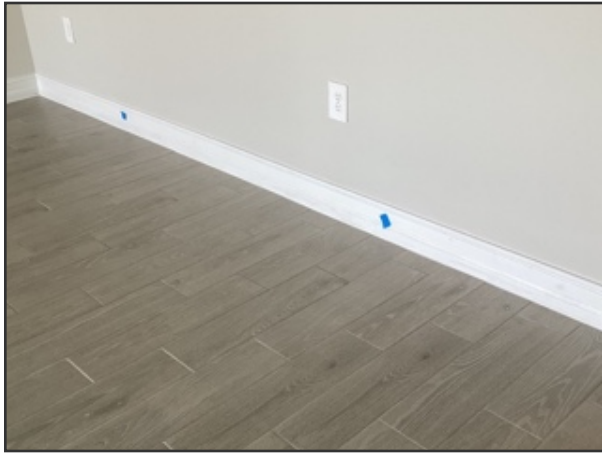
Condition: Requires Repair

There were not many concerns in general living area which includes the living room, dining room and entry hallway. There were some areas of the base board moldings that require painting, some minor imperfections in the drywall/paint.

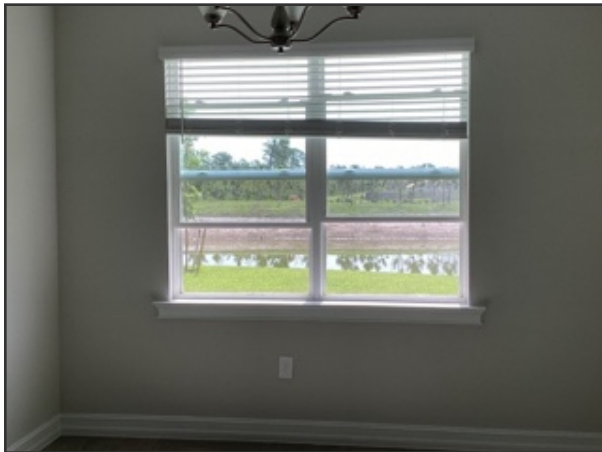
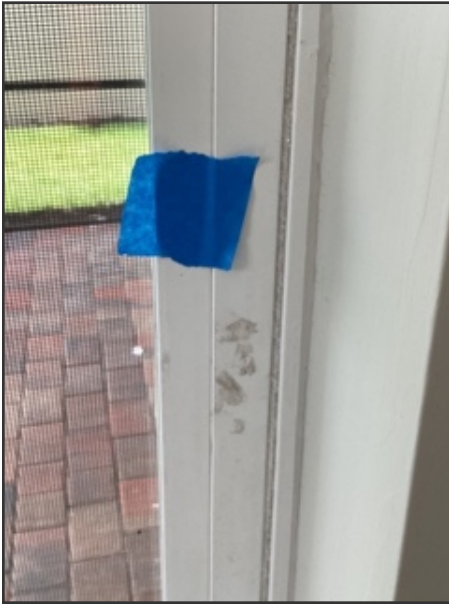
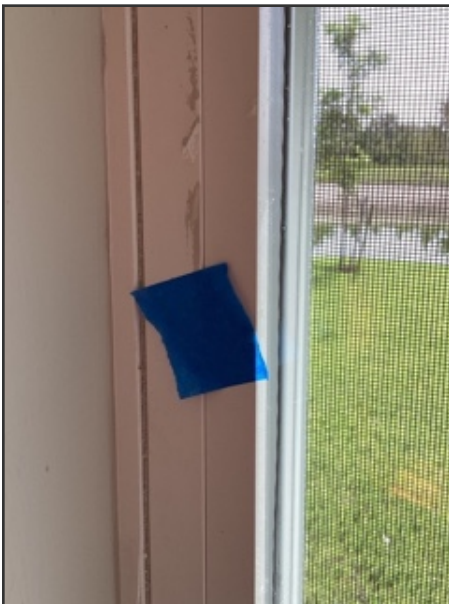
Condition: Requires Repair

All windows were tested for operation and functioned as intended. It was noted that there was caulking, glue and dead flies/residue. These windows are located in the dining room.

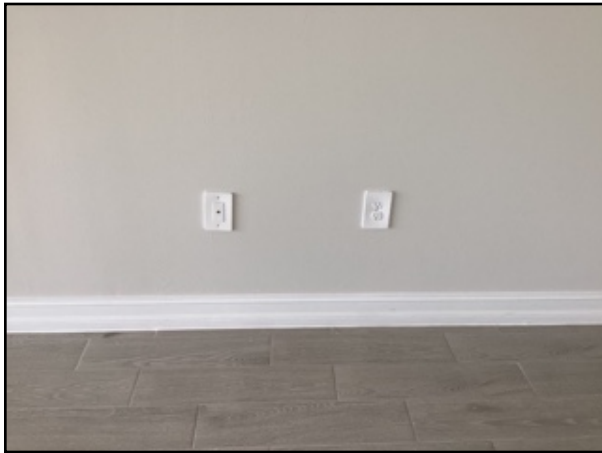
Inspected a Random Number of Switches and Outlets,
Several Outlets are Installed Crooked
Condition: Requires Repair

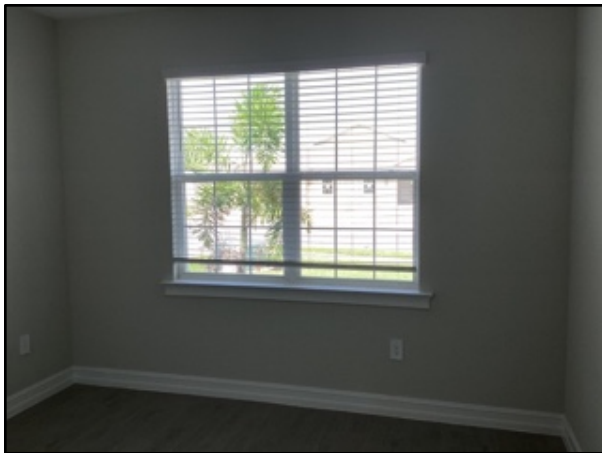
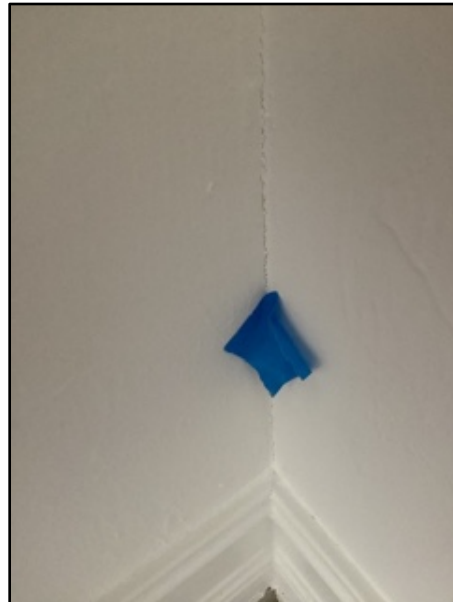
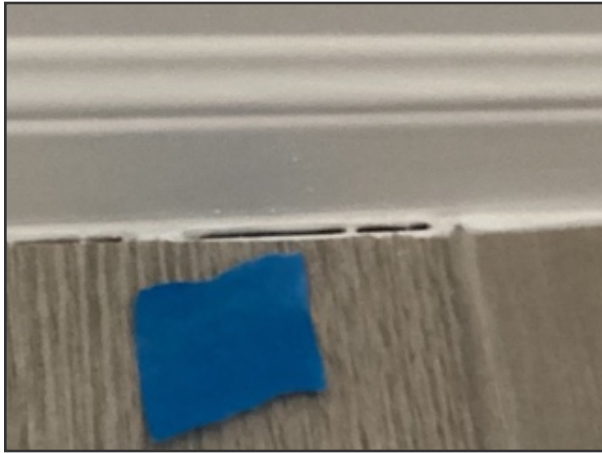
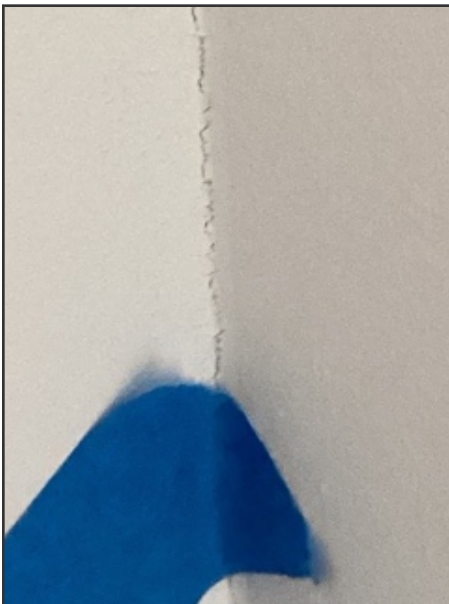
Condition: Requires Repair

The majority of the ceiling and walls were in acceptable condition with the exception of some blemishes/imperfections in the paint, drywall and some missing caulk on the baseboard trim.

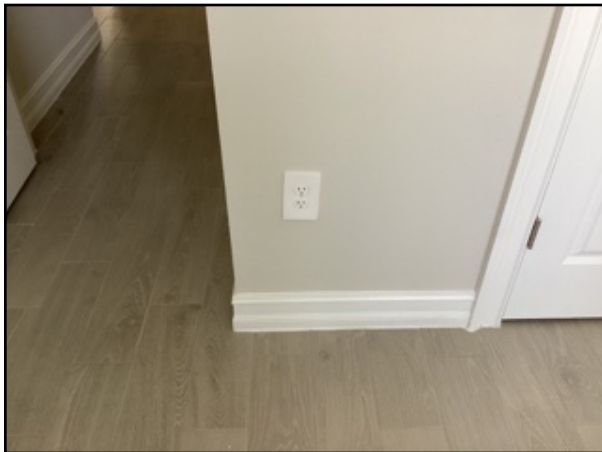
Some Switches and Outlets are Crooked
Condition: Requires Repair

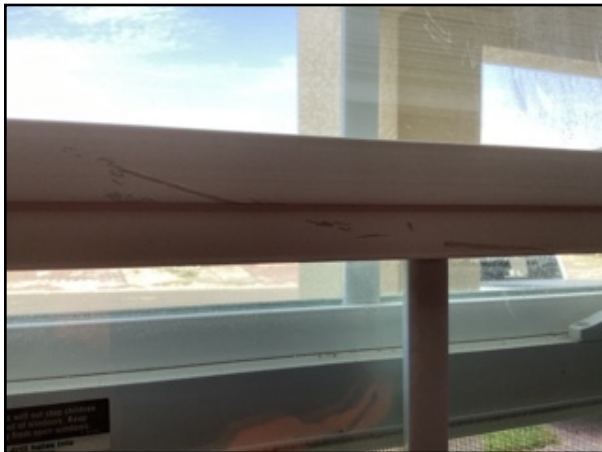
Condition: Requires Repair

Debris was found in the window jams, paint, caulk, glue, and other residue is present on several areas of the windows and an imperfection on the windowsill.

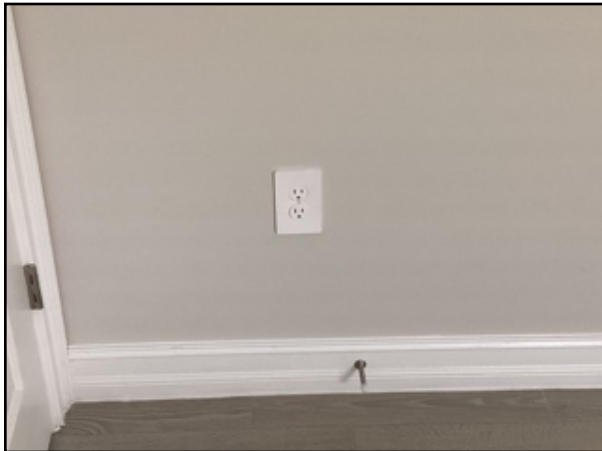
Some Switches and Outlets are Crooked
Condition: Requires Repair

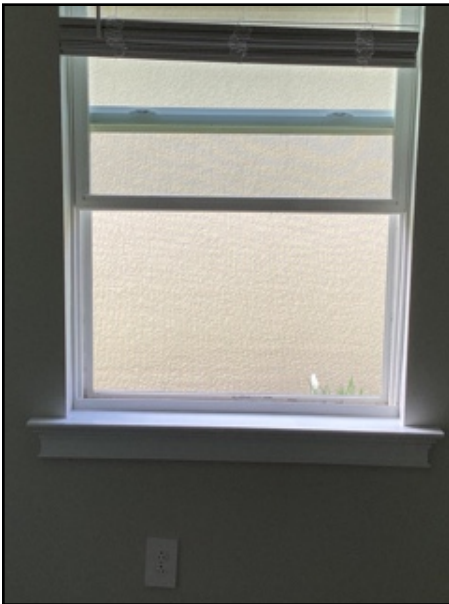
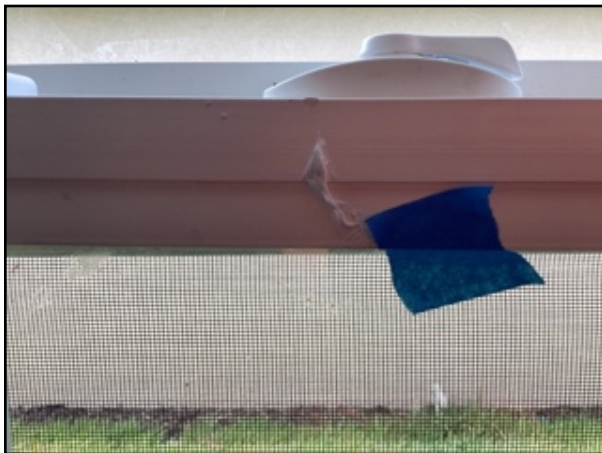
Condition: Requires Repair

Caulking and other residue was found in several areas of the window and the window jam has a couple blemishes/imperfections.

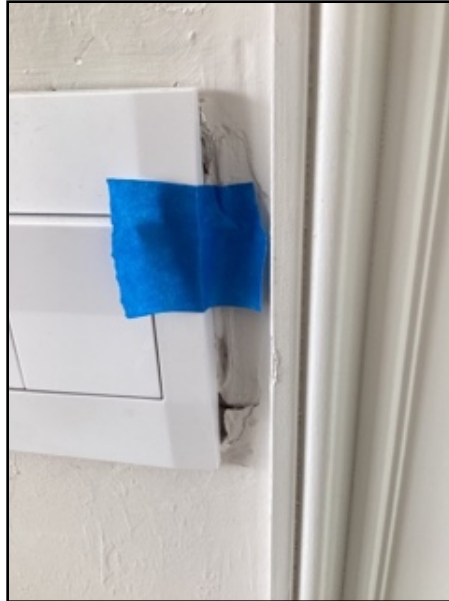
Condition: Requires Repair

The majority of the drywall was in acceptable condition with the exception of damaged drywall by the light switch.

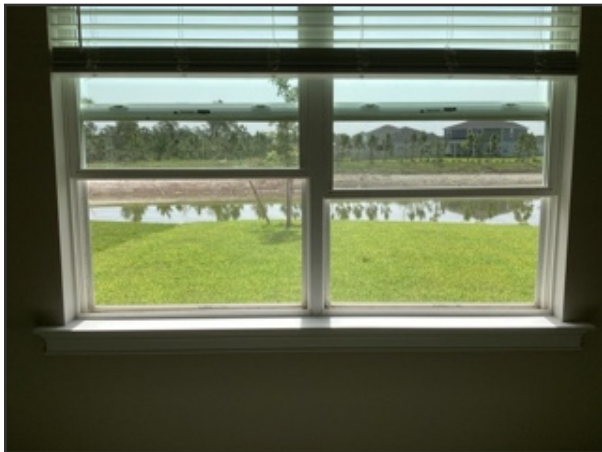
Single Hung
Condition: Requires Repair

Comment 45:
Caulking and other residue was found in several areas of the window.

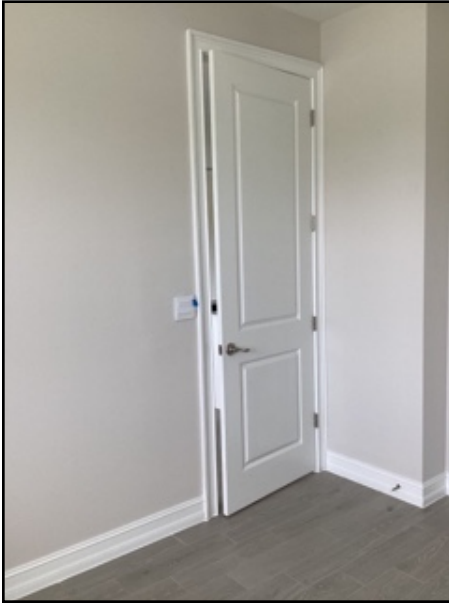
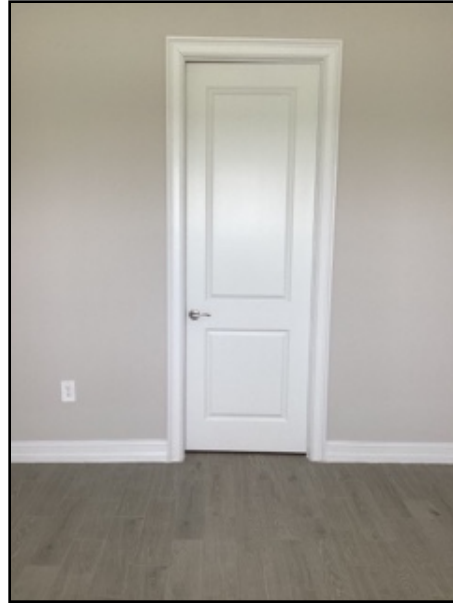
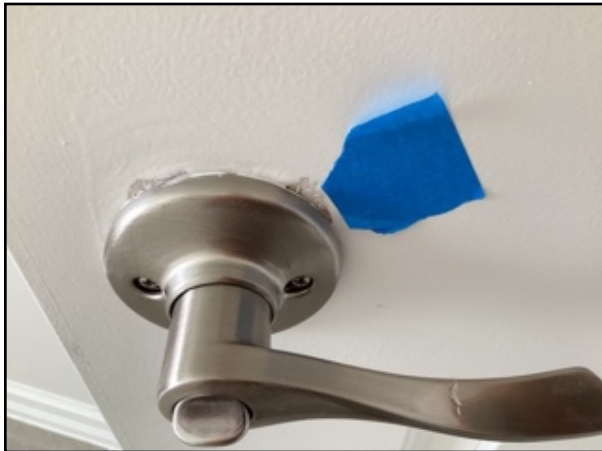
Hinged
Condition: Requires Repair

The doors are operating as intended, however there was a minor blemish/imperfection on one of the doors.

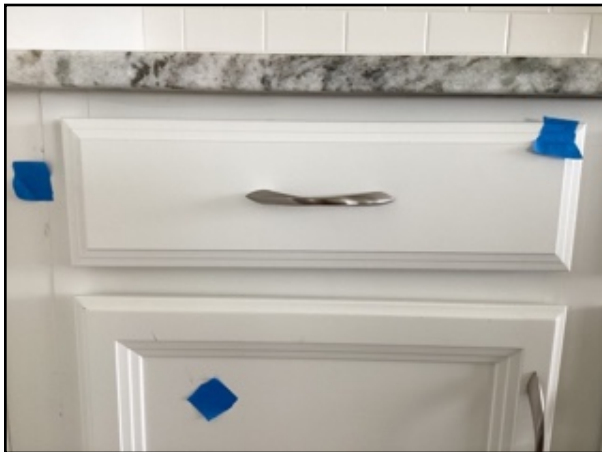
Opened and Closed as Intended
Condition: Requires Repair

There were several defects/deficiencies in regards to the cabinets to include: some doors and drawers are hung uneven, blemishes/imperfections in several areas, and a missing piece of molding was missing.

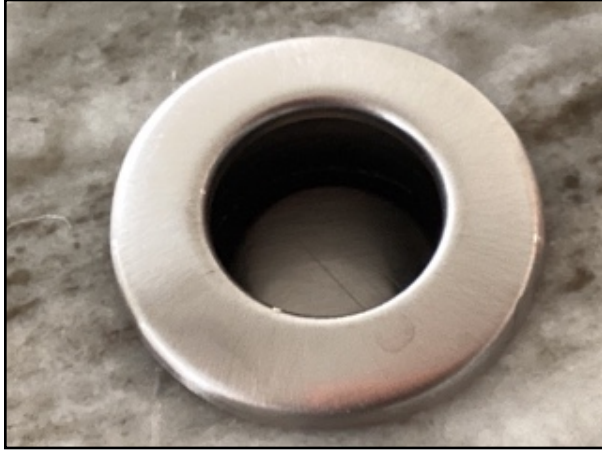
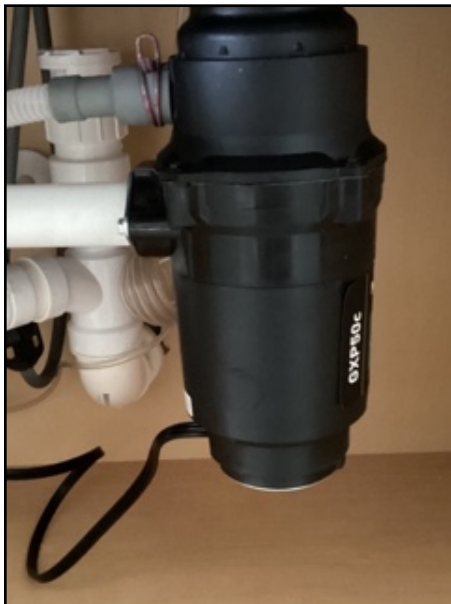
In Sink Erator, Not Operating as Intended
Condition: Requires Repair

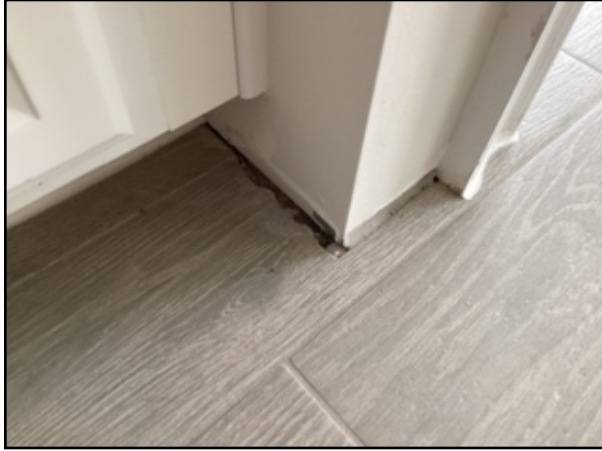
Figure 49-1

Two small pieces of base molding were missing. Installation is recommended.

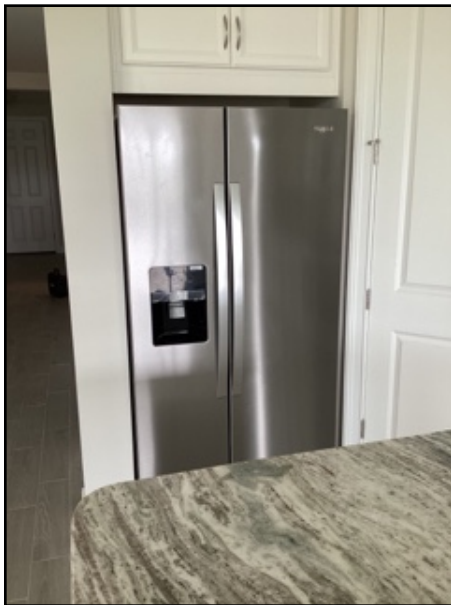
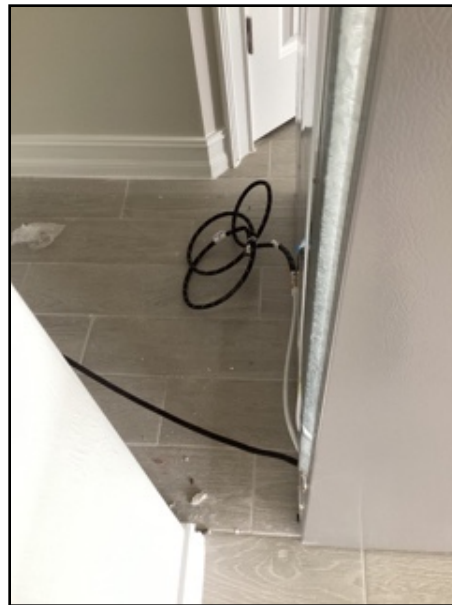
Refrigerator & Approximate Age : Whirlpool, Felt Cool, New
Condition: Requires Repair

The outlet for the refrigerator is connected to several GFCI outlets in the kitchen. It is better for the refrigerator to be wired to its own individual circuit. In addition there was not a water supply to the refrigerator. This prohibited the freezer from making ice and producing water.

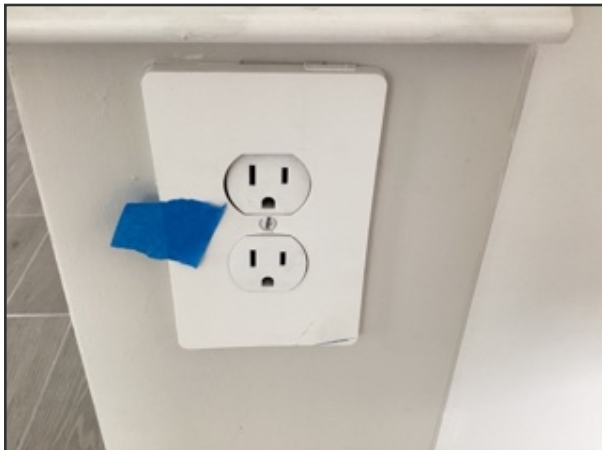
Operating as Intended, Some Outlets are
Crooked
Condition: Requires Repair

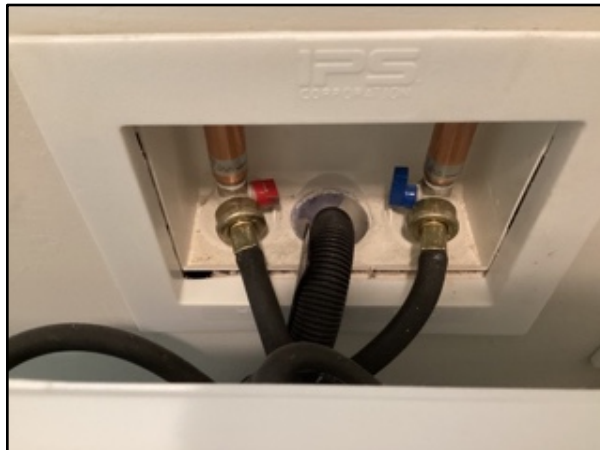
Yes
Condition: Further Evaluation Required

When testing the washer machine it was noted that hot water was coming from the cold side and cold water was coming from the hot side. It may be that the valves are crossed. Further evaluation is required and repairs made if necessary.
