Admirable Home Inspections, LLC

Home Inspection Report

Inspected on Wed, Oct 25 2023 at 8:30 AM

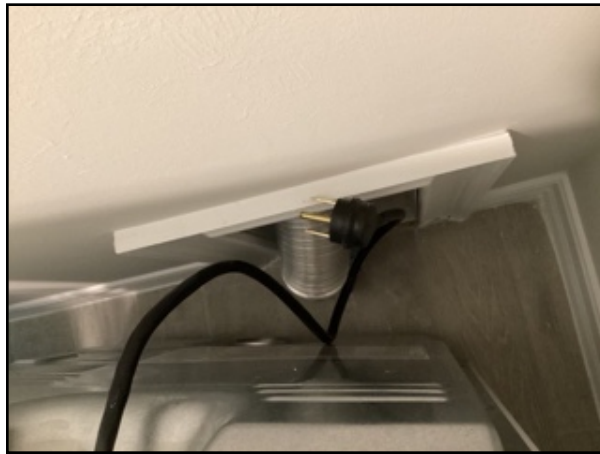
Condition: Requires Repair

The dryer vent was not connected to the dryer. If left unattended this will allow lint and moisture to vent into the laundry room.
