Admirable Home Inspections, LLC

Home Inspection Report

Inspected on Mon, Nov 6 2023 at 3:34 PM

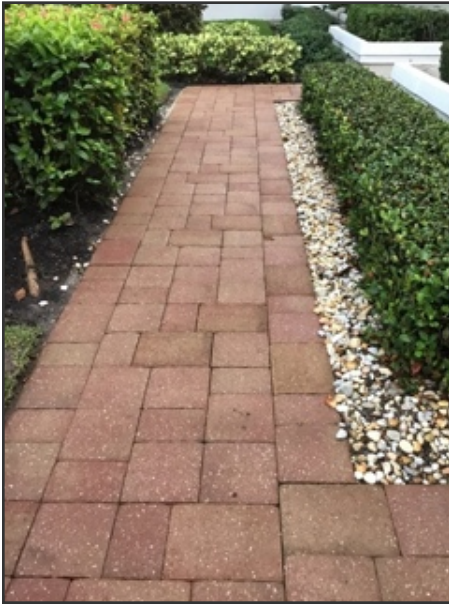
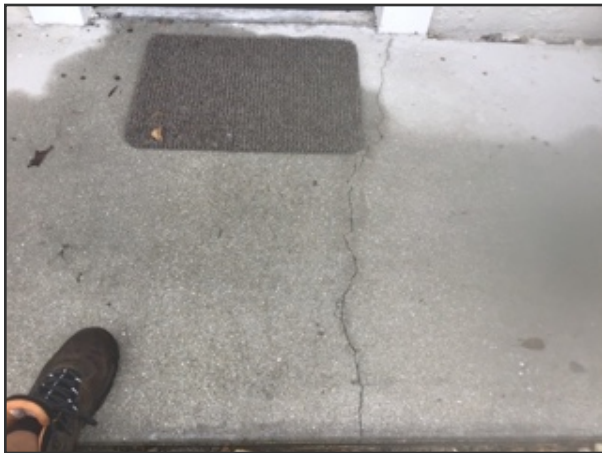
Comment 1:

The majority of the driveway and sidewalks were in acceptable condition. There was one small area on the driveway that was beginning to settle and a small crack was noted in the concrete by the non automobile door. It is recommended to monitor the settling and repair if needed and seal the crack in the concrete. This should help prevent water from penetrating and eroding the soil below.

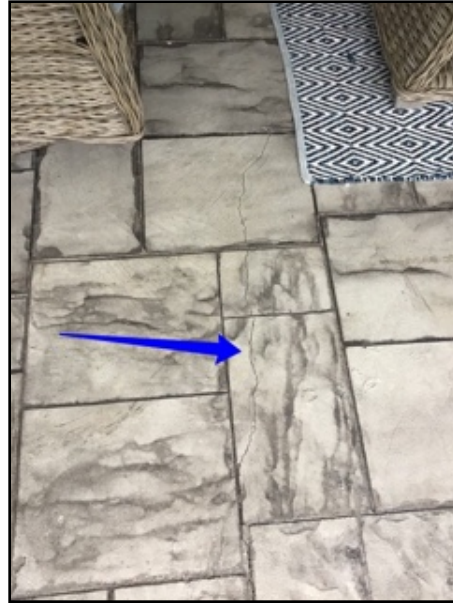
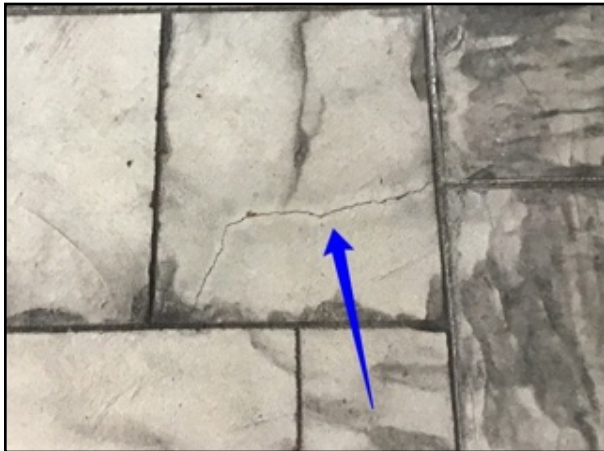
Stamped Concrete
Condition: Requires Maintenance

Day of inspection it was noted that there were several areas that have cracks. Cracks can develop from settlement in the soil below due to erosion, natural occurring slab settling, shrinking in the concrete which is typically from the evaporation of the water in the concrete during the curing process or expansion in the concrete due to the exposure to the extreme heat and fluctuations in the temperature. It is recommended to contact a licensed masonry contractor to further evaluate and to make repairs as needed.

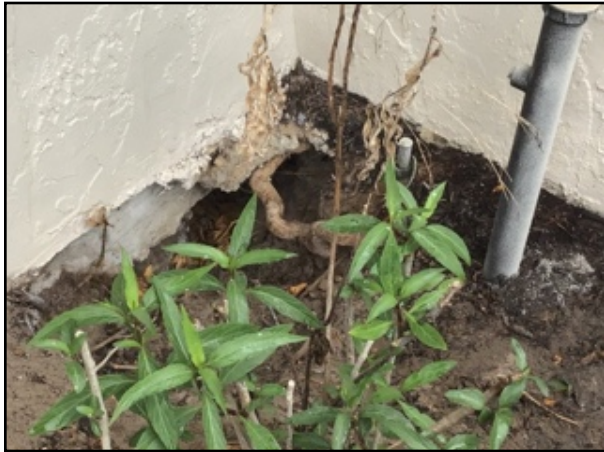
Figure 4-1

There was evidence of vermin intrusion. It is recommended to contact a pest management company to discuss a course of action and to fill the hole to avoid possible erosion from under the foundation slab.

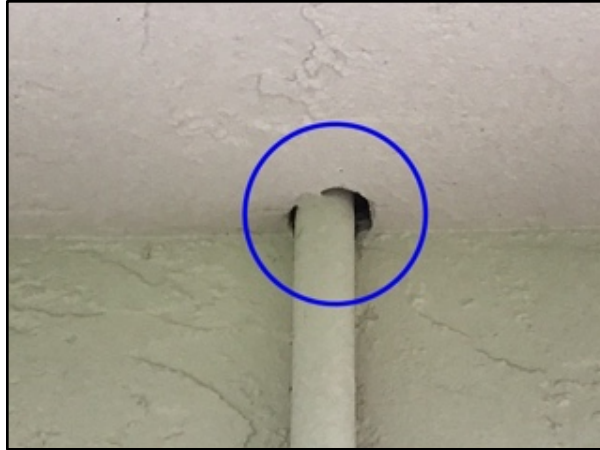
Wall Structure :	Concrete Block
	Condition: Satisfactory
Exterior Covering:	Stucco, Holes in Wall Covering
	Condition: Requires Maintenance

It is recommended to seal all protrusions. These areas can allow water/moisture, heat, insect and or vermin intrusion.

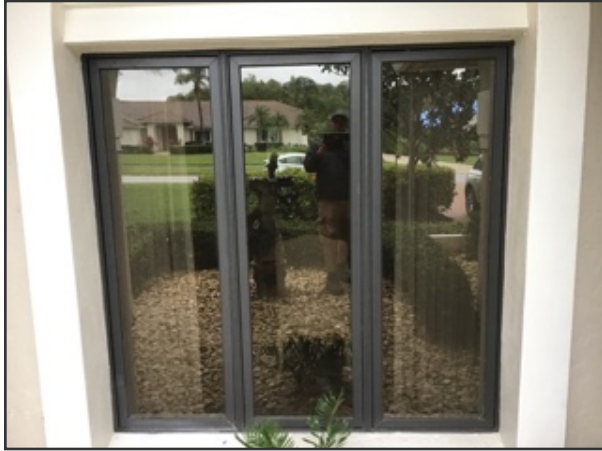
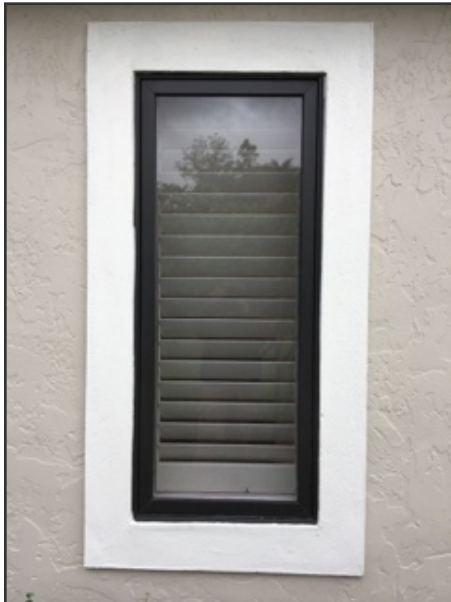
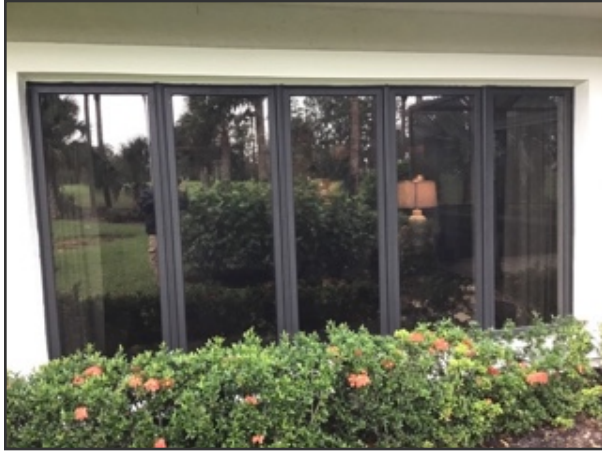
Windows:	Some Windows are Missing Screens
	Condition: Repair or Replace

The majority of the windows were an older style non insulated/energy efficient window. Some windows opened/closed/locked with difficulty. It is recommended to contact a licensed contractor to replace with windows that conform with todays standards.

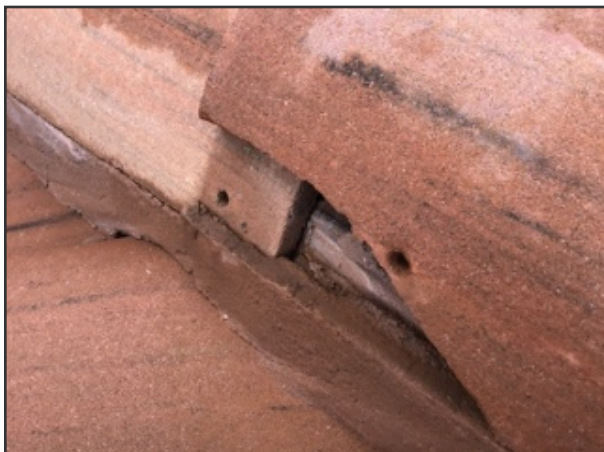
Damaged Tile, Debris Collecting in Valleys , Cracking in the Mortar

Condition: Repair or Replace

Day of inspection it was noted that the majority of the roof covering was in acceptable condition. There were a few areas that require repairing and removal of debris. It is recommended to contact a licensed roofing contractor to make repairs as needed.

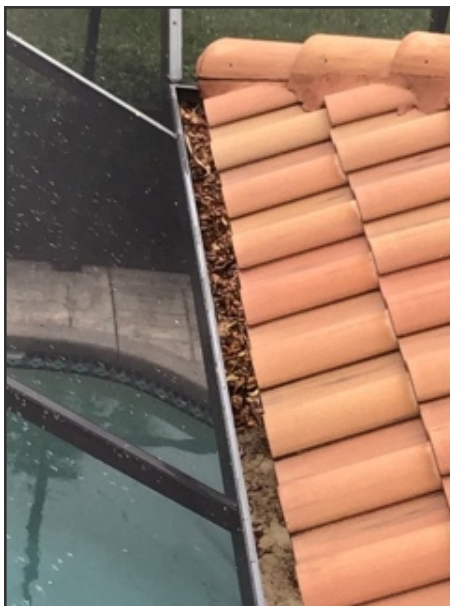
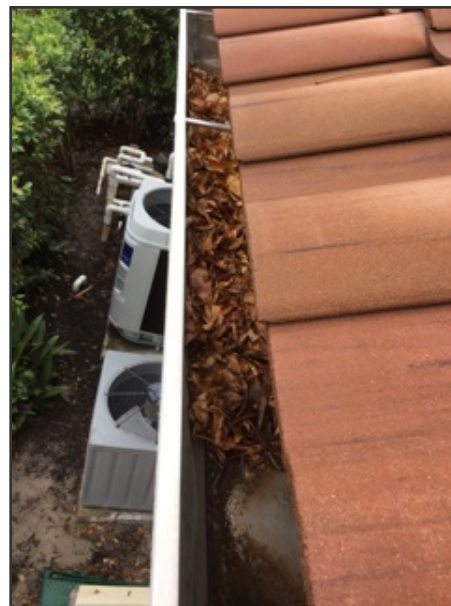
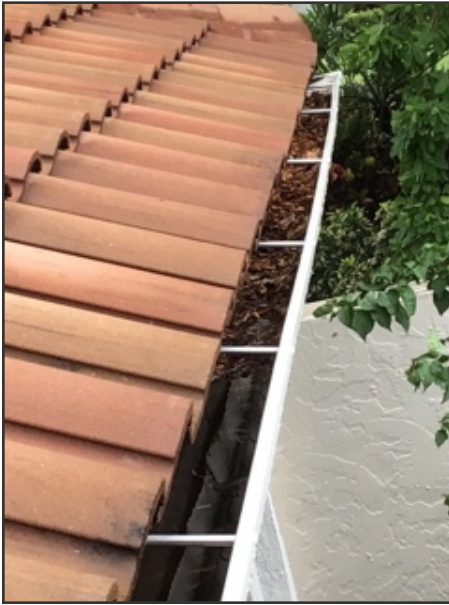
Filled with Debris

Condition: Requires Maintenance

Day of inspection it was noted that the gutters are collecting debris and pooling water was observed. Would recommend periodical cleaning to ensure they are collecting and dispensing water to the downspouts and the downspout extensions.

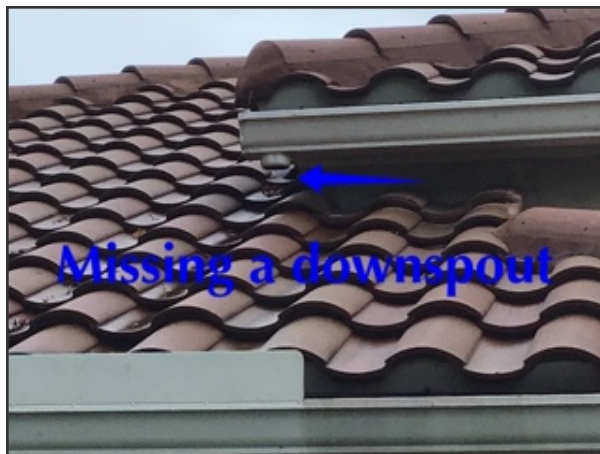
Missing

Condition: Repair or Replace

A downspout was missing. This can allow excessive water to drain on the roof. It is recommended to have the water diverted to the gutter system below by the use of a downspout. It is recommended to contact a licensed contractor to repair.

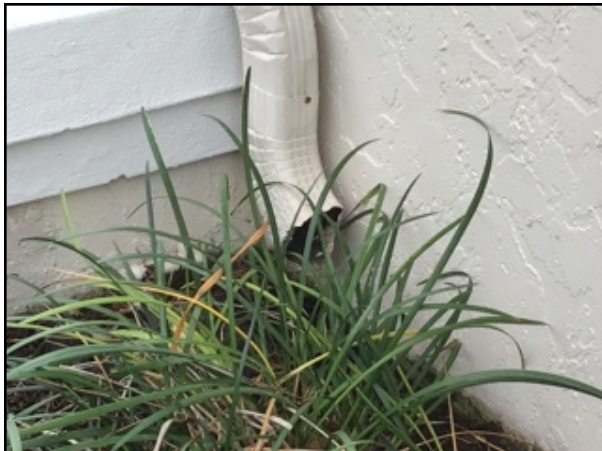
Not Long Enough

Condition: Requires Repair

Day of inspection it was noticed that the downspout extensions in some areas were not long enough. This can lead to additional water draining near the foundation system and components. Would recommend contacting a licensed contractor and repairing or replacing as needed.

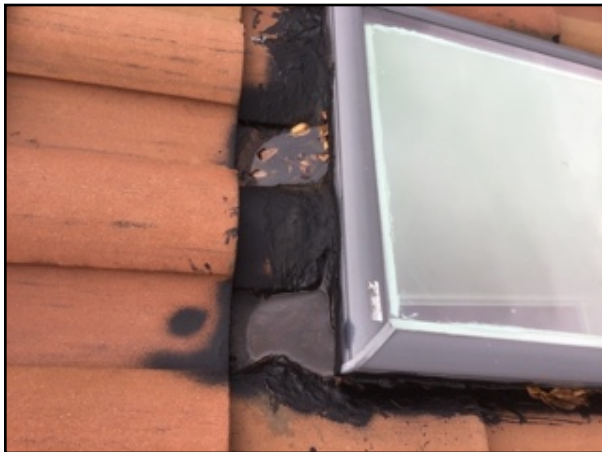
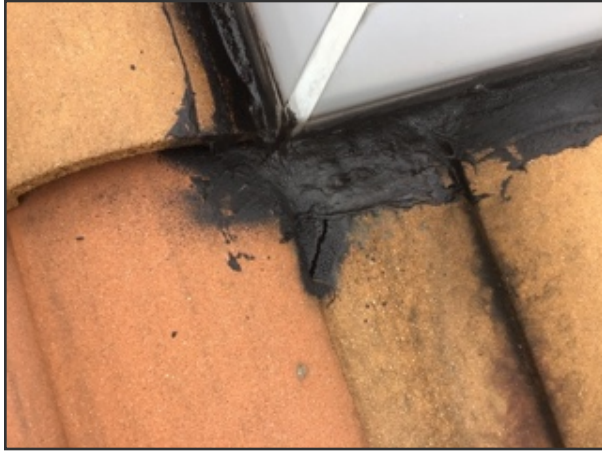
Flashings:

Tar/Caulk

Condition: Requires Repair

Day of inspection it was noted that there were concerns in regards to the flashing around the roof protrusions. If left unattended this can cause water penetration into the attic and create additional concerns. Would recommend contacting a qualified contractor to repair areas as needed.

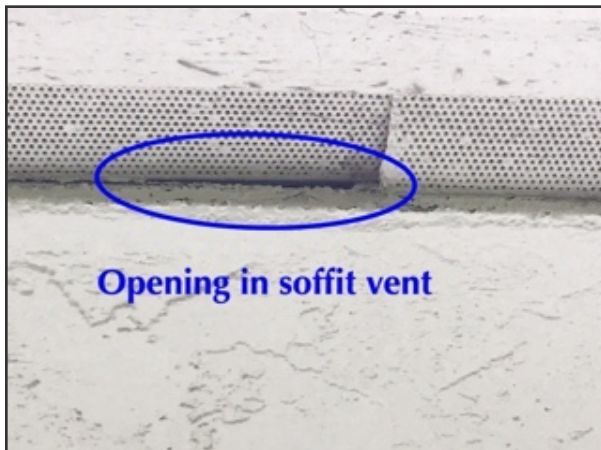
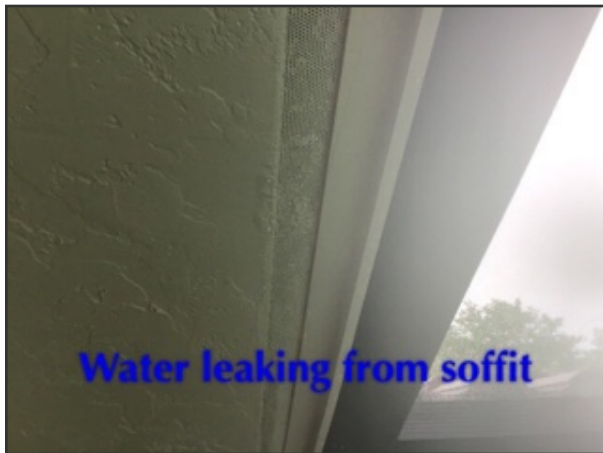
Wood, Stucco

Condition: Requires Further Evaluation and Maintenance

There were openings in areas of the soffits and water was leaking out of one area. This area was near the pool. It was also noted that the gutter in that area was filled with debris and this may be the cause. It is recommended to contact a licensed contractor to further evaluate and make repairs as needed.

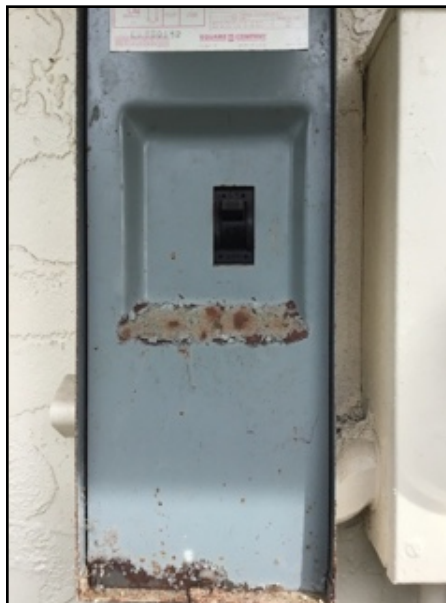
Main Panel/Sub Panel Condition :

Rust Present

Condition: Further Evaluation Required

Day of inspection it was noted that there was rust on the service panel. The moisture/dampness may deteriorate the metal components inside the panel and cause micro - arcing, premature breakdown of the breakers and breaker failure. Would recommend contacting a licensed electrician to discuss a remedy and to repair or replace as needed.

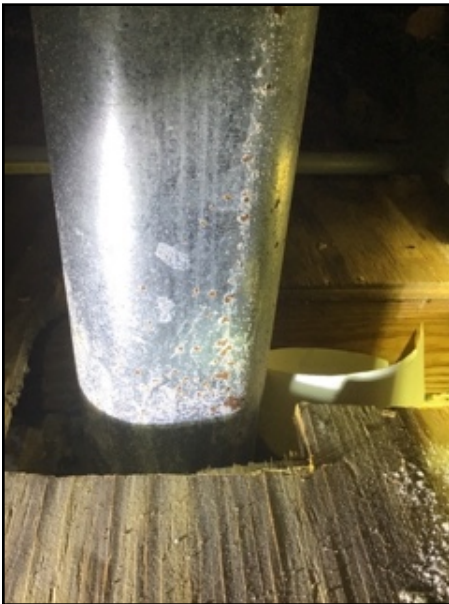
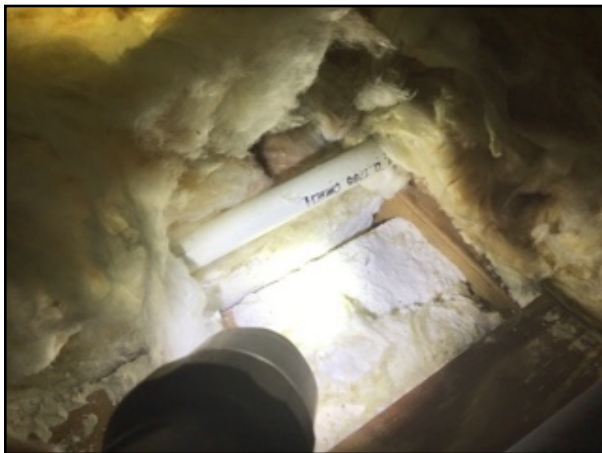
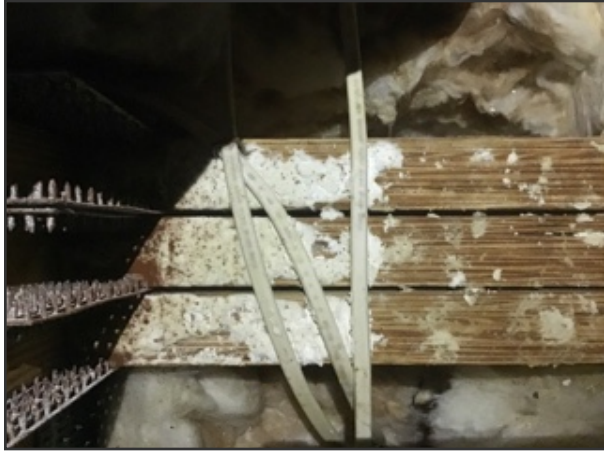
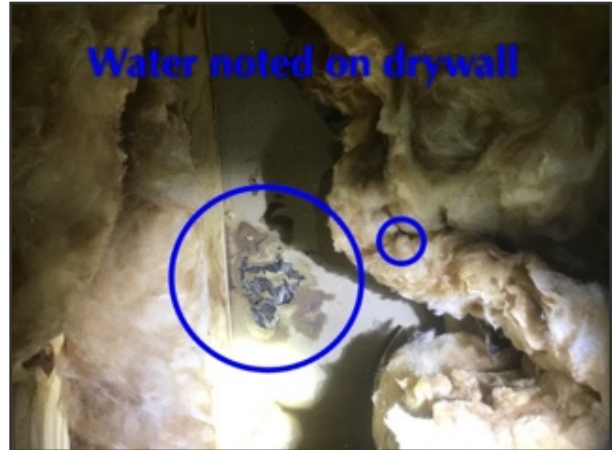
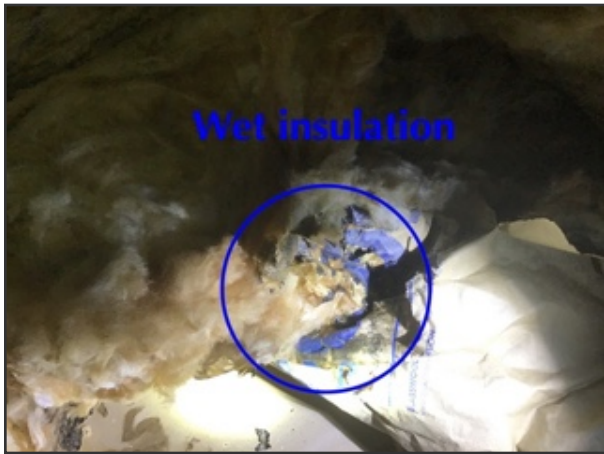
Noted
Condition: Further Evaluation Required

Day of inspection it was noted that there were signs of moisture in the attic. Several metal connectors/gussets on the trusses and vents were rusting. There was a wet area on the sheetrock and insulation. The probable cause may be from wind driven rain that entered the roof vents. Multiple wood trusses were tested with a moisture meter and indicated that there were high levels of moisture. It was also noted that main air handler was leaking cold air in to the attic. In addition, there may have been evidence of microbial growth. While we will report any substance that appears to be microbial growth, the only true way to confirm is to have a licensed specialist inspect and test the substance. It is recommended to contact a licensed contractor to further evaluate and make repairs as needed.

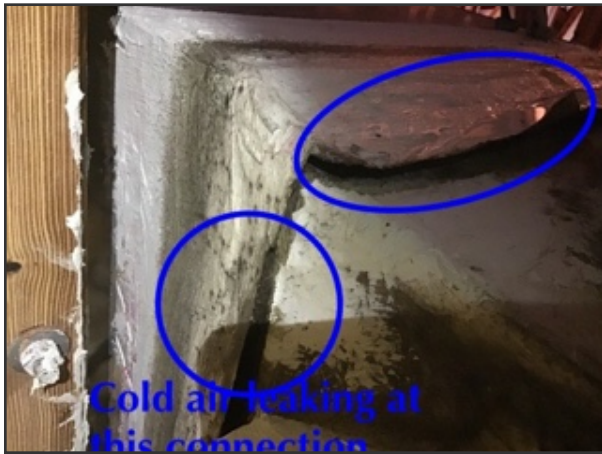
Figure 18-1

Cold air was leaking out of the air handler. This can cause moisture in the attic. There was condensation and a microbial substance on the duct work. It is recommend to contact a licensed HVAC Company to perform a duct leakage test and making all repairs as needed to include removing the microbial substance.

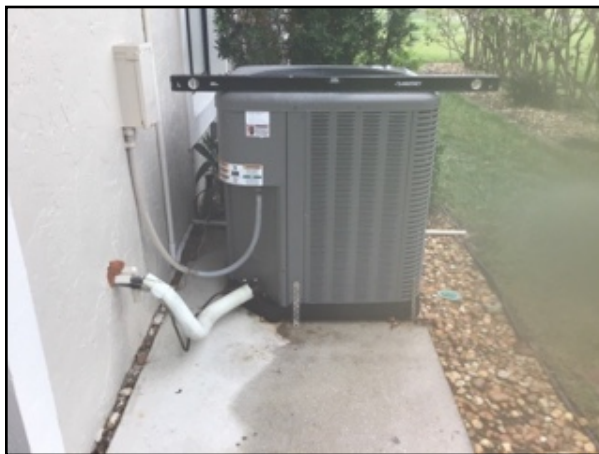
Concrete, Not Level

Condition: Requires Adjustments

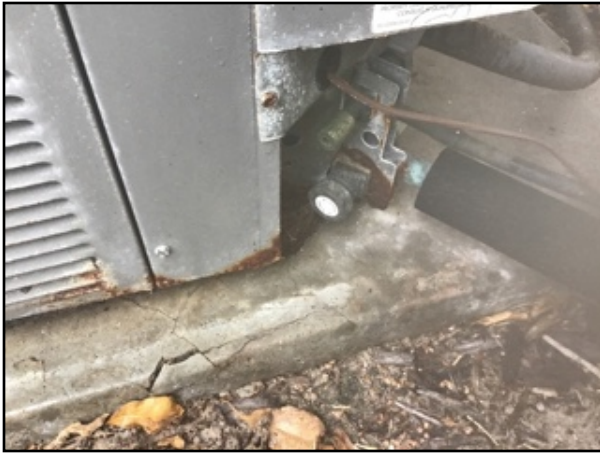
Figure 21-1

Day of inspection it was noted that the AC pad was not level. This was the secondary unit located by the pool equipment. When the unit is not level this can prohibit the proper distribution of the fluids and lubricants causing damage to the compressor. It is recommended to contact a licensed HVAC contractor to make repairs.

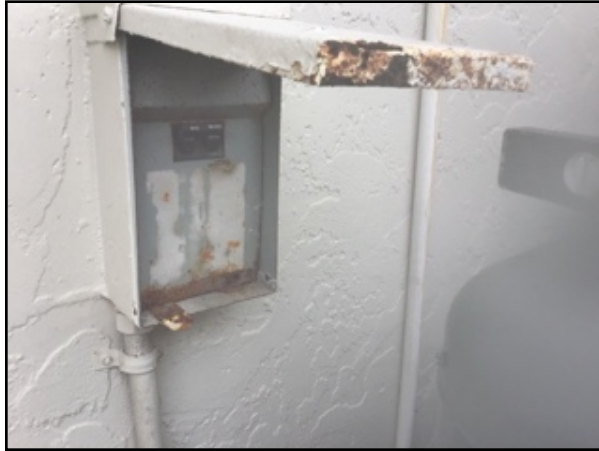
Noted and in Poor Condition
Condition: Further Evaluation Required

Day of inspection it was noted that there was rust on the electrical disconnect. The moisture/dampness may deteriorate the metal components inside the panel and cause micro - arcing, premature breakdown of the breakers and breaker failure. Would recommend contacting a licensed electrician to discuss a remedy and to repair or replace as needed.

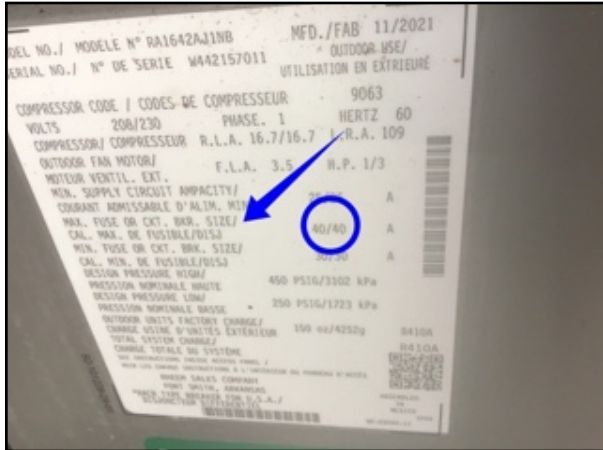
Figure 23-1

The disconnect on the main AC unit was over rated. The unit called for a maximum of 40 amps. The breaker was 60 amps. This can be a safety concern and should be repaired by a licensed electrician.

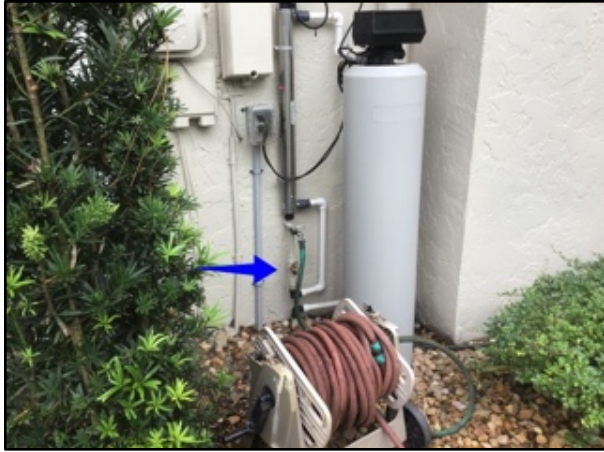
Damaged and Corrosion was Noted

Condition: Recommend Replacing

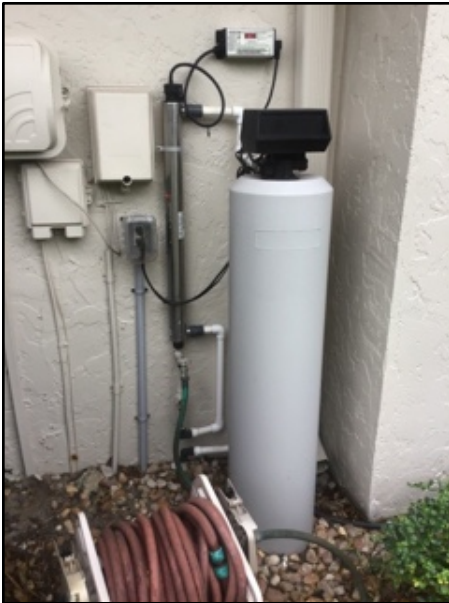
Figure 29-1

Day of inspection it was noted that there was water conditioning equipment present. It is not a "Standard of Practice" to observe and report on such systems. However, it is recommended to contact a licensed or qualified contractor for proper inspection and or servicing of the system.

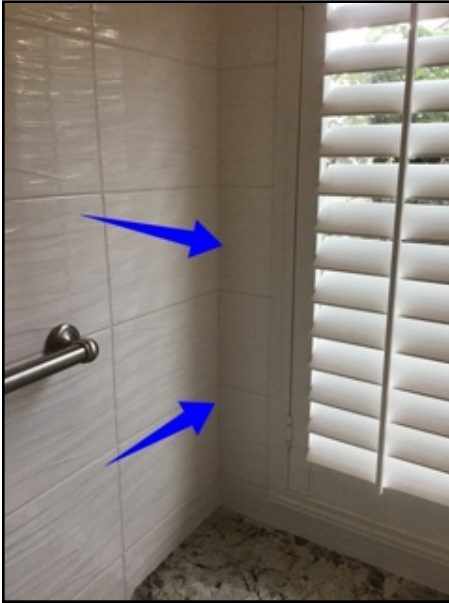
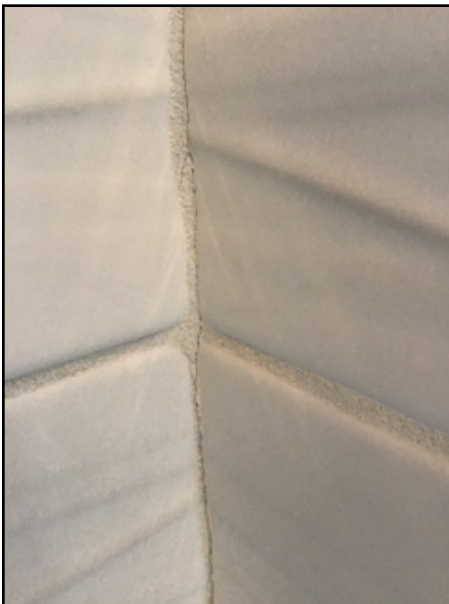
Tile, Cracked/Damaged Caulking/Grout
Condition: Requires Maintenance

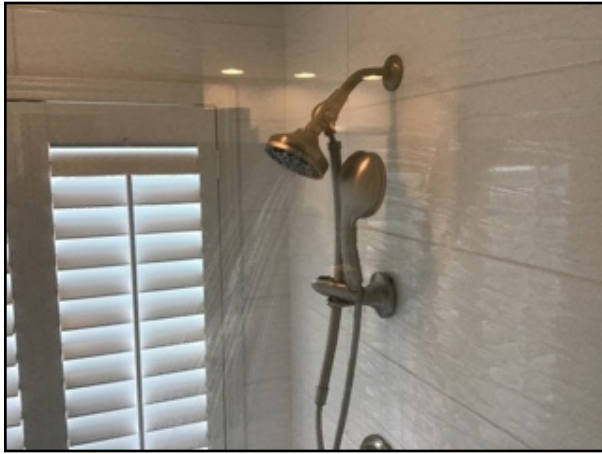
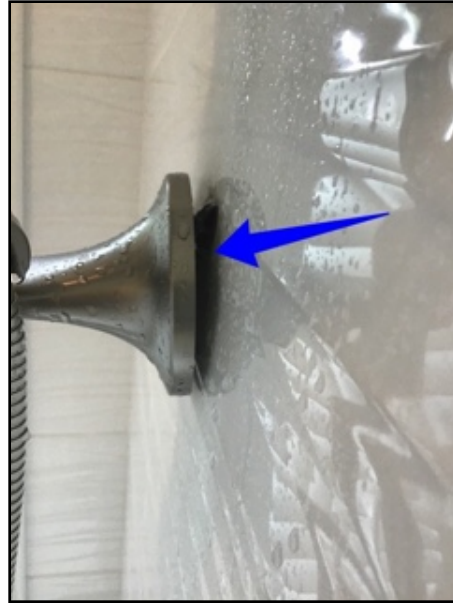
Condition: Requires Repair

The shower fixture was not fastened properly to the wall. It is recommended to contact a licensed contractor to repair.

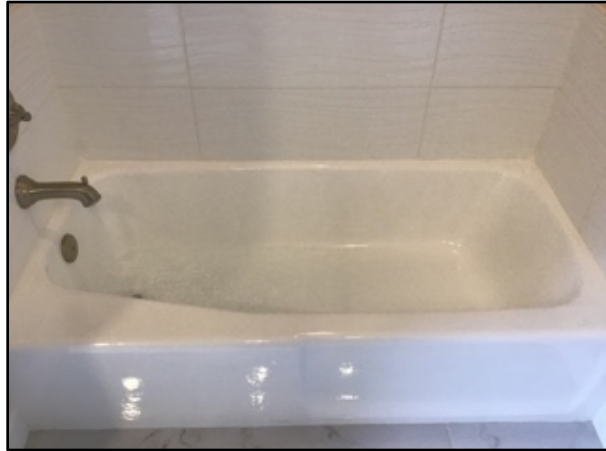
Condition: Further Evaluation Required

Day of inspection it was noted that the bath tub drained slowly. This can be from a lack of air in the waste pipes. It is recommended to contact a licensed plumber to further evaluate and make repairs as needed.

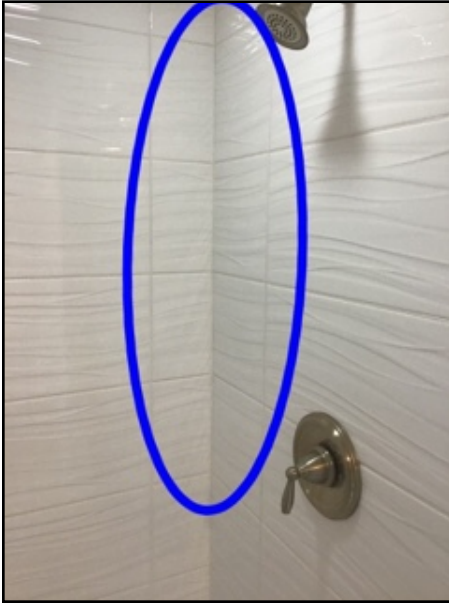
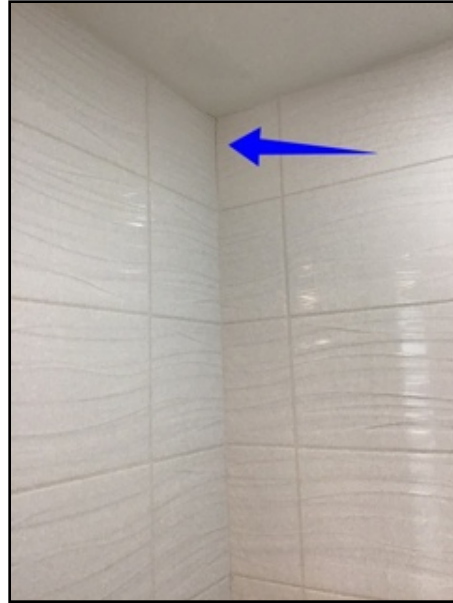
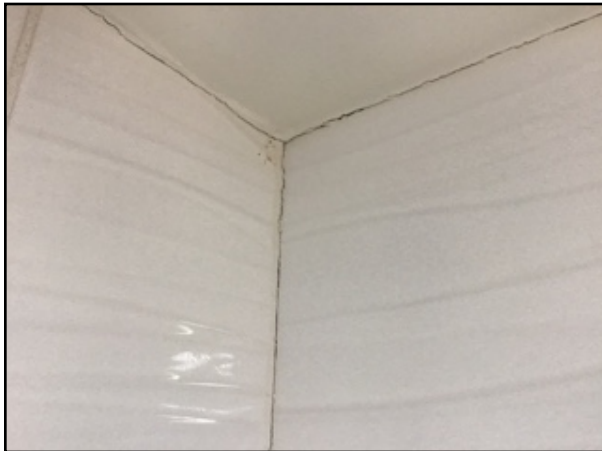
Missing/Damaged Caulking/ Grout
Condition: Requires Maintenance

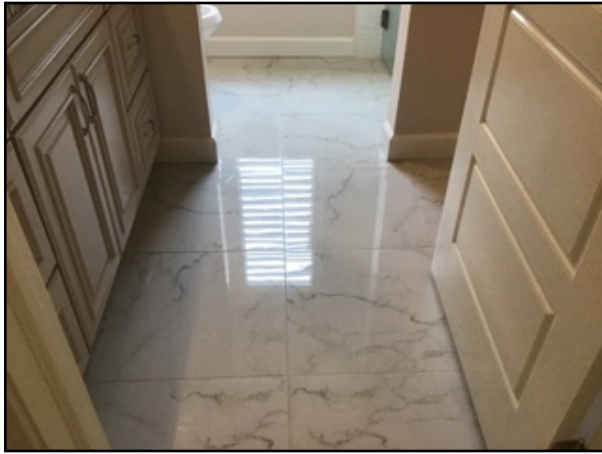
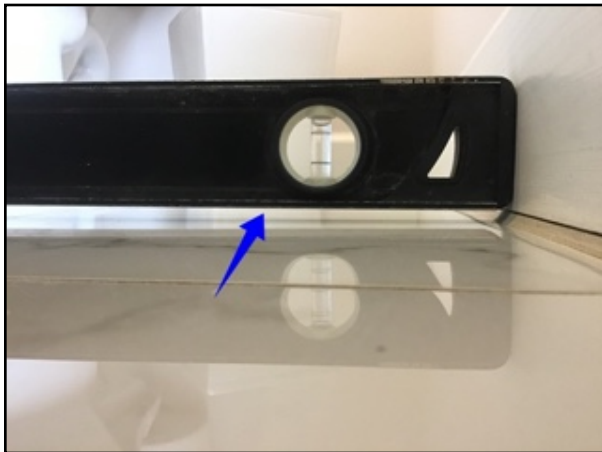
Condition: Further Evaluation Required

The floor appeared to be out of level. This was located in front of the toilet. This should be further evaluated by a licensed contractor and repaired.

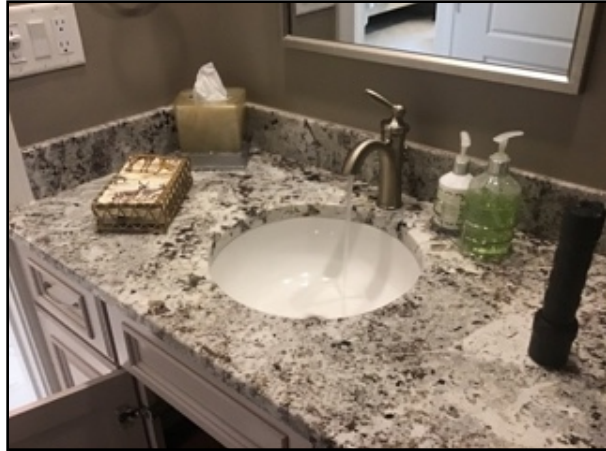
Single Vanity, Drain Stop not Operating
Condition: Requires Maintenance

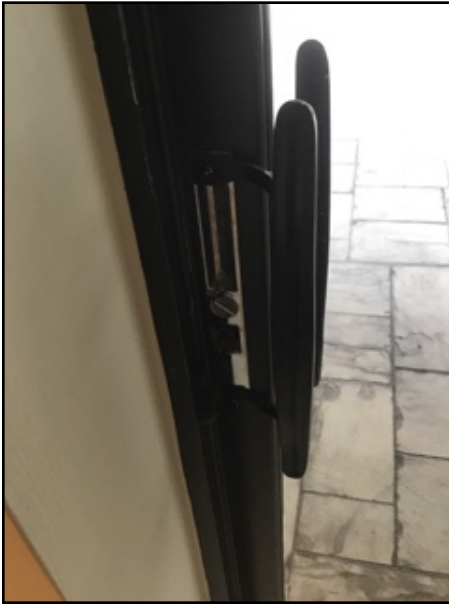
Figure 34-1

The main lock mechanism did not operate, however there was a secondary lock on the door. This was located in the master bedroom.

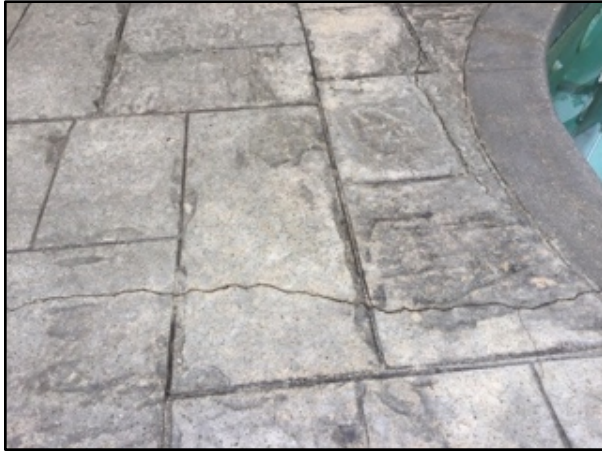
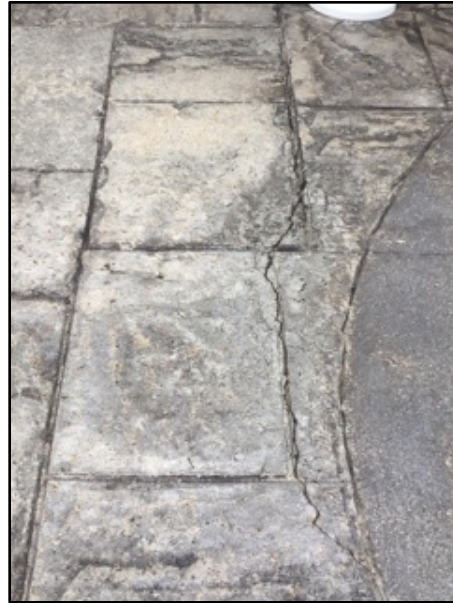
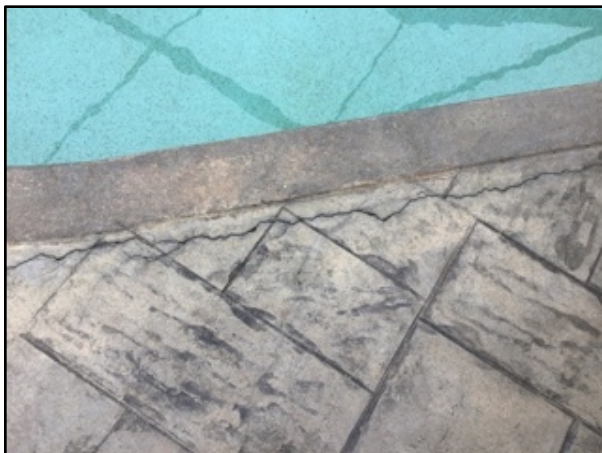
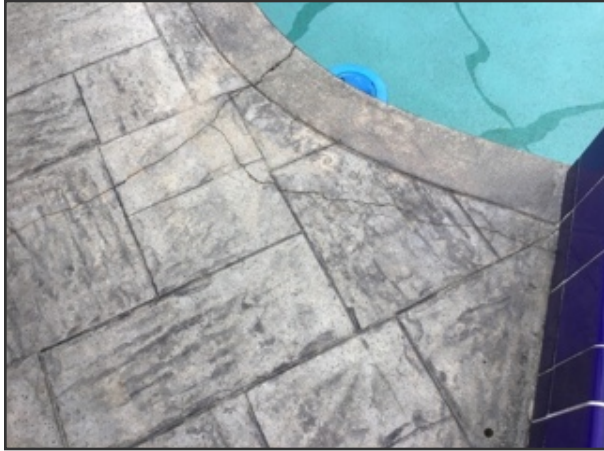
Comment 35:

Condition: Further Evaluation Required

Day of inspection it was noted that there were several areas that have cracks. Cracks can develop from settlement in the soil below due to erosion, natural occurring slab settling, shrinking in the concrete which is typically from the evaporation of the water in the concrete during the curing process or expansion in the concrete due to the exposure to the extreme heat and fluctuations in the temperature. It is recommended to contact a licensed masonry contractor to further evaluate and to make repairs as needed.

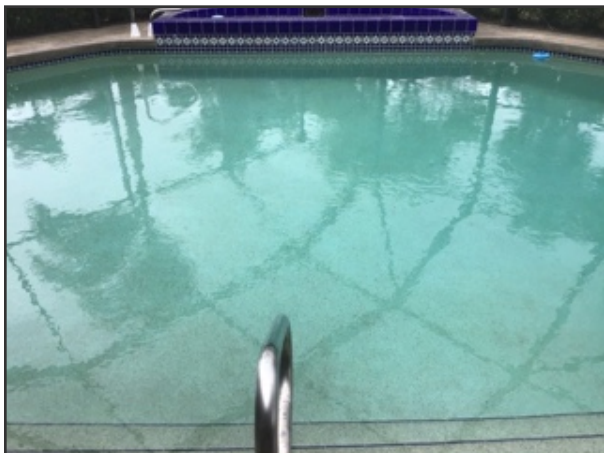
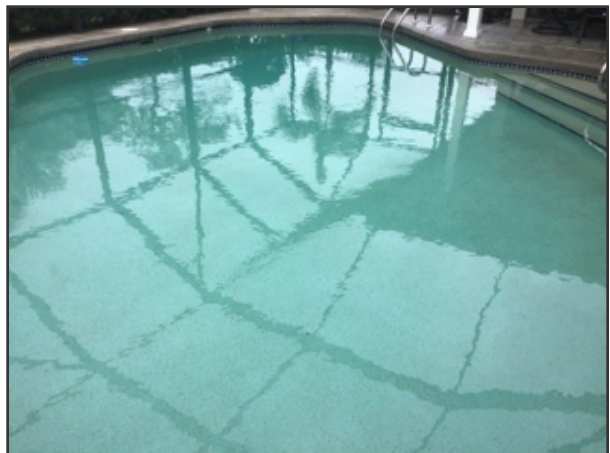
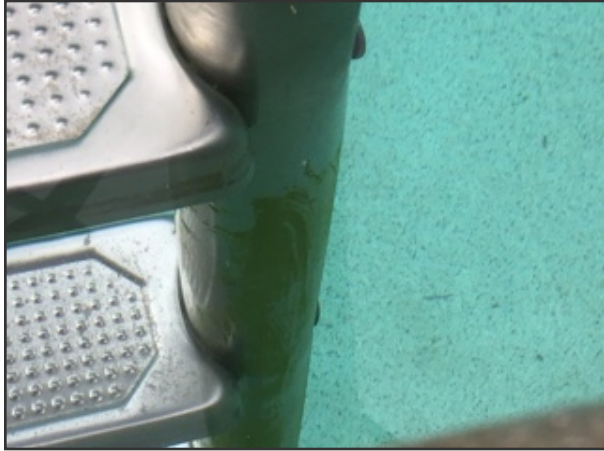
Comment 36:

Day of inspection it was noted that there were areas of discoloration/staining in the pools surface. There are several causes for the staining (mottling). They are primarily caused by metals in the water, salt, chlorine, algaecides, metal fixtures to name a few. The only true way to determine the cause is to have the stains and water tested. Knowing the cause can help prevent staining. It is recommended to contact a licensed pool management company to test the water and stains and then implement a treatment plan.

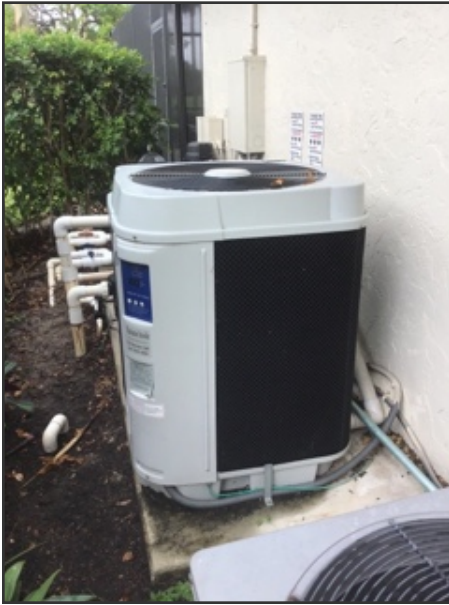
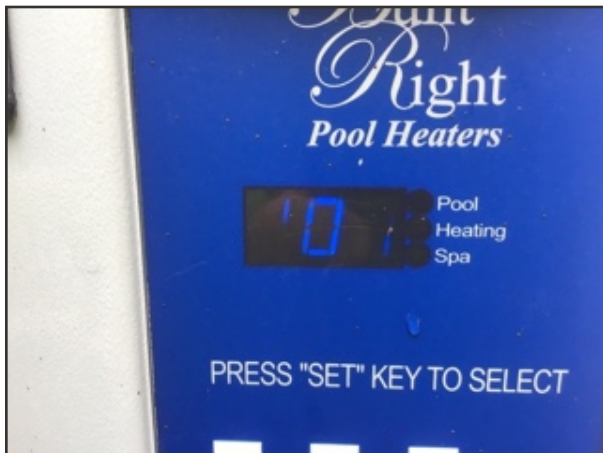
Comment 37:

Day of inspection it was noted the the equipment may have been the original equipment. The pump and filters were functioning as intended. The heater did not operate when tested. It is recommended to contact a licensed pool maintenance company to thoroughly evaluate the equipment and further evaluate the heater.

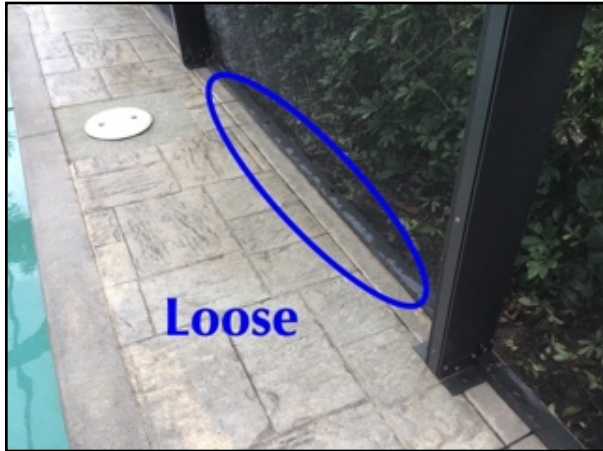
Comment 38:

Condition: Requires Maintenance

The majority of the screen enclosure was in acceptable condition. There was one screen rail that was loose. It is recommended to repair as needed.
